Repairing Cherry Tree Creek from Impacts of Flood Water

A Case Study

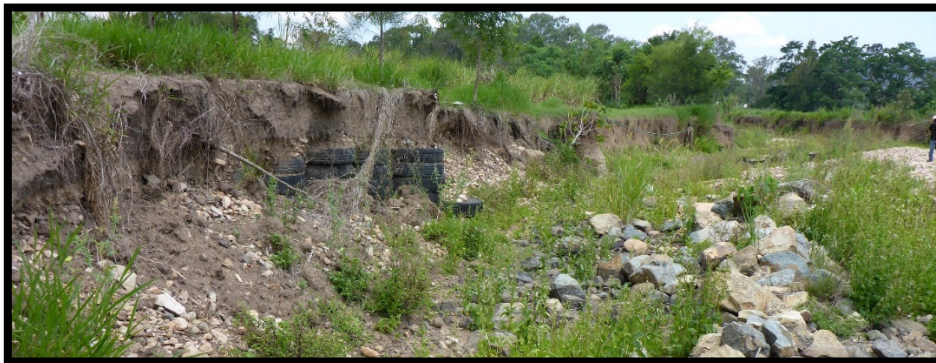
- There has been past investment in the restoration of Cherry Tree Creek. Rock toe revetment works were undertaken by Reef Catchments at CT1 in 2015 conjunction with revegetation works on a meander over a bank length of approximately 70m. This rock toe revetment has been outflanked (Fig 1) at the downstream extents of the works. It is likely that this outflanking occurred due to the floodplain being composed of historical fill material, as evidenced by the exposed vehicle tyres present in the eroded bank.

Figure 1 Looking downstream from bed at left bank where Reef Catchments rock toe protection works have been outflanked.

The options assessment determined that the application of timber pile fields, rock groynes or engineered log jams was not suitable for stabilisation of the banks along Cherry Tree Creek and recommended traditional rock toe revetment with the banks battered back. Works were recommended at six sites (Fig 4). Site naming was extended to have CT1 – CT6. Works at sites CT1-4 included reprofiling, rock protection and revegetation however sites CT5 and CT6 were reprofiled and revegetated only.

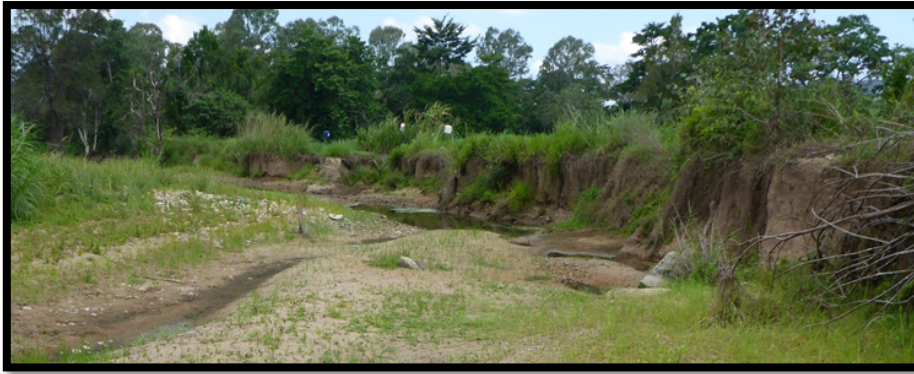
- Approximately 380m of revegetation works (left bank of Cherry Tree Creek) was undertaken by Reef Catchments in 2015. The revegetation had been successful pre STC Debbie however the site was threatened by active deepening and widening of Cherry Tree Creek, which has already resulted in significant bank erosion and loss of revegetation works in places (Fig 2).

Figure 2 Looking upstream from bed at left bank where Reef Catchments revegetation works have been lost to erosion.
