▶ **OAKY CREEK**

Restoring Riparian Resilience

Restoring Riparian Resilience along Oaky Creek
A Natural Disaster Relief and Recovery Arrangements
Funded Project Following Severe Tropical Cyclone Debbie

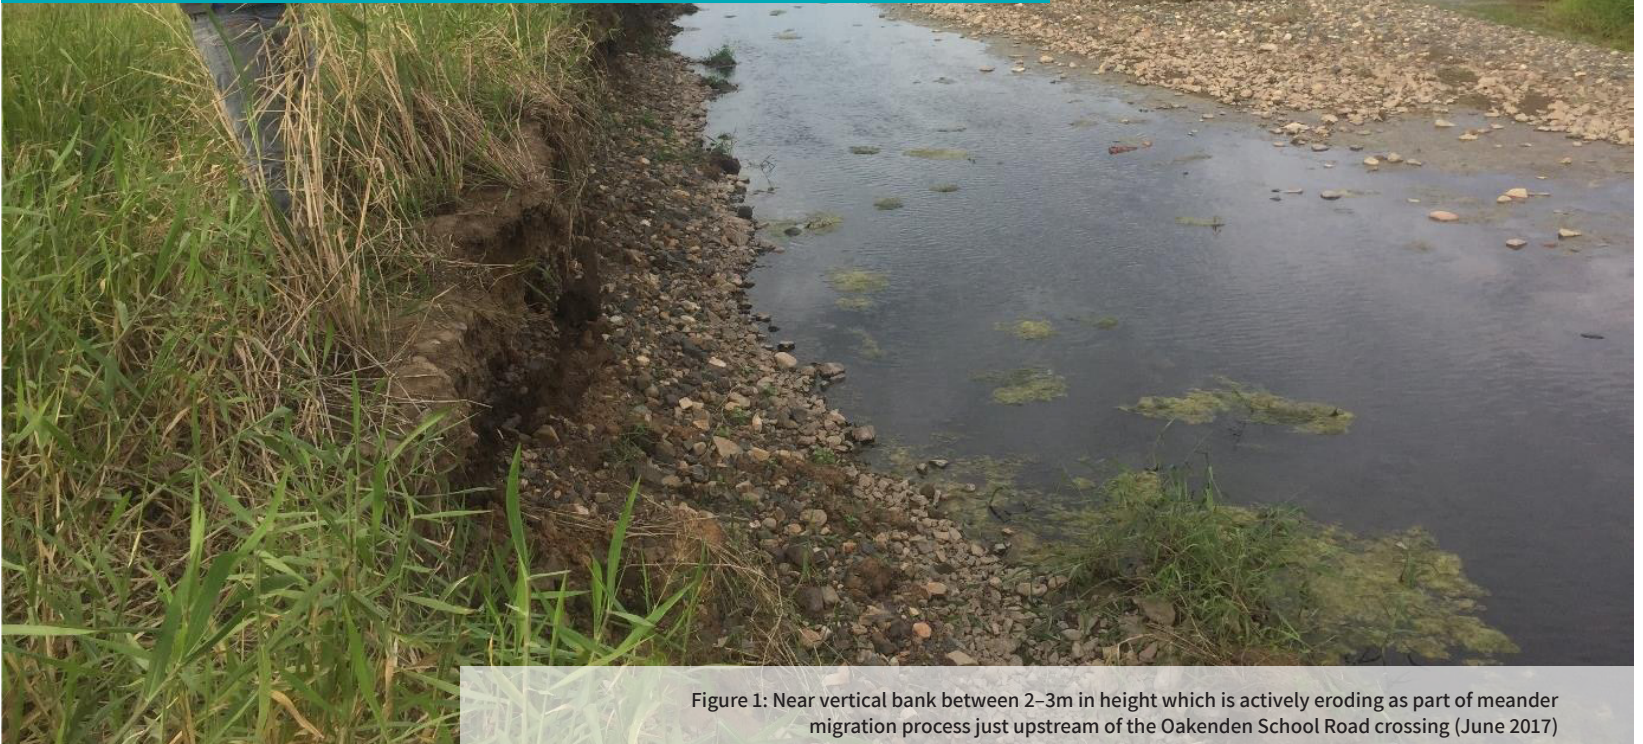
Figure 1: Near vertical bank between 2–3m in height which is actively eroding as part of meander migration process just upstream of the Oakenden School Road crossing (June 2017)

- Active bank retreat was occurring throughout. The dominant processes appeared to be meander development and migration. Numerous outside meanders were 2–3 m high, near vertical and threatening adjacent land and assets (Fig 1 and 5). The bank stratigraphy consists of a cohesive silt/clay layer overlaying a gravels and cobble matrix. The depth of the cohesive silt/clay layer varies substantially along the creek.
- Previous rock revetment bank stabilisation works have been undertaken with mixed results (Fig 6).
- Two major crevasses splays occurred upstream of the Oakenden Road crossing resulted in significant volumes of coarse sediment deposited on floodplains (Fig 4).
- Infrastructure including the Sunwater Siphon (site O-BM1), a council road (site O-BM4) and an Ergon power pole (site O-BM4 – see Fig 3) were at threat due to ongoing erosion.

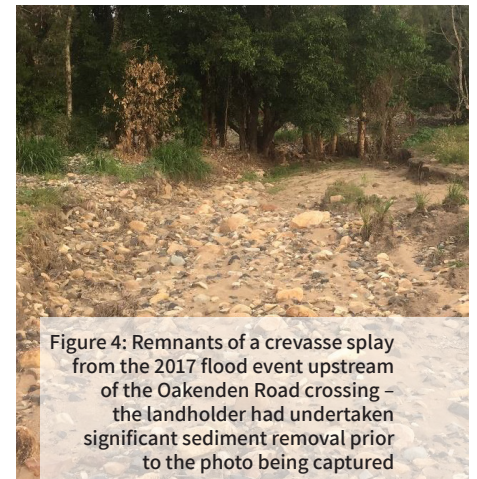
Figure 4: Remnants of a crevasse splay from the 2017 flood event upstream of the Oakenden Road crossing – the landholder had undertaken significant sediment removal prior to the photo being captured

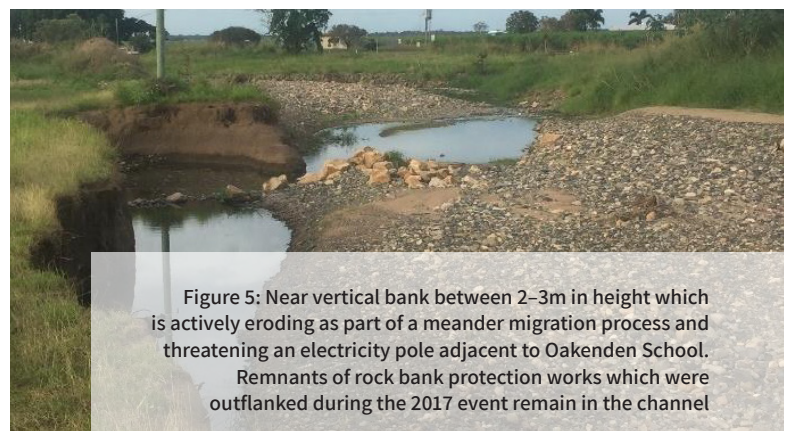
Figure 5: Near vertical bank between 2–3m in height which is actively eroding as part of a meander migration process and threatening an electricity pole adjacent to Oakenden School. Remnants of rock bank protection works which were outflanked during the 2017 event remain in the channel

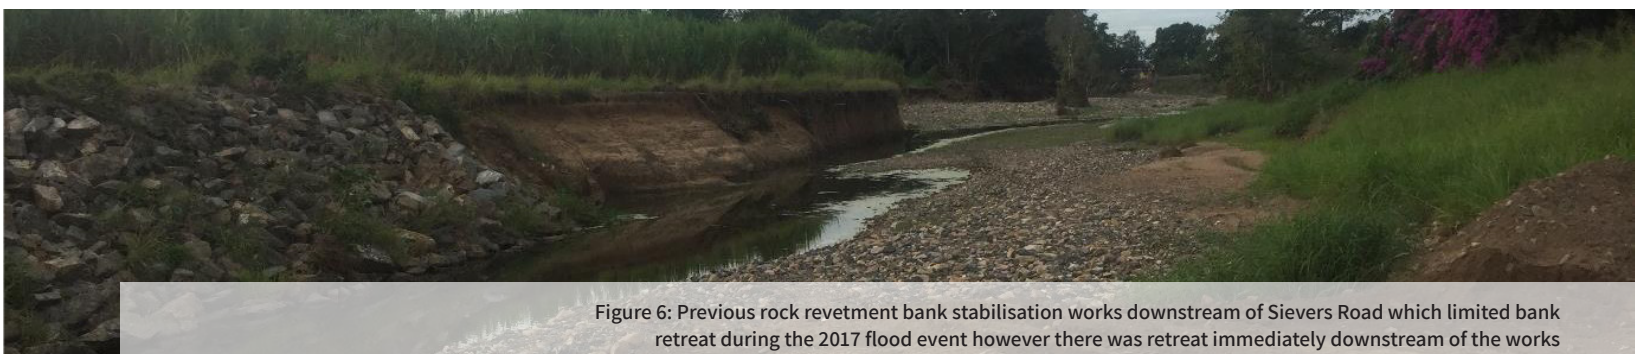
Figure 6: Previous rock revetment bank stabilisation works downstream of Sievers Road which limited bank retreat during the 2017 flood event however there was retreat immediately downstream of the works

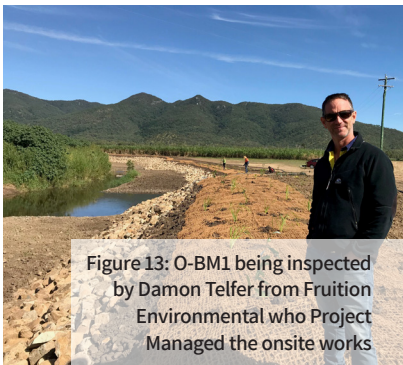
Figure 13: O-BM1 being inspected by Damon Telfer from Fruition Environmental who Project Managed the onsite works

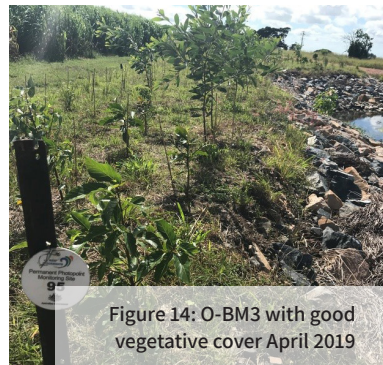
Figure 14: O-BM3 with good vegetative cover April 2019

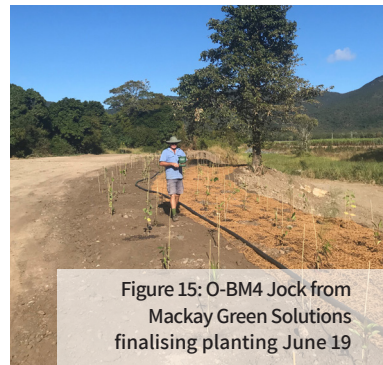
Figure 15: O-BM4 Jock from Mackay Green Solutions finalising planting June 19

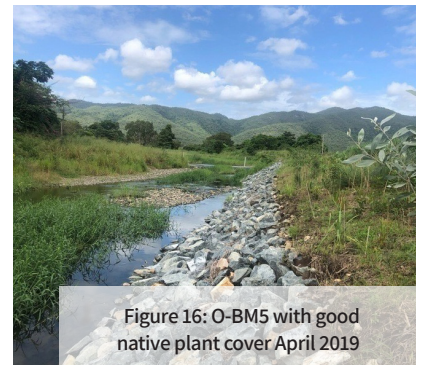
Figure 16: O-BM5 with good native plant cover April 2019
