*Mackay Coasts and Communities*

# Ball Bay

## Beach Plan

2010

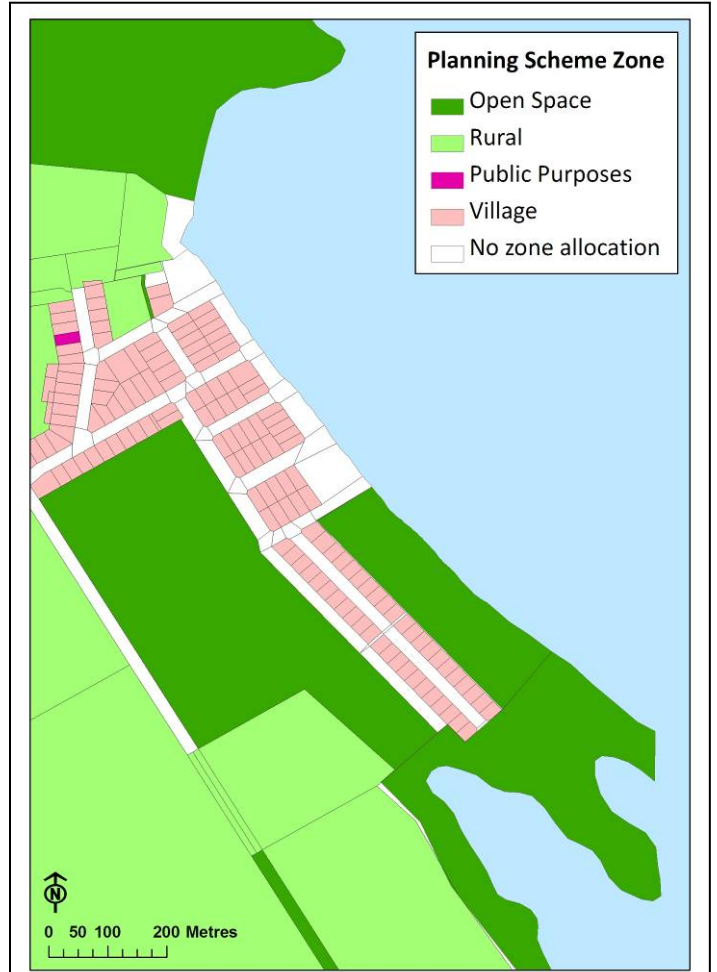
**Figure 3: Planning scheme zonation Ball Bay**

The Ball Bay residential area stretches much of the length of the beach, being predominantly Freehold tenure and zoned as Village (Figures 2, 3). An Esplanade, zoned as Open Space, of between 20 and 90 metres exists along the length of this residential settlement, and the southern 700 metres of beach front are free of settlement. Cape Hillsborough National Park borders the beach and residential area to the north. Approximately 15 hectares of State Land under the management of the Department of Environment and Natural Resource Management exists in the centre of the beach unit some 200 metres from the foreshore, however is not included in these recommendations.

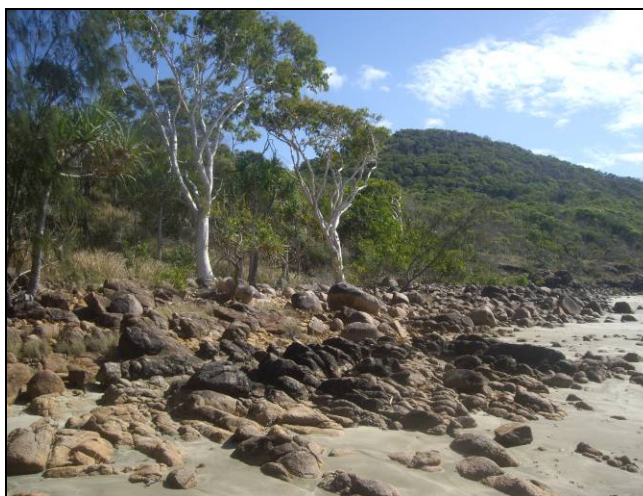
**Figure 4:** Mixed-eucalypt open to woodland forests on McBrides Point are protected by Queensland legislation.

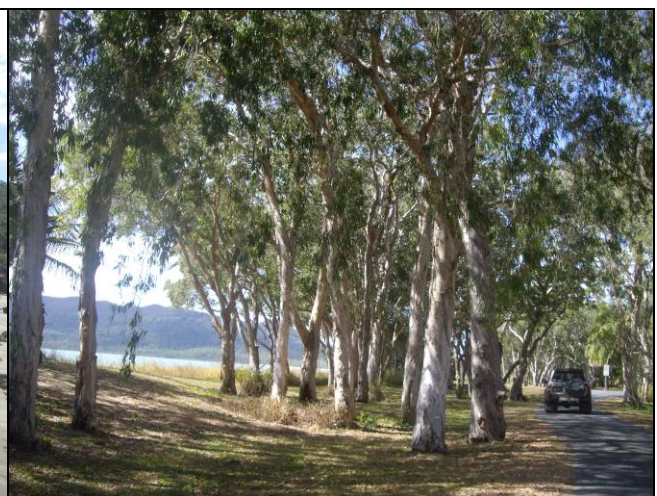
Remnant vegetation has been largely removed from the residential frontage, and pre-clearing mapping shows that this area was previously a combination of eucalypt and acacia open forest with beach scrub understorey (RE 8.2.6a, 90%); melaleuca species woodland (RE 8.2.11, 5%); and casuarina open forest with spinifex dominated ground layer on foredunes (RE 8.2.1, 5%) (Environmental Protection Agency, 2003). Localised stands of these communities are still present along with Esplanade (Figure 5), which would have reached some 350 metres inland.

**Figure 5:** Stands of *Melaleuca spp.* along the Esplanade of Ball Bay beach are representative of pre-clearing vegetation.

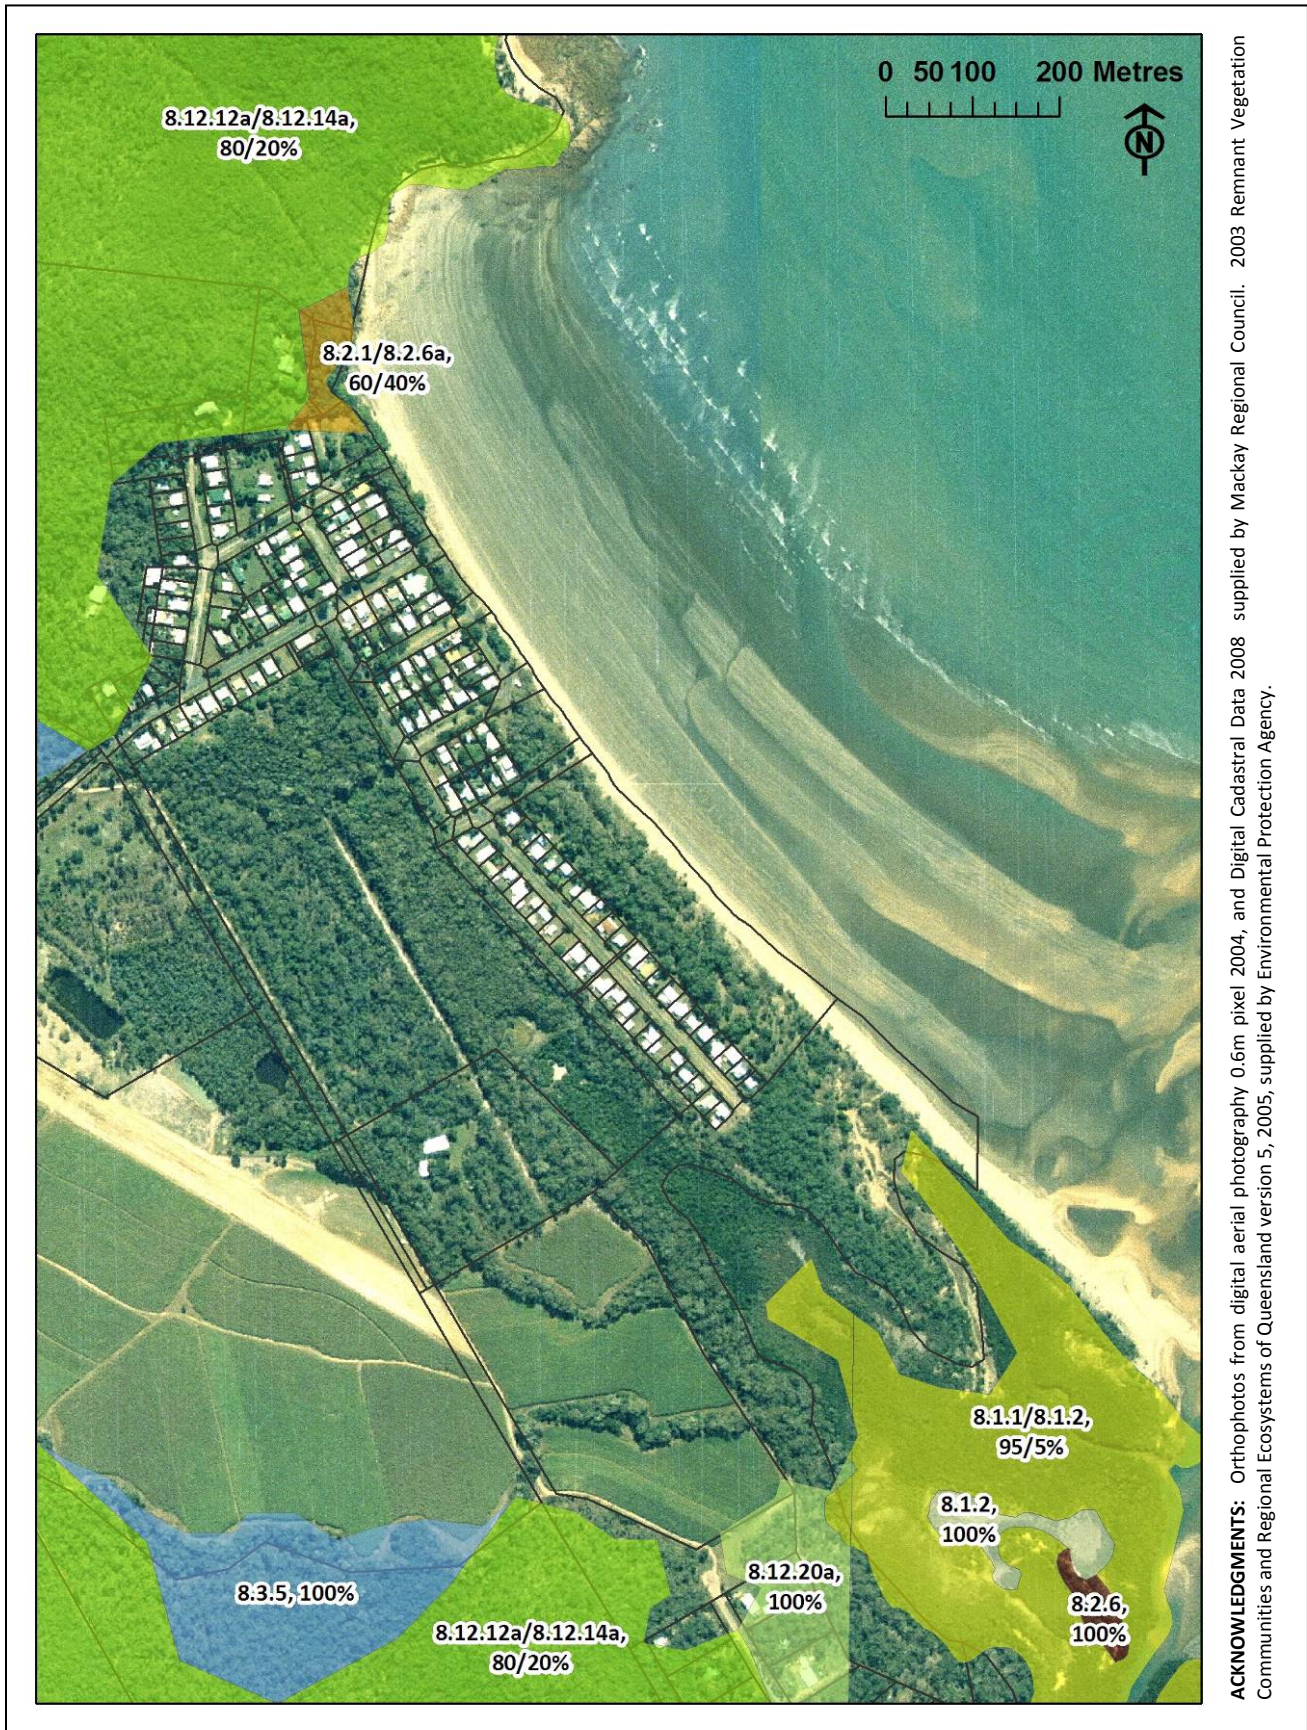
Figure 6: Remnant vegetation Ball Bay

The largest amount of remnant vegetation remains at the northern end of Ball Bay beach under National Park tenure (Figure 6, Table 1). These mixed-eucalypt open to woodland forests are protected under Queensland legislation (Figure 4).

Mangrove and salt flat communities extend in behind the creek in the south of the beach unit (Figure 6).

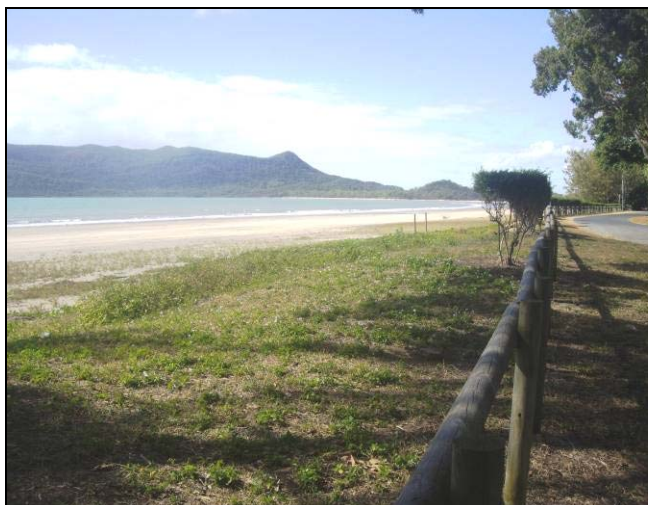
Natural vegetation zonation has largely been removed along the length of the Ball Bay residential settlement. At the northern end of the beach, Ward Esplanade is in close proximity to the foredune and precludes the existence or reinstatement of natural dune vegetation zonation (Figure 7). In the central section of Ball Bay beach the Esplanade widens, and large expanses of dunes are being maintained as mown laws, preventing the re-establishment of the full complex of native vegetation (Figures 8, 9). Fencing off a suitable foredune buffer zone south from Sivyer Street, and managing this area to encourage the rehabilitation of native vegetation, is recommended.

**Figure 7:** At the northern end of the beach, natural dune vegetation zonation has been removed and Ward Esplanade is in close proximity to the foredune.

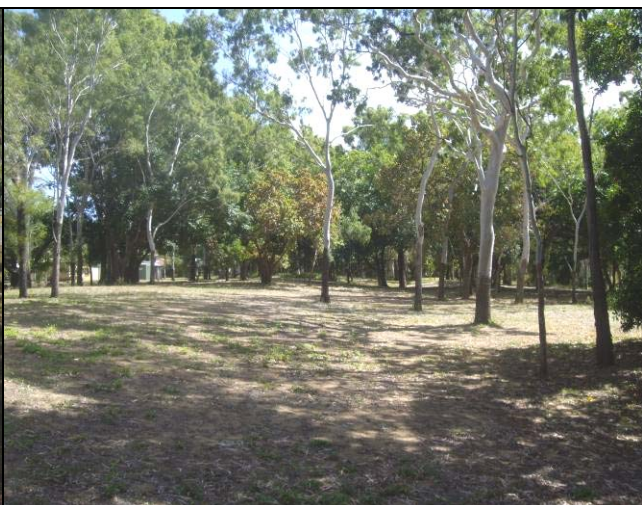
**Figure 8:** In the centre of Ball Bay beach, the dunal Esplanade is being maintained as parkland, preventing natural regeneration.

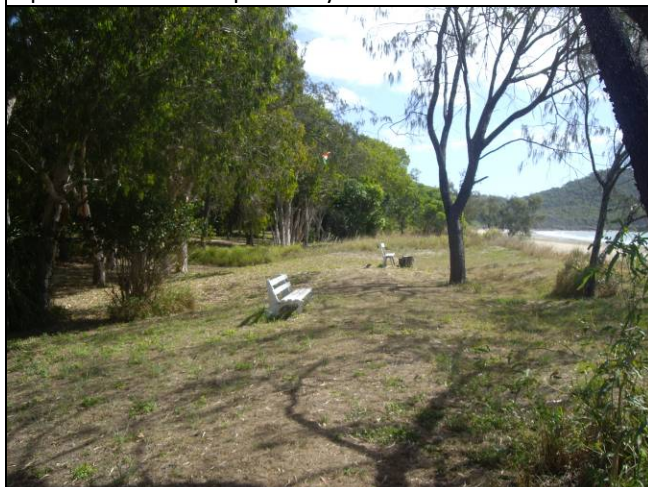
**Figure 9:** In some areas along Ball Bay beach, the dunal Esplanade is being mown to the foredune, preventing natural regeneration and vegetation zonation.

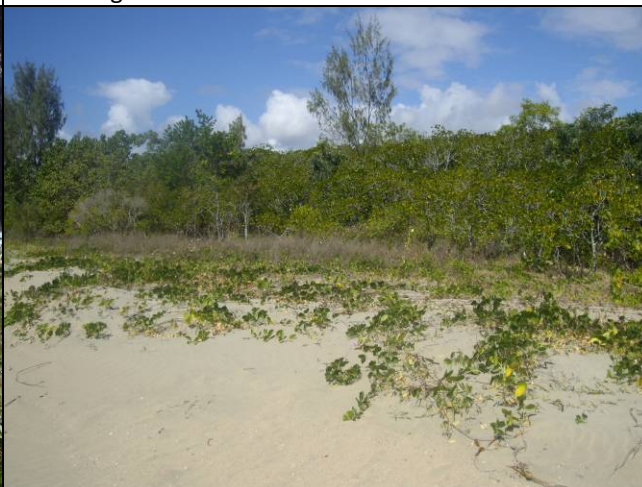
Beyond the residential settlement, at the southern and northern ends of Ball Bay beach, natural vegetation zonation is present. This variously includes strand thickets, colonising spinifex and casuarina woodland, and mangroves communities (Figure 10). The condition of parts of this vegetation is reduced in some areas owing to inappropriate access and weed invasion.

**Figure 10:** Natural vegetation zonation remains south of the residential settlement of Ball Bay beach.

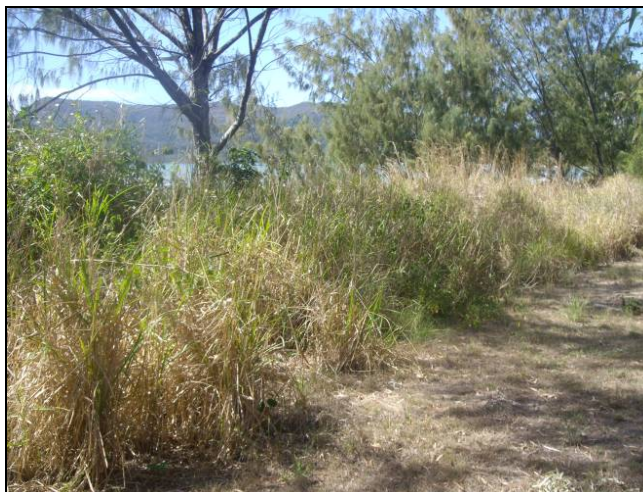
Many non-native species are present along Ball Bay beach, reflecting the high levels of past disturbance and proximity to urban residence. These include a variety of both garden escapees, and environmental weeds such as Guinea grass (*Megathyrsus maximus*) which increase fuel loads and smother native vegetation (Figure 11). Declared weeds recorded along the length of the beach include prickly pear (*Opuntia sp.*) and mother of millions (*Bryophyllum sp.*) (*Land Protection Pest and Stock Route Management Act, 2002*). Dense stands of coconut palms (*Cocos nucifera*) are present in some areas of the Esplanade (Figure 12). These trees drop fronds which smother native vegetation, do not reduce wind erosion, and accelerate wave erosion when they fall (Environmental Protection Agency, 2004).

**Figure 11:** Dense stands of Guinea grass (*Megathyrsus maximus*) along the frontal dunes smother native vegetation and increase the risk of fire.

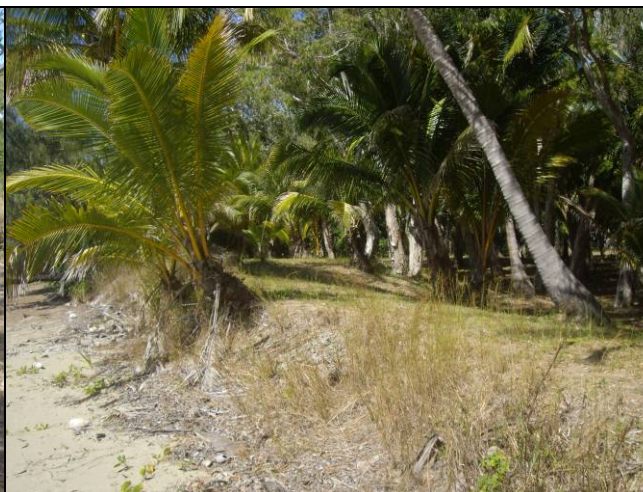
**Figure 12:** Dense stands of coconut palms (*Cocos nucifera*) pose problems with the risk of falling coconuts and fronds, and fronds which smother native vegetation.

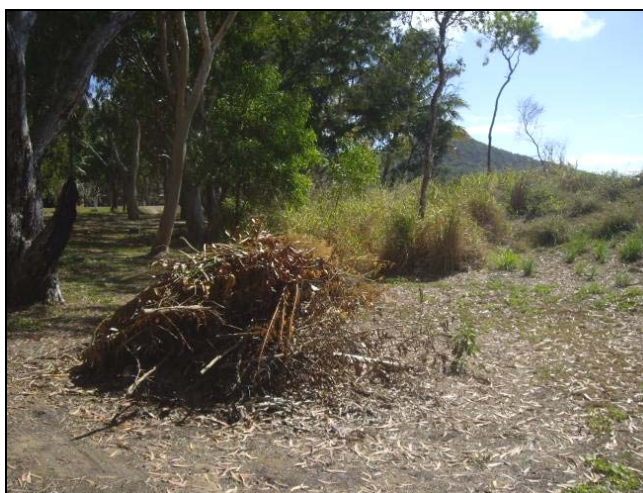
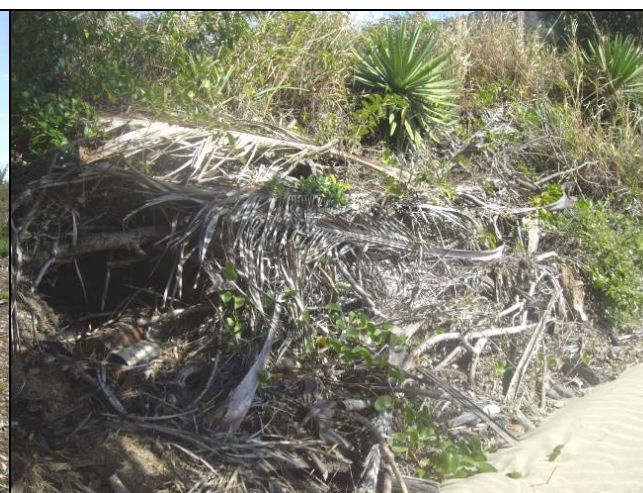
Vegetative waste is present on dunes along Ball Bay beach, particularly where there are adjacent residential areas (Figures 13, 14). This leads to the smothering of native vegetation, increases the risk of fire, and encourages the spread of non-native species.

**Figure 13 and 14:** The dumping and accumulation of vegetative waste on dunes along Ball Bay beach, increases the risk of fire and spread of non-native species.

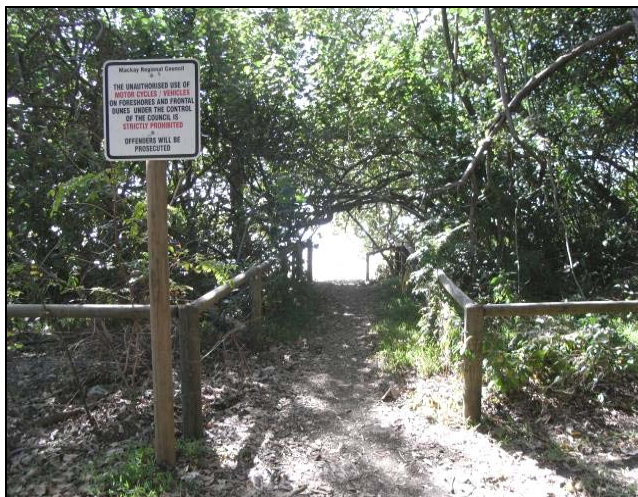
**Figure 15:** Access 1, from Ball Bay campground.

There are six designated beach access points provided with various fencing, signage, and associated infrastructure along Ball Bay beach (Figures 15, 19). Vehicle access to the beach for boat launching is permitted at two of these access points (Figures 16, 19). Recreational facilities and a camping reserve are provided at the northern end of Ball Bay beach, with barbeques, tables, and amenities.

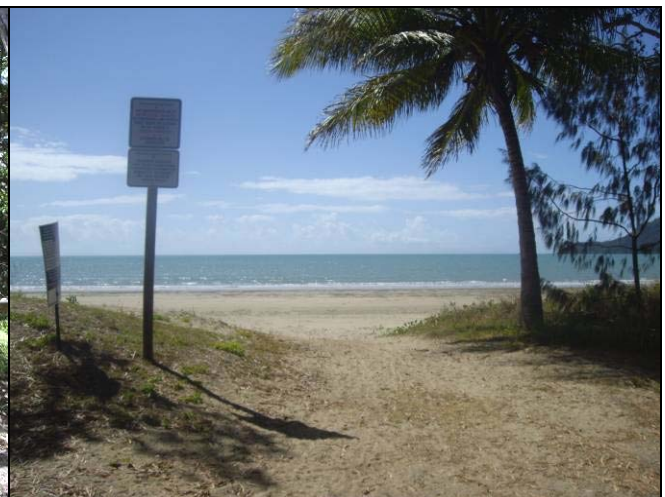
**Figure 16:** Access 5 includes boat access to beach.

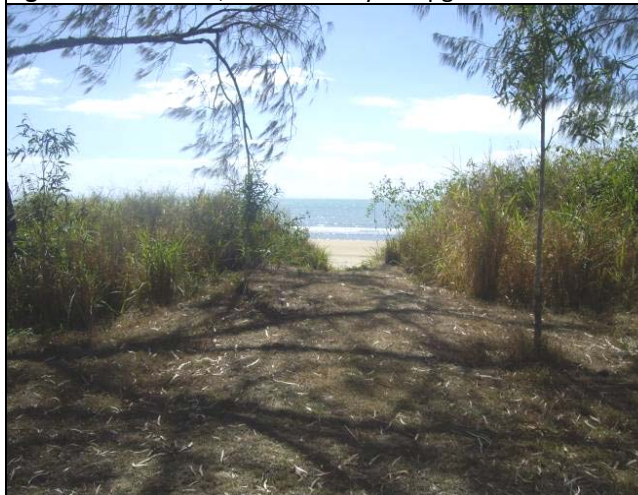
Fencing has been installed along the Esplanade to protect foredune vegetation and direct pedestrian access, from the northern extent of the Esplanade to just south of Smith Street (Figure 19). Open access to the beach is available south of this point, and many unofficial pedestrian access tracks have been created (Figure 17). Additionally, vehicle access through the Esplanade, foredunes, and salt flats south of the residential community causes disturbance to dune and salt marsh vegetation and can lead to localised erosion (Figure 18).

**Figure 17:** Unofficial access tracks to the beach exist along central Ball Bay beach where no direction to official access tracks is provided.

The formalisation and fencing of pedestrian access points south from the current Esplanade fenceline is recommended to direct pedestrian access, prevent vehicle access, and protect native vegetation on dune and salt flat communities.

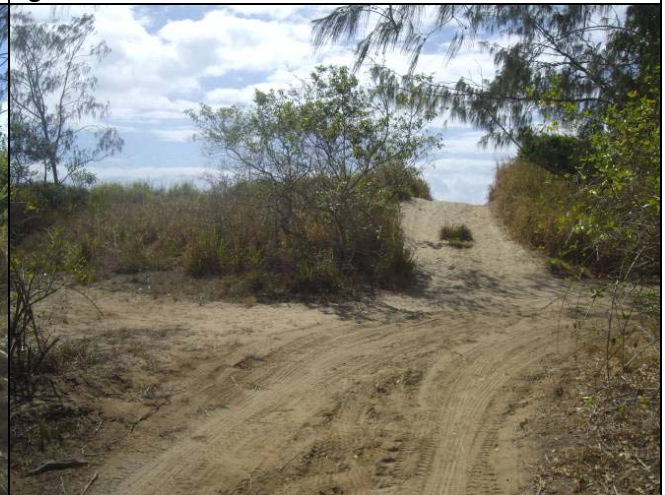
**Figure 18:** Unofficial vehicle access through Council land to the beach front disturbs dunal and salt flat communities at the southern end of Ball Bay beach.

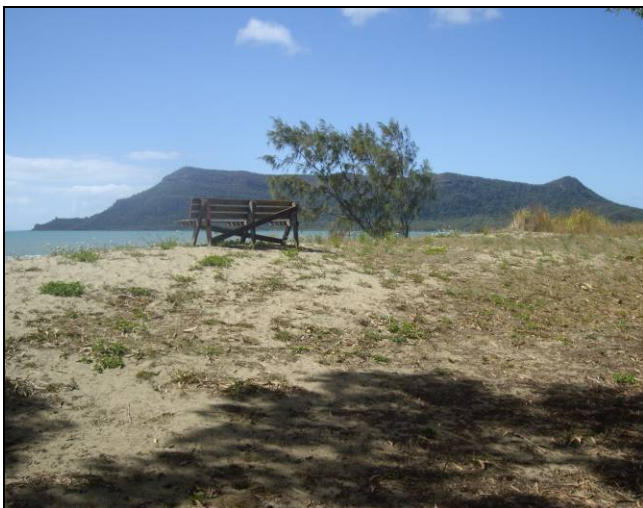
Development has occurred within the erosion prone area within the Ball Bay beach unit (Figure 23). The retention and maintenance of the Esplanade buffer zone is important to prevent threats to property boundaries and infrastructure into the future. Some sections of frontal dune along Ball Bay beach are lacking native vegetation, leaving them vulnerable to erosion processes (Figure 21). Frontal dunes being maintained as an extension of residential lawns and lacking natural dune vegetation zonation along the length of the beach face a greater risk of erosion into the future. Fencing off a suitable foredune buffer zone south from Sivyer Street, and managing this area to encourage the rehabilitation of native vegetation, is recommended.

**Figure 21:** Frontal dunes which lack native vegetation are more vulnerable to erosion processes.

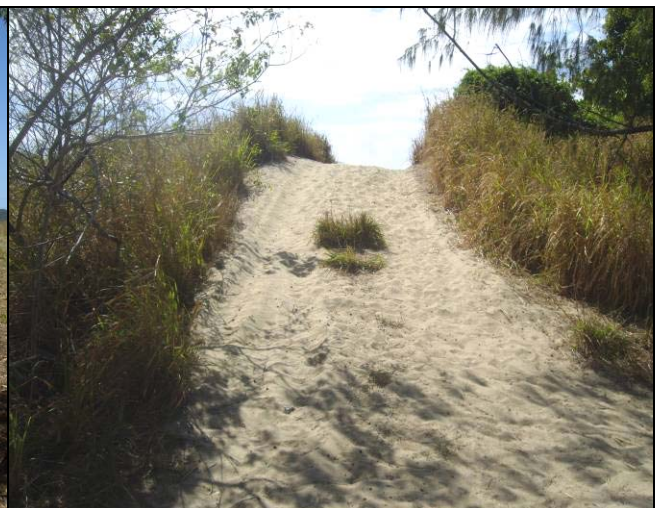
Unofficial vehicle and pedestrian access points result in disturbance to coastal vegetation and subsequent localised erosion (Figure 22). Restriction of inappropriate vehicle access to the foreshore and formalisation of official pedestrian beach access tracks at the southern end of the Ball Bay beach residential area, are recommended.

**Figure 22:** Inappropriate vehicle access at the southern end of Ball Bay disturbs native vegetation and opens up bare sand areas to erosion and weed invasion.

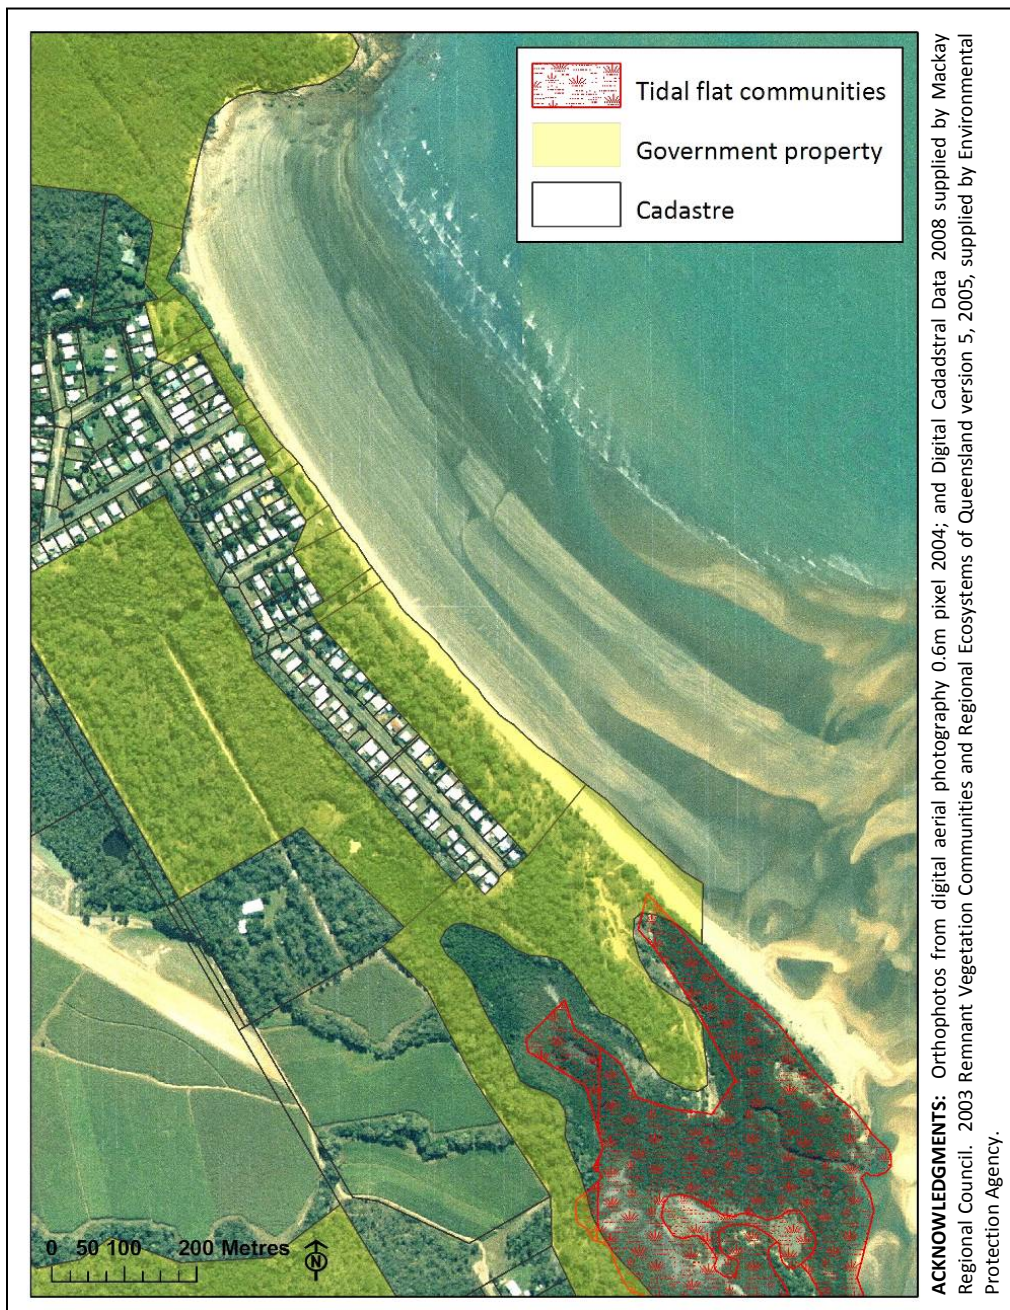
**Figure 24: Current extent of tidal flat communities Ball Bay (Landzone 1)**

Tidal flat communities extend in behind the creek to the south of Ball Bay Beach (Figure 24). Adjacent land should remain free of development and infrastructure to allow for migration of these communities as sea level changes occur.
