Reef Rescue Water Quality Farm Trials Update

By John Agnew, AgriServ Central

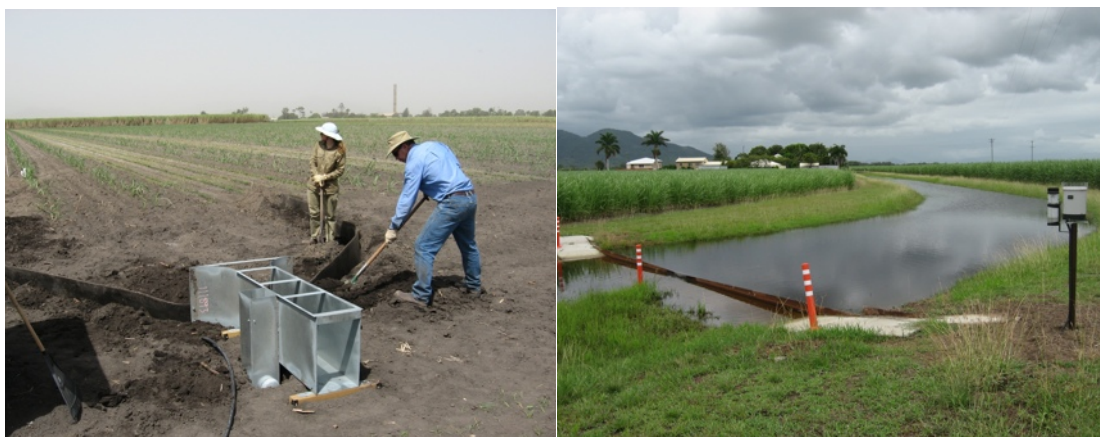
Photos

Left: John Agnew and Amanda Bush installing paddock scale monitoring equipment

Right: Multi-block scale water quality monitoring site.

Measurement of water quality in a near-by farm drain captures information from a small multi-block catchment (about 50ha). Further down the Sandy Creek catchment another in-drain water sampling site

captures information from multiple farms (about 3000ha). To make sense of water samples we are collecting management practice information including the area under controlled traffic, fertiliser and herbicide use. Changes in practices over time should be reflected in water quality change.

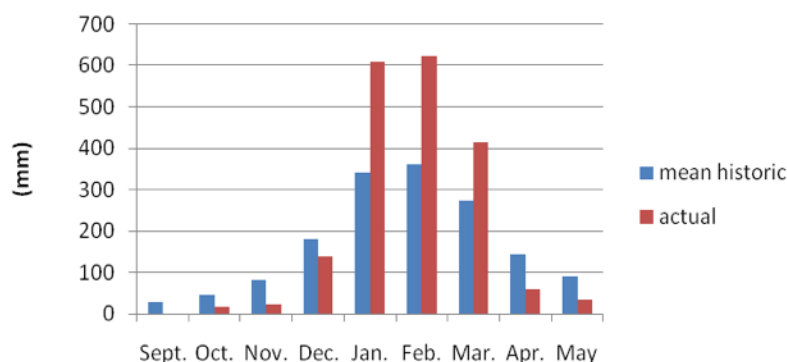
Figure 1- actual monthly rainfall at North Eton water quality trial versus historic mean

Actual rainfall V historic mean at North Eton loam soil site 09/10

rainfall/runoff events. Side-dressing occurred in mid October and was followed up with irrigation 1 week later. A further 200mm of irrigation was applied between end October and end December, after which the first useful falls of rain occurred. Relatively high concentrations of phosphorus (20 times the clay soil site) were found however this block has high background P (BSES P of 100+ mg/kg). Low concentrations of herbicides were found coming off the block, due to soaking rain and irrigation prior to runoff events. Excessive summer rain causing runoff from adjacent blocks and flooding of water sampling gear meant some data was lost. January-March rainfall totalled 1645mm which was 70% above historic average (Figure 1).
