Mackay Coasts and Communities

Seaforth

Beach Plan

2010

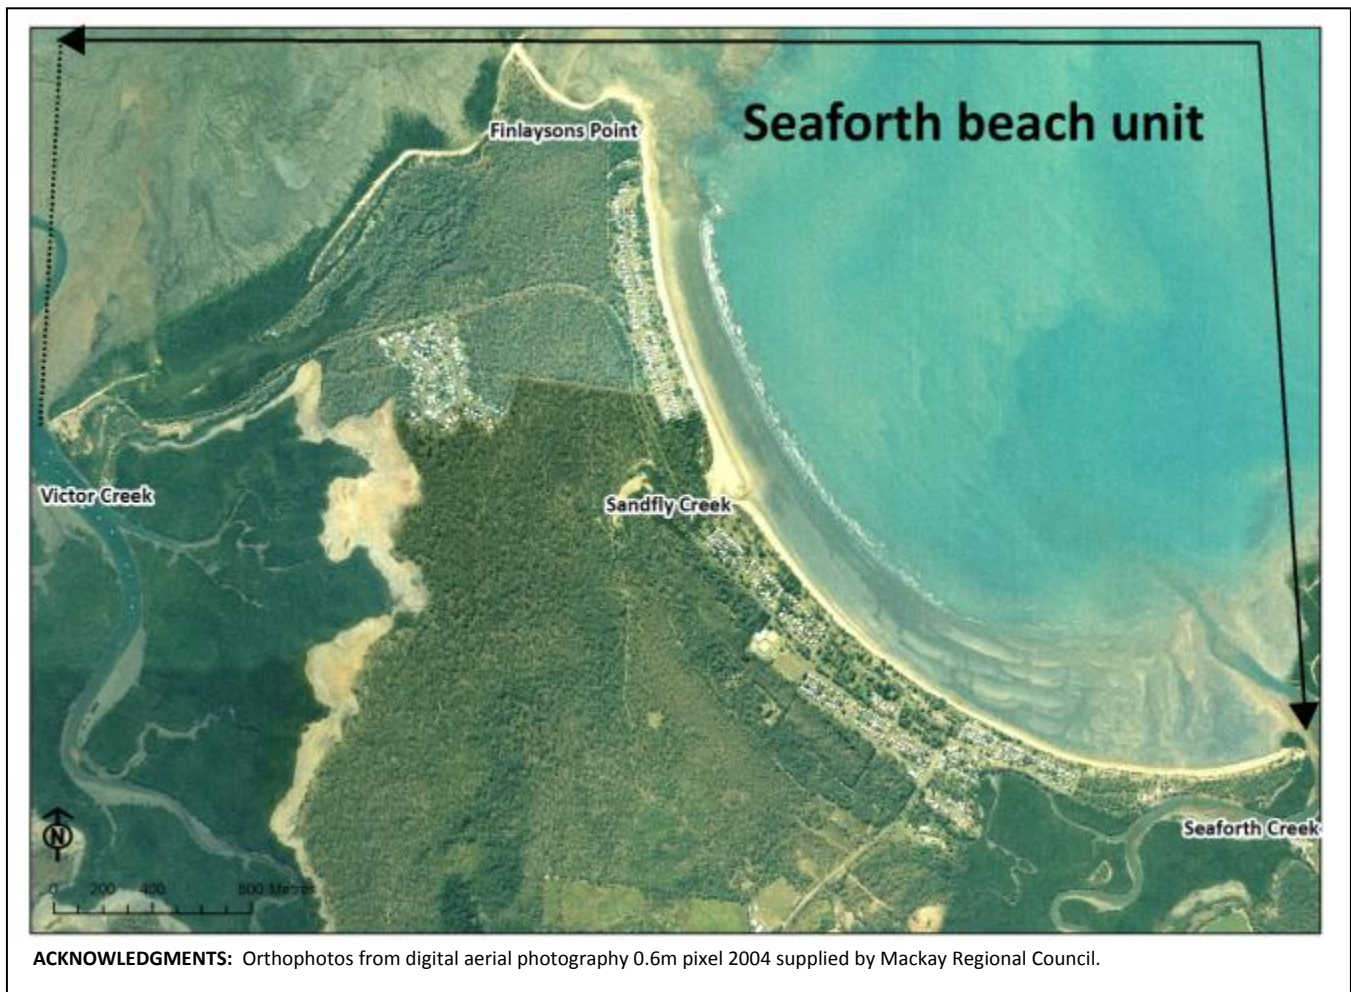
Figure 1: Extent of Seaforth beach unit

The Seaforth beach unit covers approximately eight kilometres of coastline from Victor Creek to Seaforth Creek (Figure 1). Seaforth beach is a five kilometre long sandy beach which curves from Seaforth Creek in the south, to Finlayson Point in the north. This is a wide, low gradient beach backed by low sandy foredune ridges, and with extensive tidal sand flats in the south (Short, 2000). Finlayson Point forms the northern boundary of Seaforth beach and is 1.5 kilometre, low, rocky, north-east facing headland. Two approximately 300 metre long sandy beaches are located on the point where there are breaks in the mangrove-fringed, or rocky shoreline. At low tide, sand and rock flats connect the mainland with Redcliffe Island (National Park) to the north (not pictured).

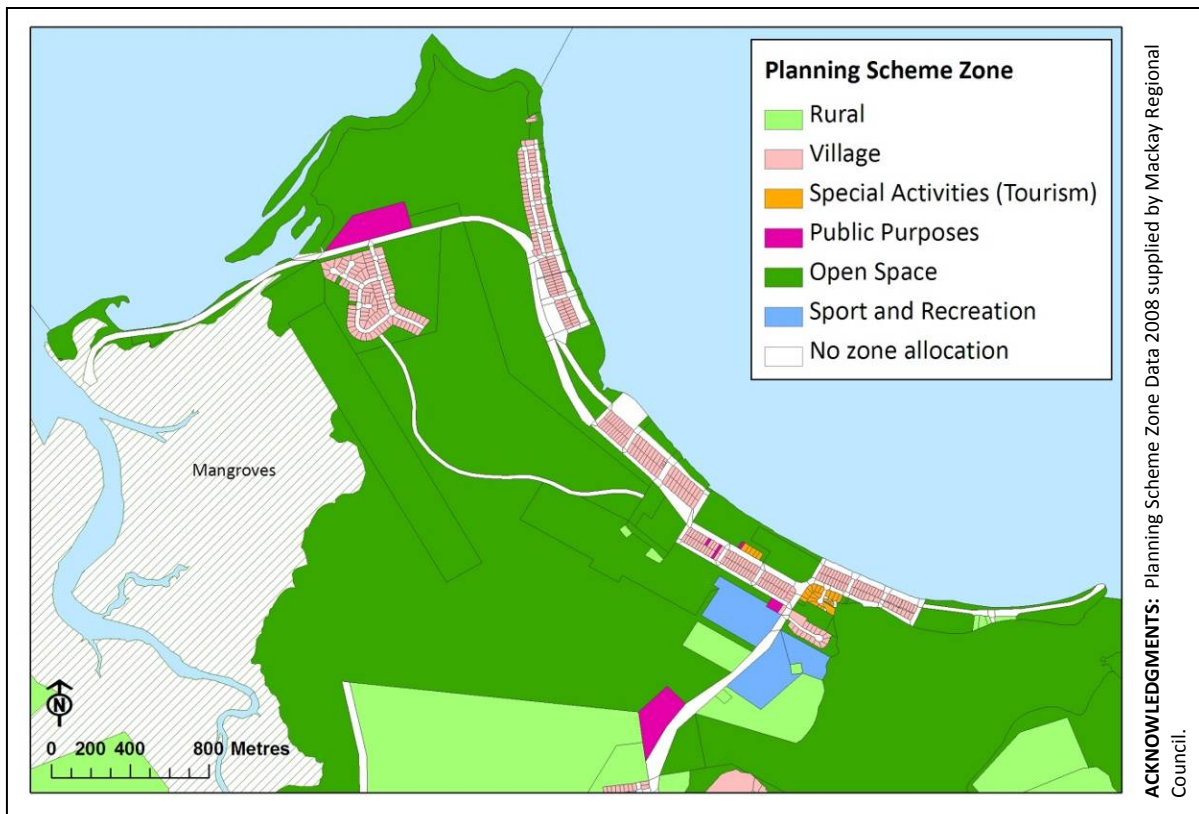
Figure 3: Planning scheme zonation Seaforth

The Seaforth beach unit has extensive Freehold residential areas along the length of Seaforth beach (Figures 2, 3). Reserve and Esplanade tenures line the foreshore as Open Space, with Finlayson Point tenured as Reserve and under the management of Mackay Regional Council. State Land extends in behind the residential community, bordering Seaforth Creek.

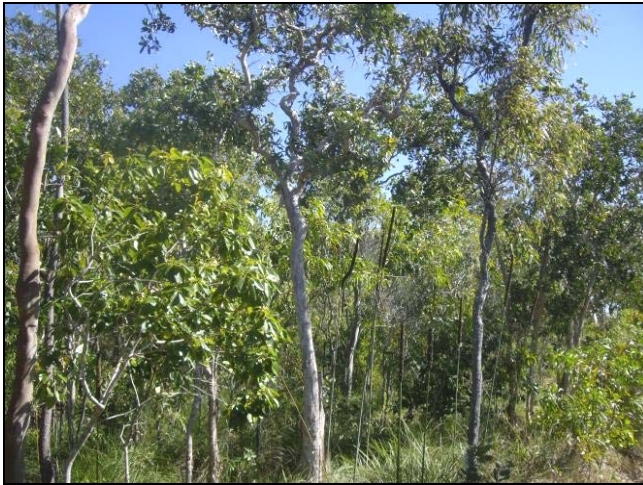
Figure 4: Remnant eucalypt communities (RE 8.12.20a) remain over much of Finlayson Point.

The largest portion of this is located on Finlayson Point and is a combination of eucalypt woodland (RE 8.12.20a, Figure 4) and eucalypt and acacia open forest with beach scrub understorey (RE 8.2.6a), both of which are listed as 'of concern' biodiversity conservation status (*Vegetation Management Act, 2005*). The condition of remnant vegetation on Finlayson Point is threatened by weed invasion, inappropriate fire regimes, waste dumping, and unrestricted vehicle access.

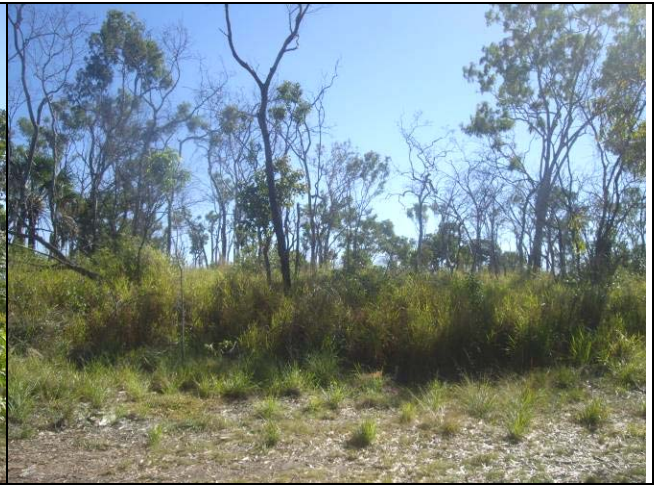
Figure 5: Remnant vegetation at the southern end of the Seaforth beach unit (RE 8.2.6a) is being impacted by inappropriate fire regimes, vehicle access and weed invasion.

Much of the remnant vegetation has been removed from the dunes along Seaforth beach, with the exception of small pockets of eucalypt and acacia open forest with beach scrub understorey (RE 8.2.6a) in the centre and at the southern end of the beach (Figure 5). These remnants are similarly being impacted by weed invasion, waste dumping, and unrestricted vehicle access. Pre-clearing mapping shows that this vegetation previously extended along the length of the beach and some 600 metres inland (Environmental Protection Agency, 2003). A buffer zoned as Open Space is present along the Seaforth beach, and opportunities exist to expand and protect vegetation communities present through weed management, and rehabilitation of disturbed dune vegetation.

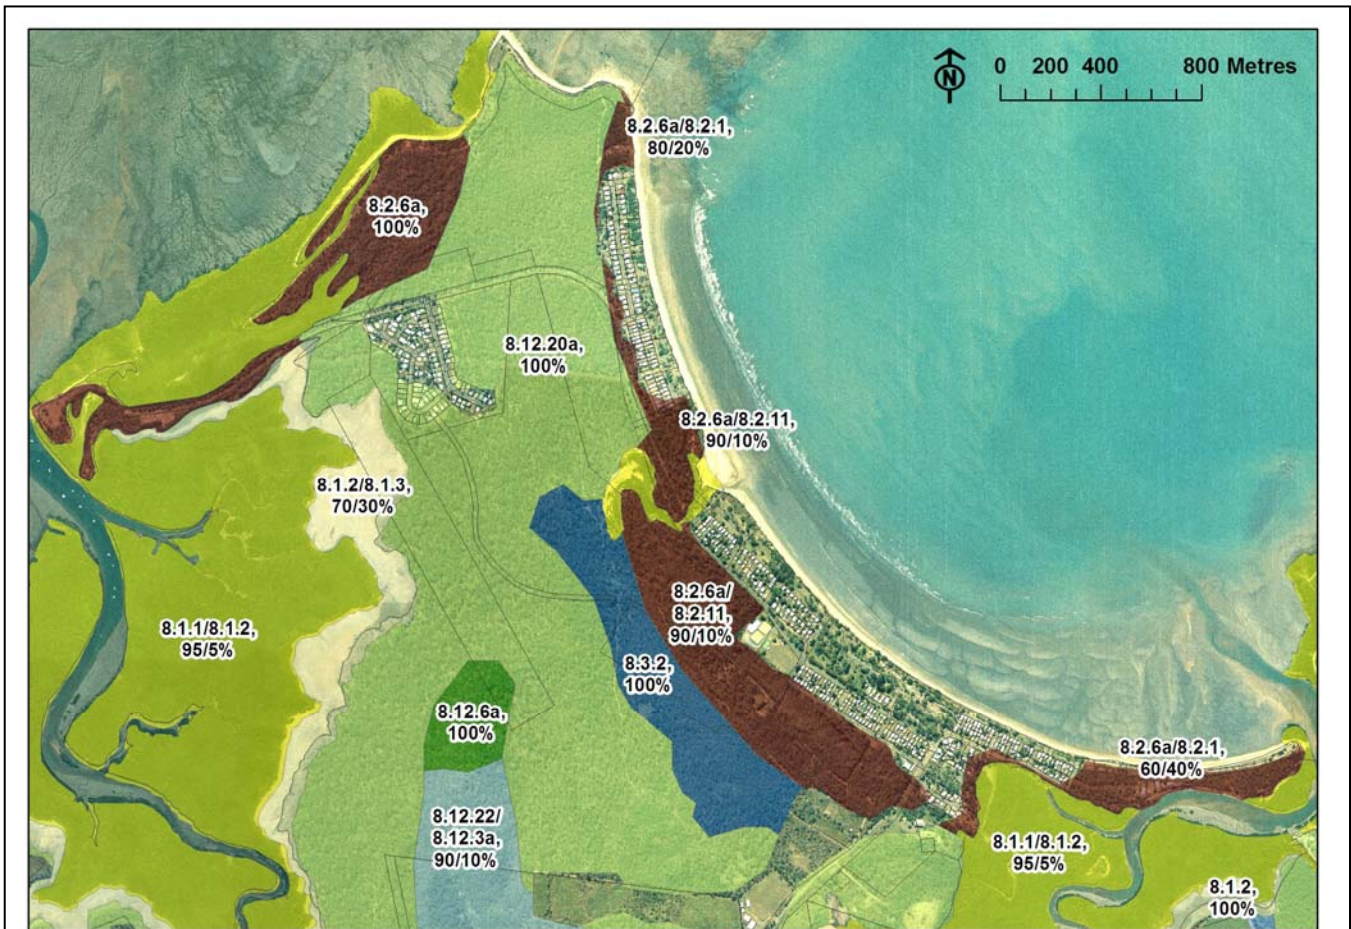
Figure 6: Remnant vegetation Seaforth

Approximately 100 ha of remnant vegetation remains on coastal Reserve and Esplanade tenured land in the Seaforth beach unit (Table 1, Figure 6).

Mangrove and salt flat communities line much of the Finlayson Point coastline, Victor Creek, Seaforth Creek, and Sandfly Creek (Figure 6).

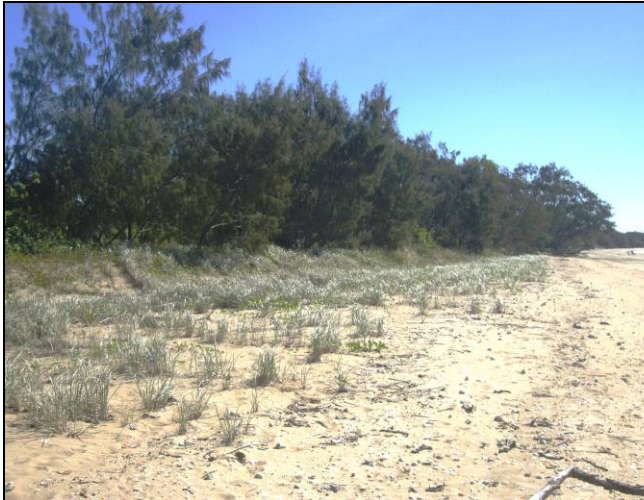
Figure 7: Localised patches of natural dune vegetation zonation remain along Seaforth Beach.

Dune vegetation zonation along the length of Seaforth Beach is highly variable, and there are localised areas which retain natural dune zonation including colonising spinifex and casuarina woodland on foredunes, and open forest communities beyond the frontal dune (Figure 7).

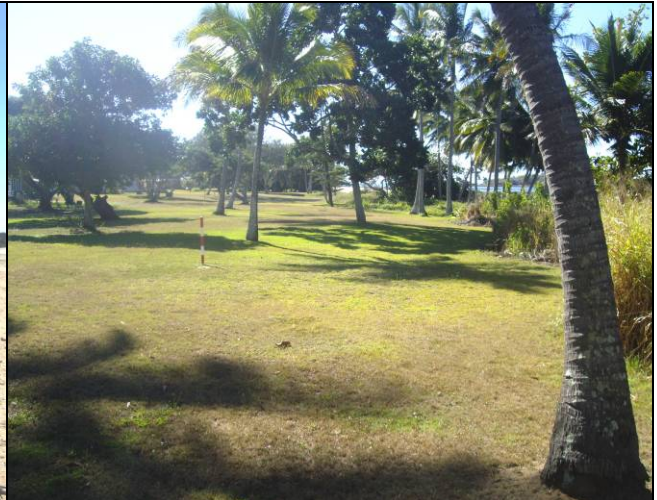
Figure 8: Where residential areas are directly adjacent to Council-tenured land at the northern end of the beach, there are large areas being maintained as an extension of adjacent lawns.

Where residential areas are directly adjacent to Council-tenured land at the northern end of the beach, there are large areas where native vegetation has been removed and dunal areas have become an extension of adjacent lawns and gardens, preventing natural dune vegetation zonation (Figure 8). Similarly in the central section of Seaforth Beach, large expanses of the dunes are being maintained as mown lawns, even to the east of foredune fencing (Figure 9), preventing the re-establishment of the full complex of native vegetative. Natural vegetation zonation has also been removed along the southern end of Seaforth Beach (Figure 10).

| # | On-ground activity details (Figure 30) |
|---|---|
| 4 | Fencing and formalisation of pedestrian access points. Fencing (Appendix 2) along the length of the Esplanade, incorporating a series of formalised pedestrian access paths to the beach. This will provide a vegetation zone to define the revegetation area, limit mowing to the fenceline, provide a fire break from freehold properties, and define pedestrian access points. |

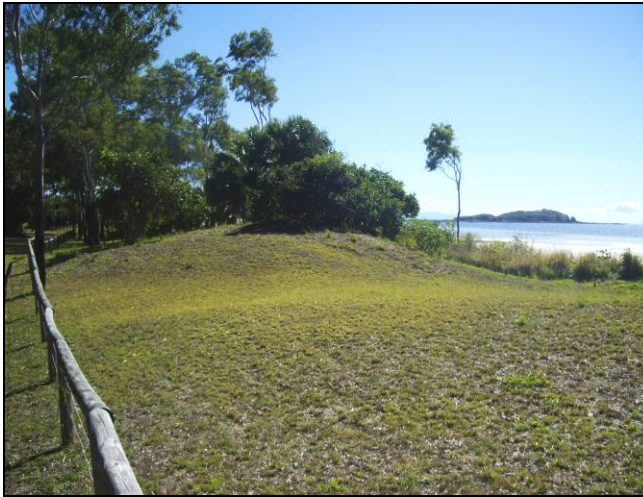
Figure 9: Dunes in the central section of Seaforth Beach are being mown to the east of the dune boundary fence, preventing natural regeneration.

Some sections of the frontal dune along Seaforth Beach are lacking native vegetation, leaving them vulnerable to erosion processes (Figure 26). Frontal dunes being maintained as an extension of residential lawns and lacking natural dune vegetation zonation along the length of the beach face a greater risk of erosion into the future (Figure 9).

| # | On-ground activity details (Figure 30) |
|---|---|
| 5 | Weed control, revegetation, remove waste dumping. Major target weed species include Guinea grass, lantana, prickly pear (<i>Oputnia sp.</i>), sable palms (<i>Sabal palmetto</i>), guajava (<i>Psidium guajava</i>), agave, coconut palms (<i>Cocos nucifera</i>), and various herbaceous garden escapees. Revegetation using local native species to replace removed weed species and support frontal dune. Remove vegetative waste dumping on dunes. Fire and mowing to be excluded from the dunal vegetation to the east of the current fenceline, to encourage natural regeneration. |

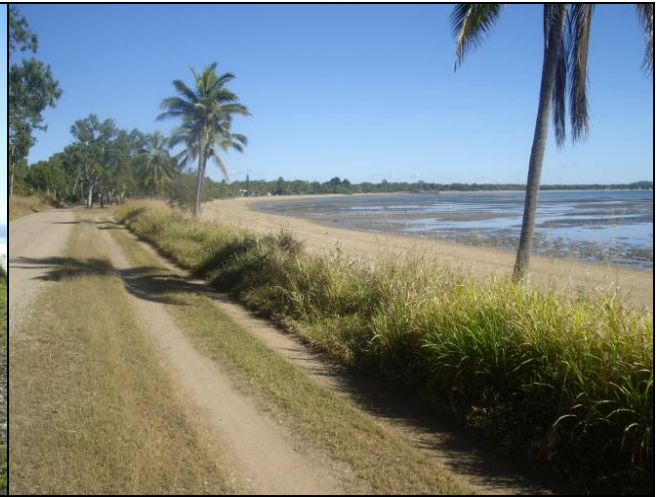
Figure 10: Natural dune zonation has been removed at the southern end of Seaforth Beach.

| # | On-ground activity details (Figure 30) |
|---|---|
| 6 | Weed control, revegetation. Target weed species are Guinea grass and agave. Revegetation to replace removed weed species and support frontal dune structure. Unofficial vehicle access track running parallel to current designated road to be closed and revegetated (Figure 22). Pedestrian access ways to be incorporated into rehabilitation activities. |

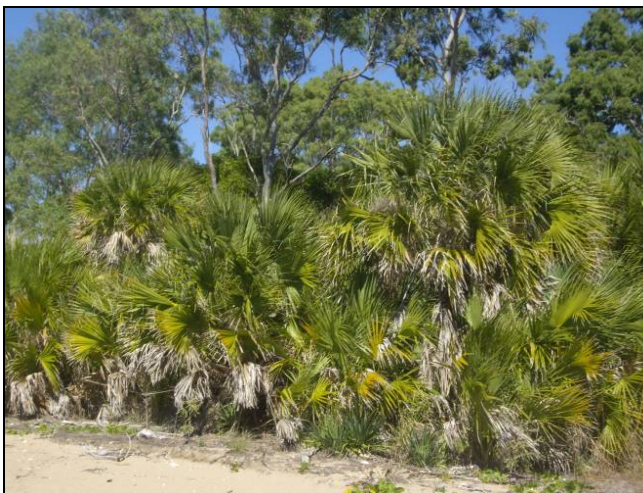
Many non-native species are present along Seaforth beach, reflecting the high levels of past disturbance and proximity to urban residence. Included in these are a variety of both garden escapees and environmental weeds such as Guinea grass (*Megathyrsus maximus*) and lantana (*Lantana camara*) which increase fuel loads and threaten to outcompete native vegetation. Stands of sable palms (*Sabal palmetto*) and agave (*Agave sp.*) were recorded in large numbers along Seaforth Beach (Figures 11, 12).

Figure 11: Dense stands of sable palms (*Sabal palmetto*) threaten to out-compete native vegetation along Seaforth Beach.

| # | On-ground activity details (Figure 30) |
|---|---|
| 3 | Weed control, revegetation, remove waste dumping. Major target weed species include Guinea grass, lantana, prickly pear (<i>Oputnia sp.</i>), sable palms (<i>Sabal palmetto</i>), guajava (<i>Psidium guajava</i>), agave, coconut palms (<i>Cocos nucifera</i>), and various herbaceous garden escapees. Revegetation using local native species to replace removed weed species and support frontal dune. Remove vegetative and other waste dumping on dunes. Remnant vegetation community on northern bank of Sandfly Creek to be included in weed control and rehabilitation works. |

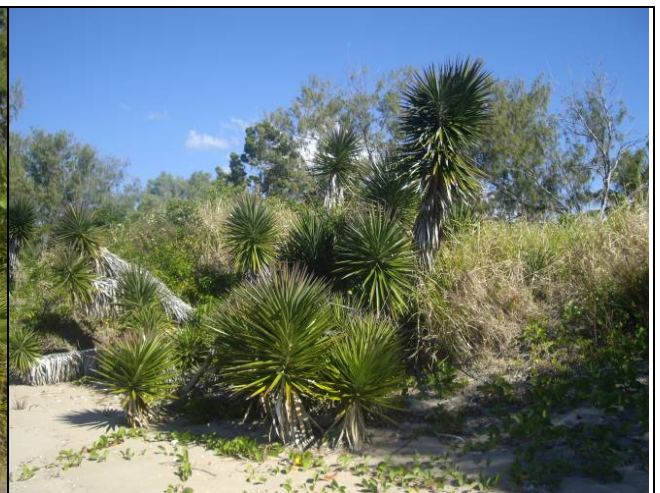
Figure 12: Agave (*Agave sp.*) is present along Seaforth Beach and Finlayson Point.

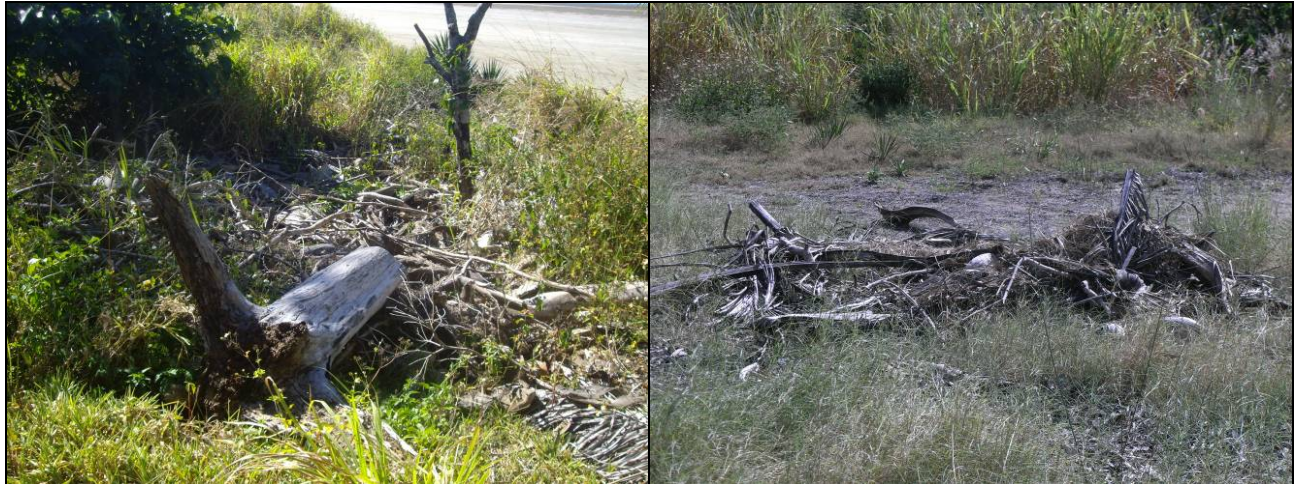
Vegetative and other waste dumping is present in the Seaforth beach unit, particularly on Finlayson Point, the Reserve adjacent to Seaforth Creek in the south, and areas along the Seaforth Beach adjacent to residential areas (Figures 13, 14).

Figure 13 and 14: Dumping of vegetative and other waste on Esplanade and Reserve tenures in the Seaforth beach unit, creating a public nuisance, introducing weed species, increasing fire risk, and reducing the vegetation condition.

| Zone E Seaforth Creek Reserves (6 ha) | |
|--|---|
| 13 | Educate coastal community on requirement to dispose of garden waste and other debris at designated Council refuse sites. Enforce local laws regarding rubbish dumping. |

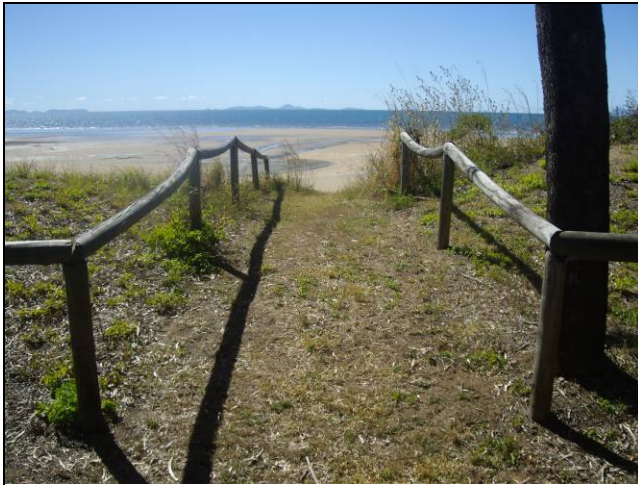
There are seven designated beach access paths provided with fencing and associated infrastructure along the Seaforth Esplanade Reserve (Figures 15, 22). All of these are located in the central section of Seaforth Beach, where associated fencing has been installed to protect foredune vegetation. Open access to the beach is available south of the Seaforth Camping Reserve (Figure 10), and many unofficial access tracks have been created at the northern end of the beach causing disturbance to dune vegetation and localised erosion (Figure 16). The formalisation and fencing of access points in both the northern and southern sections of the beach is recommended to direct access and protect native vegetation on dune systems.

Figure 15: Example of official beach access on Seaforth beach.

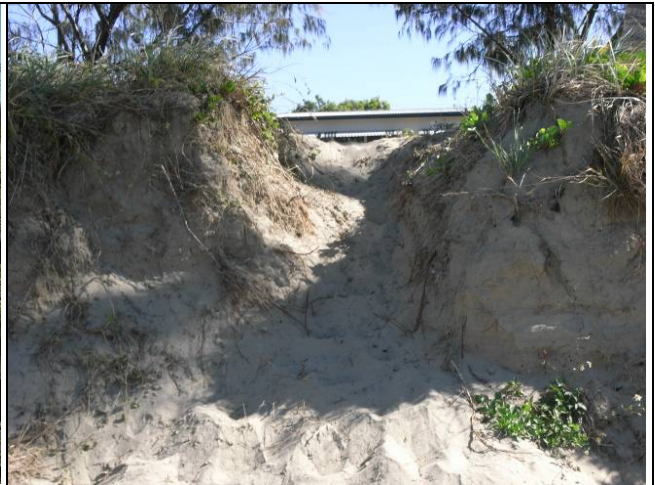
Figure 16: No official beach access paths are present at the northern end of Seaforth beach, opening up multiple access tracks through foreshore vegetation.

Unofficial vehicle and pedestrian access points result in the disturbance of coastal vegetation and subsequent localised erosion (Figures 16, 27). Restriction of inappropriate vehicle access to the foreshore and formalisation of official pedestrian beach access tracks in the northern section of Seaforth Beach, are recommended.

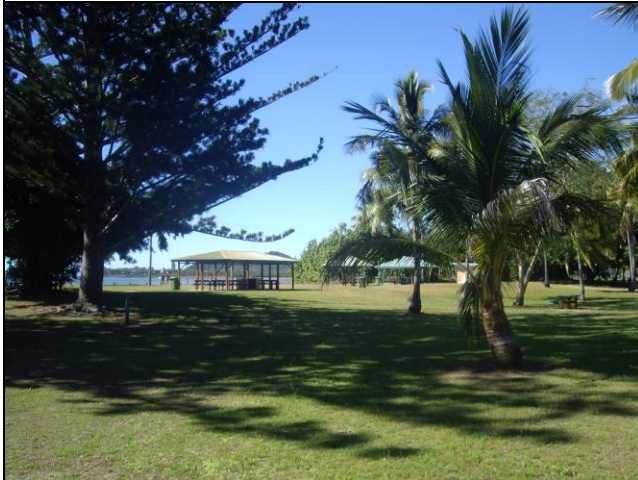
Recreational facilities and a camping reserve are provided in the central section of Seaforth Beach, with barbeque, shelters, playground, parking, and a swimming enclosure net provided (Figure 17). Two additional playground facilities are located to the north, on Acacia and Frangipani Avenues. There are two boat ramps in the beach unit; on Victor Creek in the west (Figures 18, 21), and on Seaforth Creek in the east (Figure 22).

Figure 17: Seaforth Esplanade Reserve recreational area.

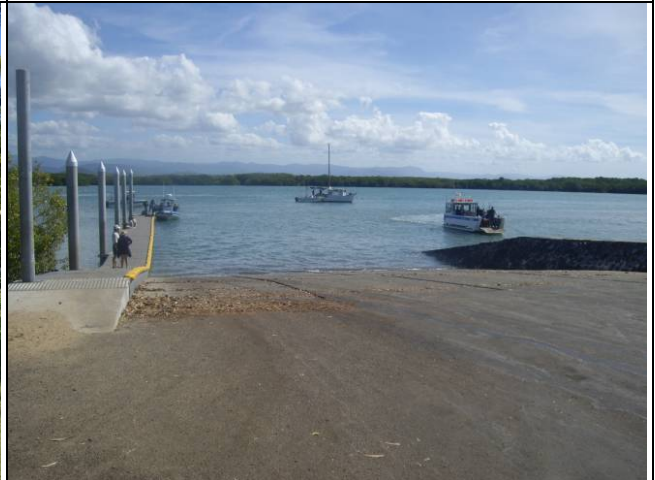
Figure 18: Victor Creek boat ramp in the Seaforth beach unit.

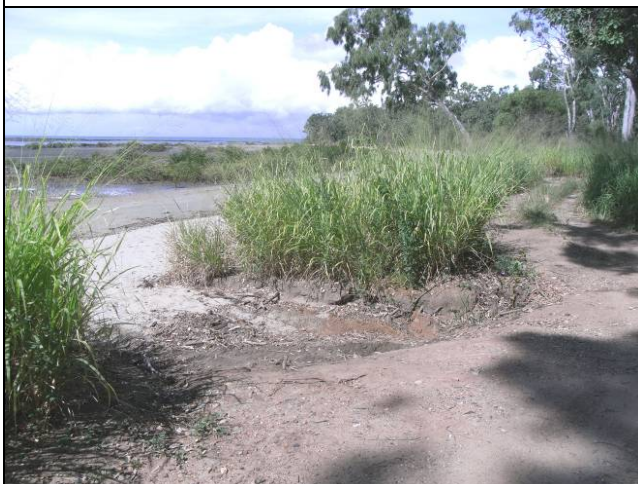
Unregulated vehicle access is currently occurring off Finlayson Point Road, and through the southern Reserves adjacent to Seaforth Creek. Vehicle access via these paths is being used for waste dumping, and further reduces the condition of remnant vegetation communities through increased disturbance and the introduction of weed species. Vehicle access to the beach and salt flats disturbs coastal vegetation and creates localised erosion (Figures 19, 20, 27). It is recommended that vehicle access be restricted from the unofficial access tracks in the Seaforth Creek Reserves and the Finlayson Point Reserve (Figures 21, 22).

Figure 19: Vehicle access to the beach front at Finlayson Point.

| # | On-ground activity details (Figure 30) |
|---|---|
| 2 | Fencing or bollarding. Fencing or bollarding as required to confine vehicle access to Finlayson Point Road, to assist in the protection of the aboriginal stone fish trap and native vegetation communities. Access to the foreshore, headland and unofficial access tracks in the Reserve (Figure 21) to be open for pedestrian access only. |

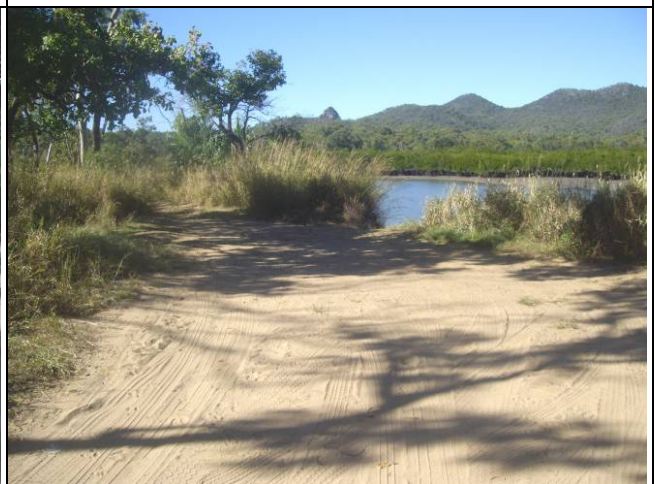
Figure 20: Multiple vehicle access tracks are present through the Reserve adjacent to Seaforth Creek.

| Zone E Seaforth Creek Reserves (6 ha) | |
|--|---|
| 8 | Fencing. Fencing of the Reserve margins as required to restrict vehicle access to prevent ongoing waste dumping, introduction of weed species, increased disturbance to remnant vegetation, and bank erosion. |

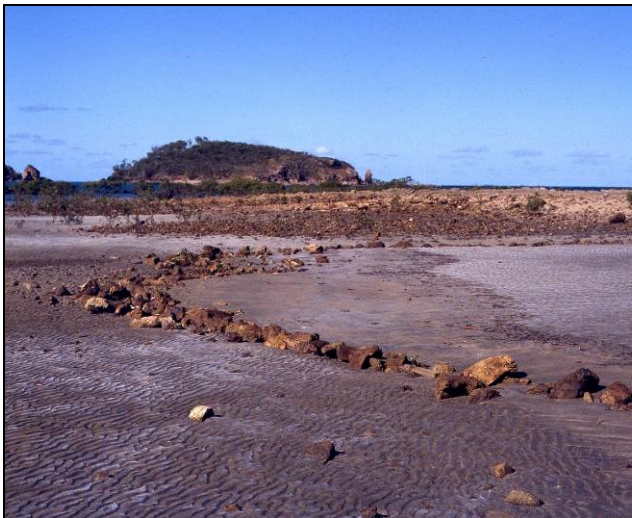
The Seaforth area was previously inhabited by Traditional Owners and the retention and rehabilitation of natural areas remains of significance to the Yuibera people (Mooney, G. 2009, pers. comm., 9 March). An Aboriginal stone fish trap is located at Finlaysons Point (Figures 23, 24), and is under protection by the *Aboriginal Cultural Heritage Act 2002* (Barker and Bernard, 2007). Other items or sites of cultural significance, such as shell middens and artefacts are also likely to be present in the area.

Current threats to the fish trap include damage by vehicles access the foreshore (Figure 25), and the natural processes of tides and storms leading to sedimentation. Restricting vehicle access to the foreshore, and installation of interpretive signage to increase the broad awareness of its cultural importance, are recommended (Ball and Bernard, 2007).

Figure 24: Fish trap at Finlayson Point 2007 (Photo by Matt Bloor).

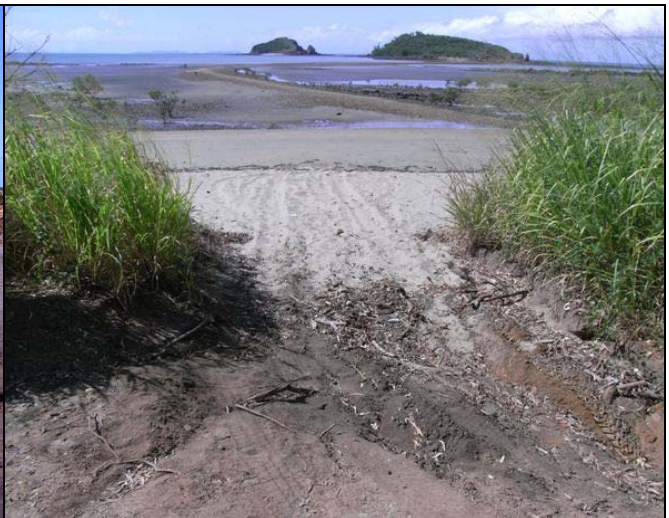
Figure 25: Vehicle access to the foreshore is occurring directly at the fish trap site.

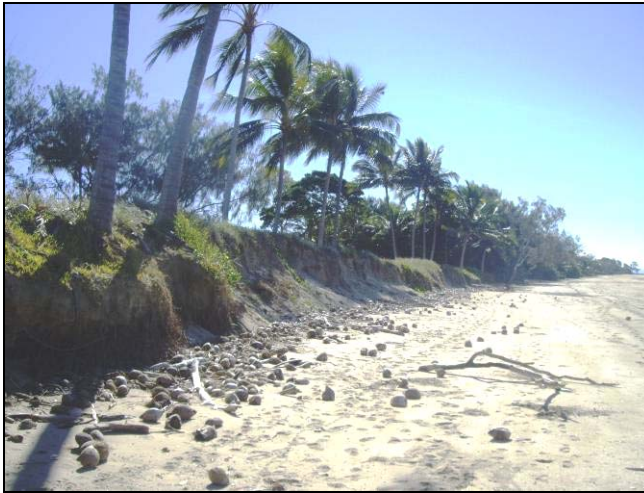
Figure 26: Some sections of the frontal dune along Seaforth Beach are lacking native vegetation, leaving them vulnerable to erosion processes.

The presence of a buffer zone along much of Seaforth Beach means it has some potential to protect against the predicted effects of climate change. Stabilising the dunes and improving their structure through weed control and rehabilitation activities along the length of the beach is recommended.

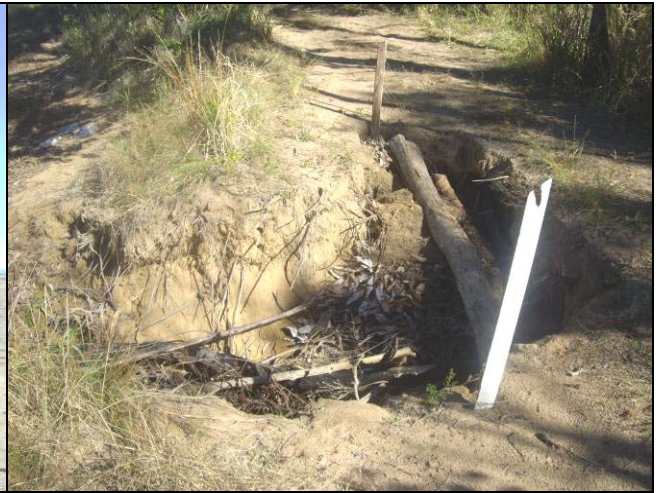
Figure 27: Inappropriate vehicle access has resulted in localised erosion.

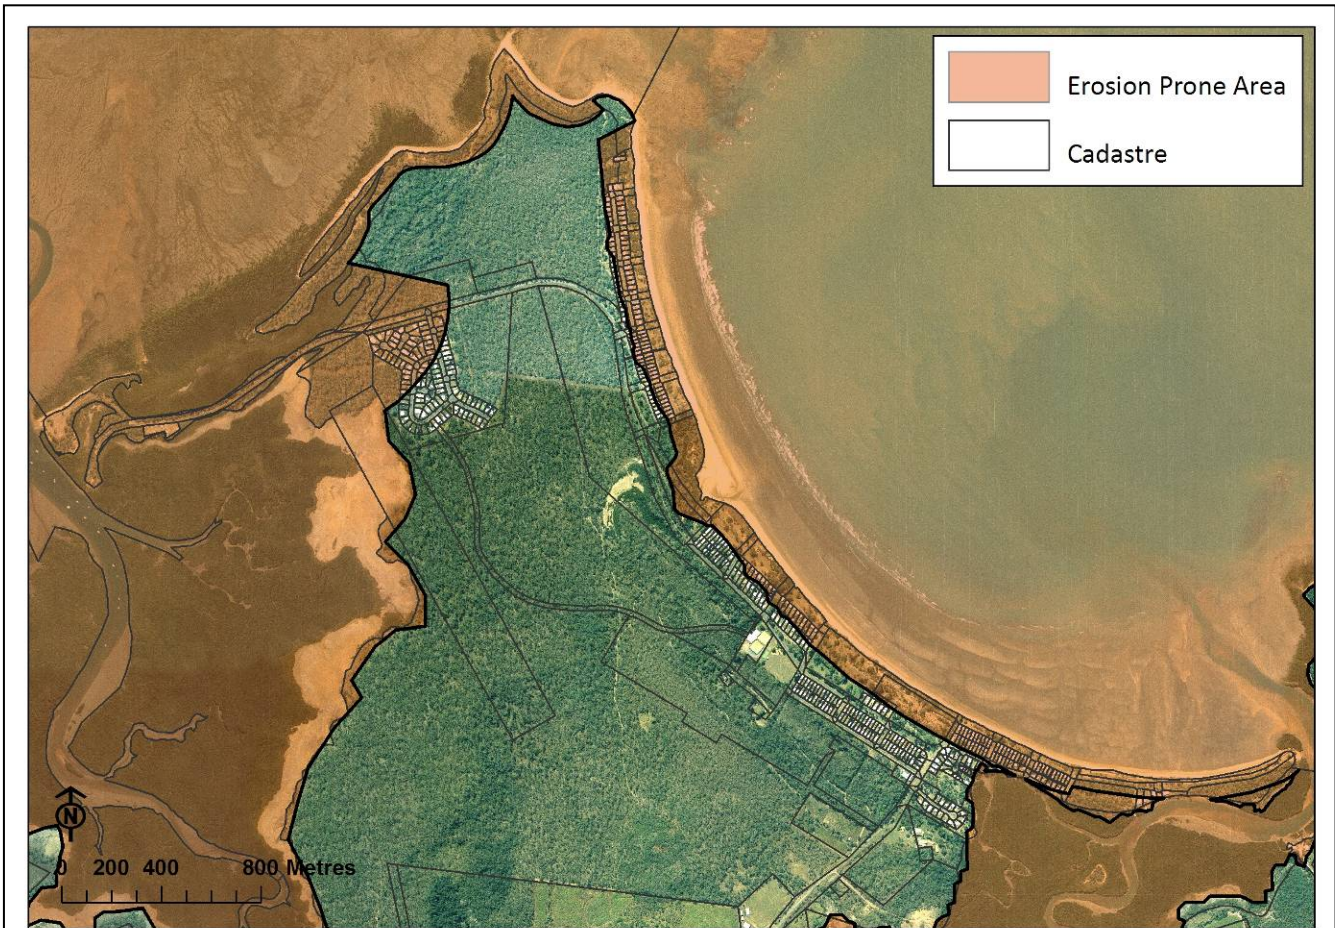
Figure 28: Erosion Prone Area Seaforth beach unit

Development has occurred within the erosion prone area along the residential frontage of Seaforth Beach (Figure 28). The retention and maintenance of the Council-tenured buffer zone in this area is important to prevent threats to property boundaries and infrastructure into the future.
