Bakers Creek system repair site – water quality report 2014/15

Bakers Creek system repair site – water quality report

May 2015

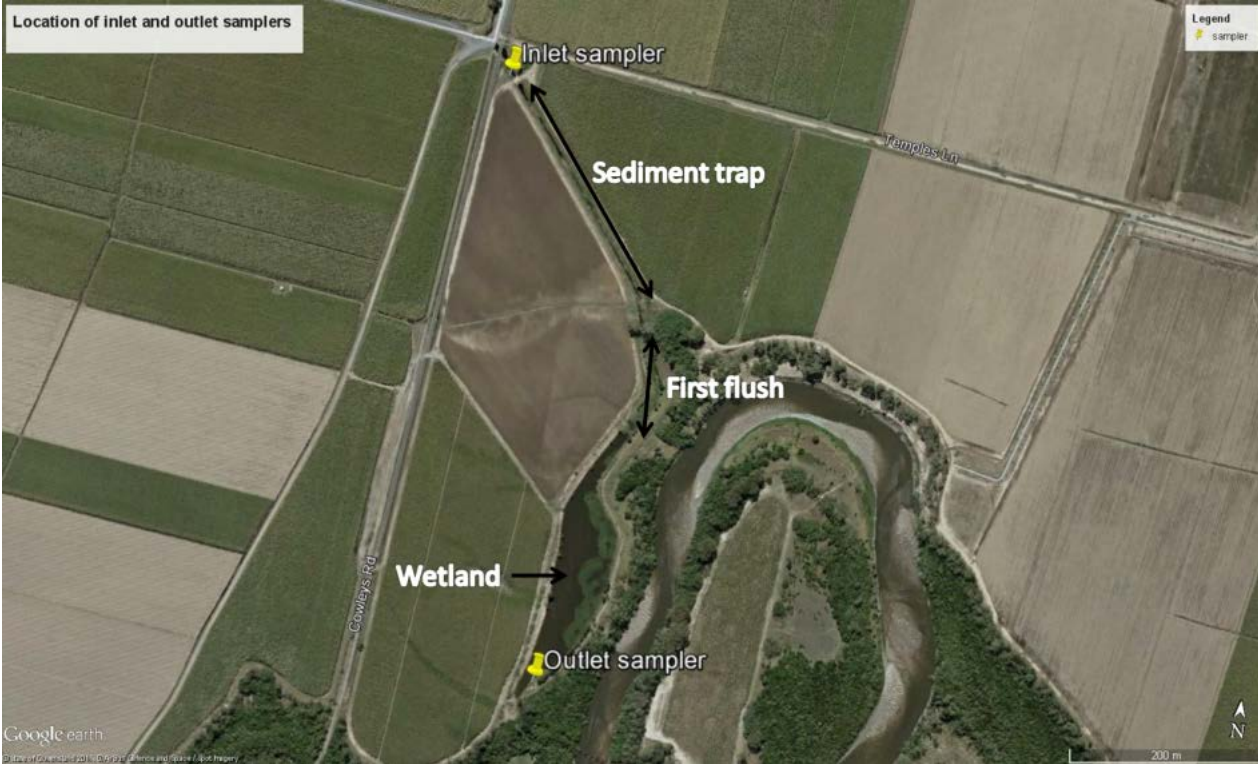
Figure 2 The three components of the system repair site, and the location of the water quality samplers

The system repair site consists of three components of a treatment train constructed during 2014 (Figure 2):

- The water from the catchment area enters a shallow **sediment trap/basin** of approx. 1 ML capacity.
- This then flows into a **first flush** irrigation sump (approx. 4 ML), which would ideally be pumped out onto adjacent cane paddocks after it has filled from the first flush of runoff.
- This then flows into a rehabilitated natural **wetland** (approx. 15-20 ML).

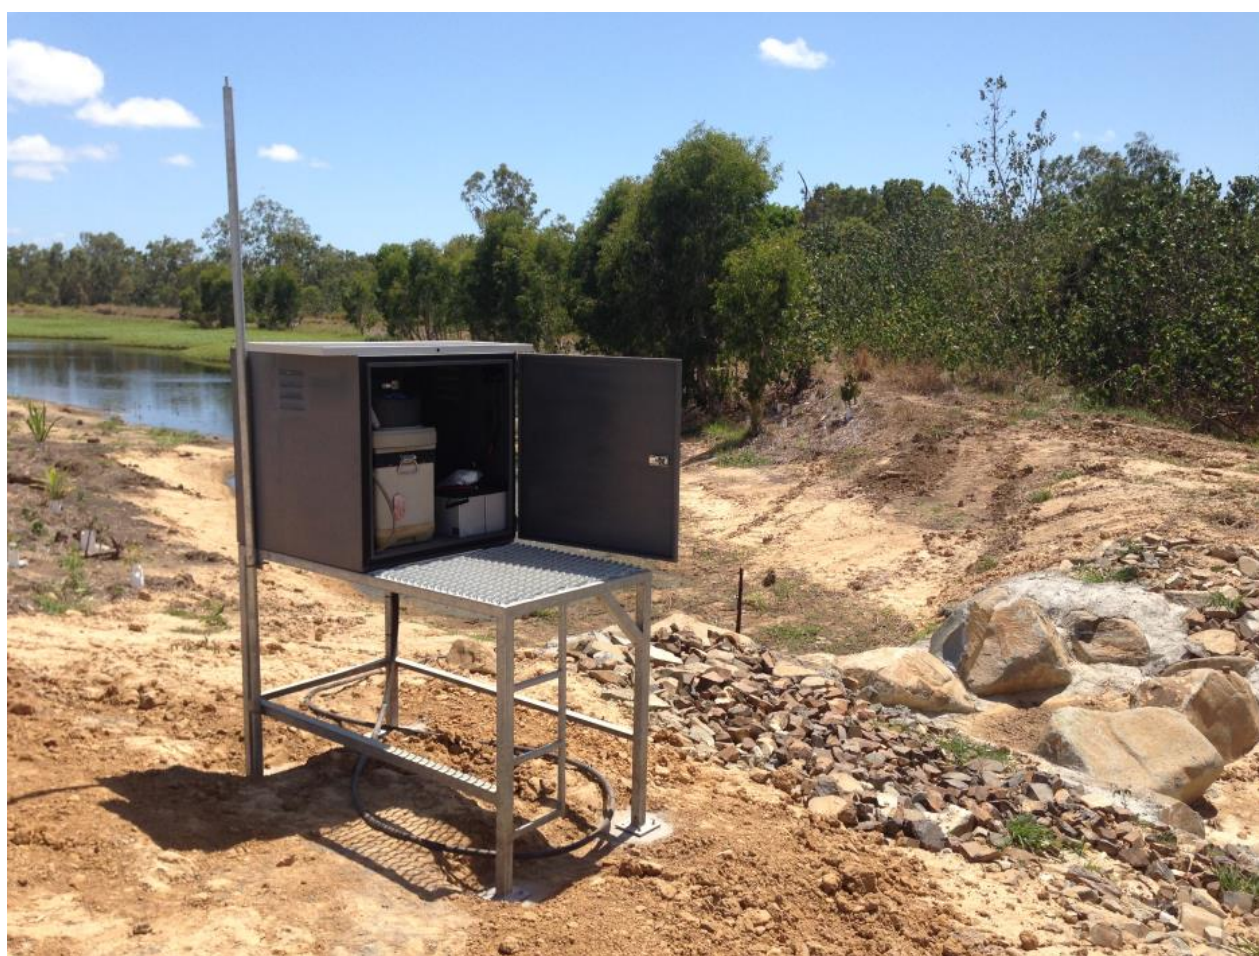
Figure 3 Water quality sampling equipment at the outlet of the Bakers Creek system repair site, showing the ISCO Avalanche sampler in the grey enclosure. The float switch is attached to the star picket in the centre of the photo.

Water samples from the inlet and outlet of the system repair site were collected using an ISCO Avalanche auto-sampler containing 14 x 1 L plastic bottles. The refrigeration system was activated after collection of the first sample. The samplers were triggered by float switches set approximately 100 mm above cease to flow levels. The samplers were then programmed to sample every 3 – 6 hours until the water level dropped below the triggered water height.

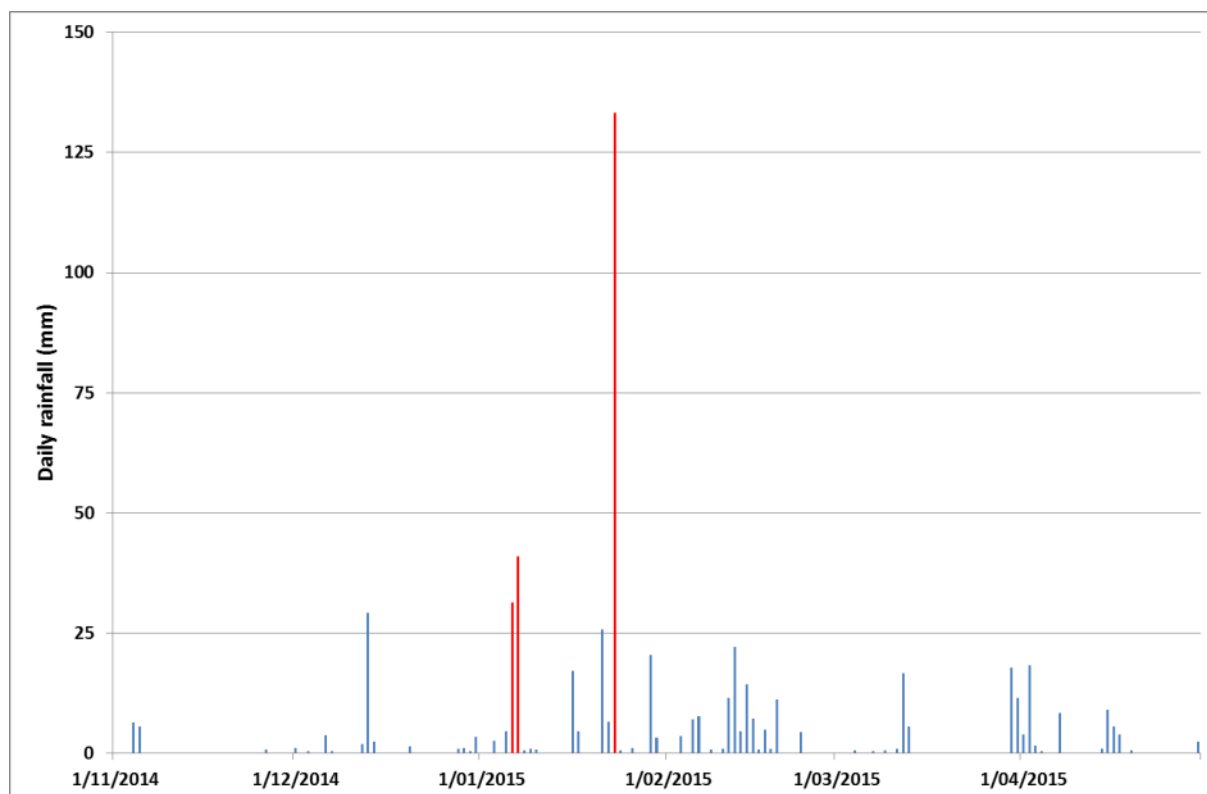
Figure 4 Daily rainfall (mm), Mackay Airport for 1st November 2014 to 30th April 2015

(Note – the red bars denote the rainfall that caused sufficient runoff to be sampled)

Daily rainfall totals above 30 mm only occurred on 6th/7th January (total 72.4 mm) and 23rd January 2015 (133.2 mm) (shown by the red bars in Figure 4). Both of these events caused sufficient runoff to be sampled. These runoff events are referred to as “Event 1” and “Event 2” throughout this report.

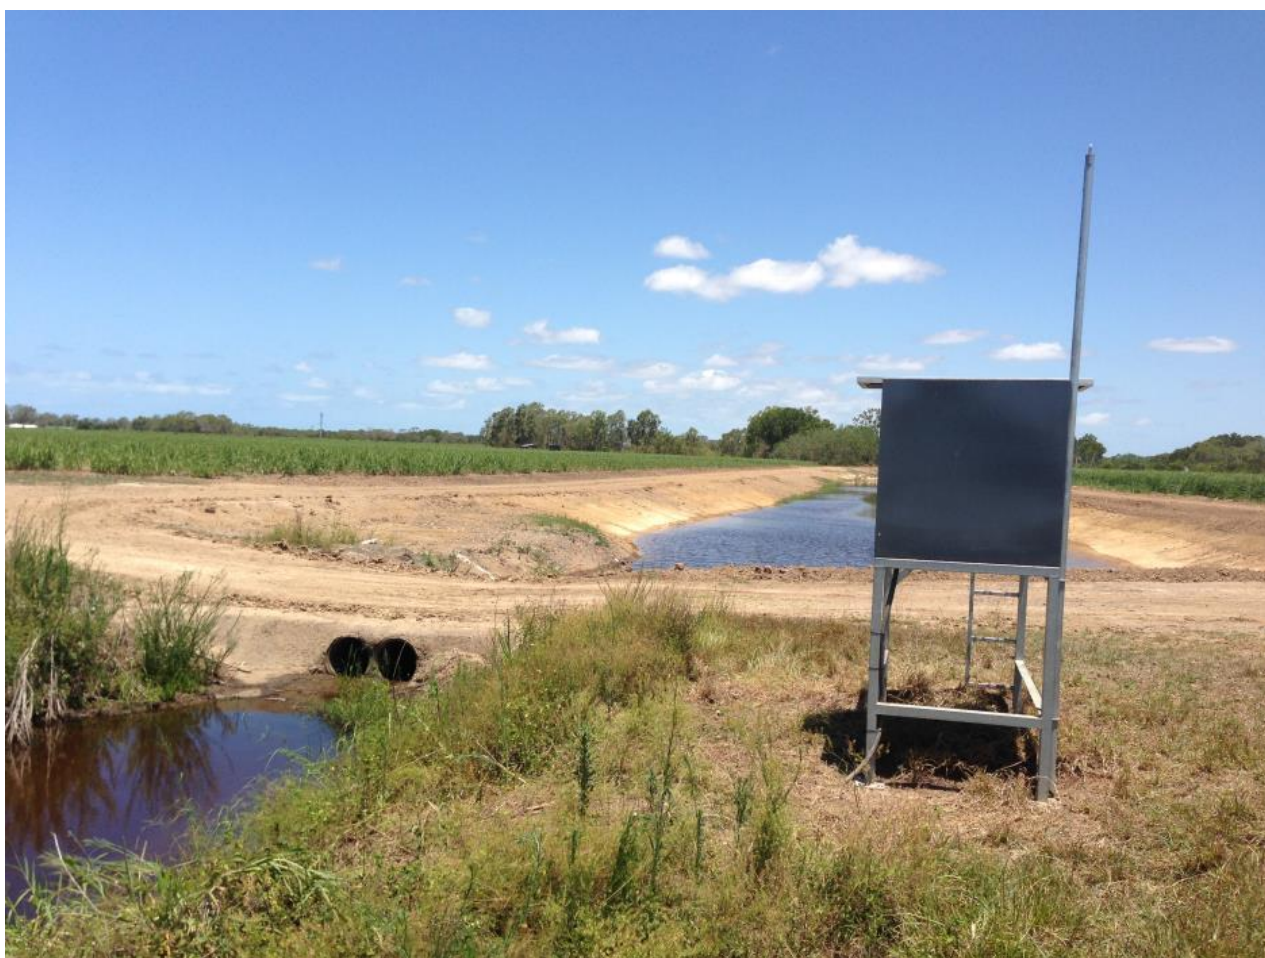
Figure 5 The bare, battered banks are a possible cause of increased sediment concentrations at the outlet (looking downstream from the inlet sampler, along the sediment basin)

The increase in sediment concentrations at the outlet (compared to the inlet) are thought to be a function of the bare battered banks during the period of sampling (e.g. Figure 5). Sampling during future seasons should see a decrease in sediment concentrations at the outlet due to the revegetation of the banks.

1. Revegetate or mulch the battered banks prior to the next wet season to reduce bank erosion.
2. Vegetate the sediment basin to allow accumulation, volatilization and/or transformation/degradation of nutrients and herbicides.
3. If possible, limit the amount of water draining directly into the system repair site from the sugar cane blocks directly to the west of the site (approx. 10 ha). This direct runoff may be limiting the measured efficiency of the site.
4. Conduct regular water quality sampling (monthly?) in the lead-up to the next wet season to assess the quality of water contained within the system. This will assist in the interpretation of the first runoff event for the following season.
5. Conduct regular water quality sampling after the wet season to assess the persistence and breakdown of pollutants (mainly herbicides) in this system.

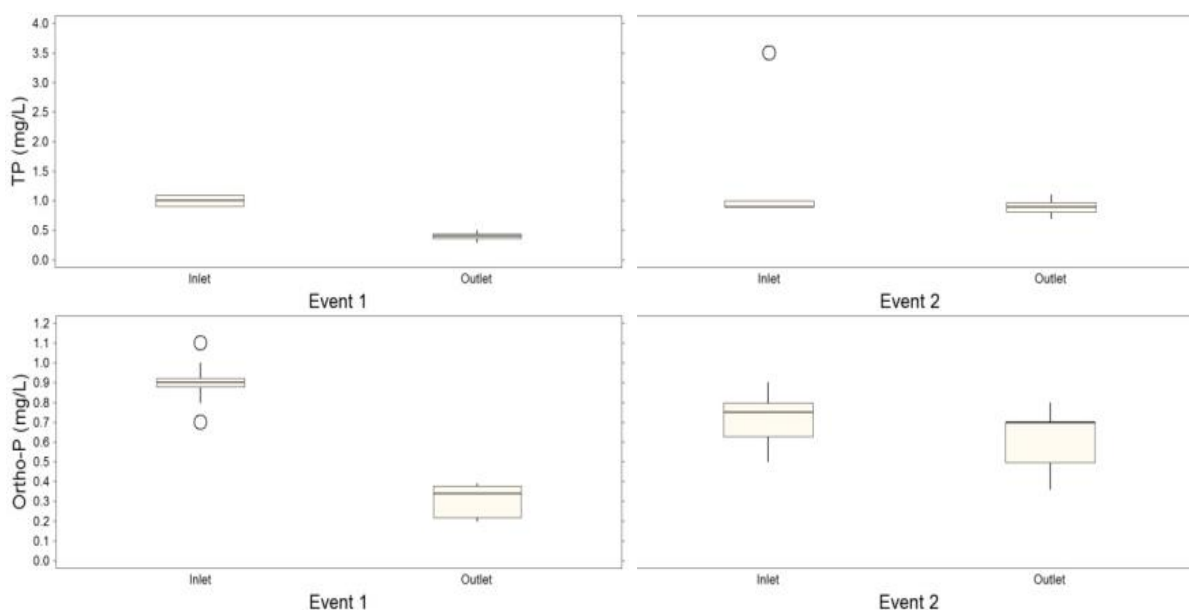
Figure 7 Box plots of total phosphorus (TP) and ortho-P concentrations from the inlet and outlet of the Bakers Creek system repair site, measured over two runoff events during the 2014/15 wet season

Concentrations of phosphorus (total and ortho-P) at the outlet during Event 1 were approximately half those of the inlet, but similar during Event 2 (Figure 7). Similar to the $\text{NO}_x\text{-N}$ findings, the reduction in concentrations for Event 1 may be due to dilution through the system for the small runoff event, whereas the much larger Event 2 fully flushed the system.
