## Natural Disaster Recovery at West Hill Creek

Three sites along West Hill Creek near Ilbilbie were identified as a priority for remediation under the Natural Disaster Relief and Recovery Arrangements (NDRRA) to assist with environmental recovery and repair from the impacts of Severe Tropical Cyclone Debbie and its associated rainfall and flooding.

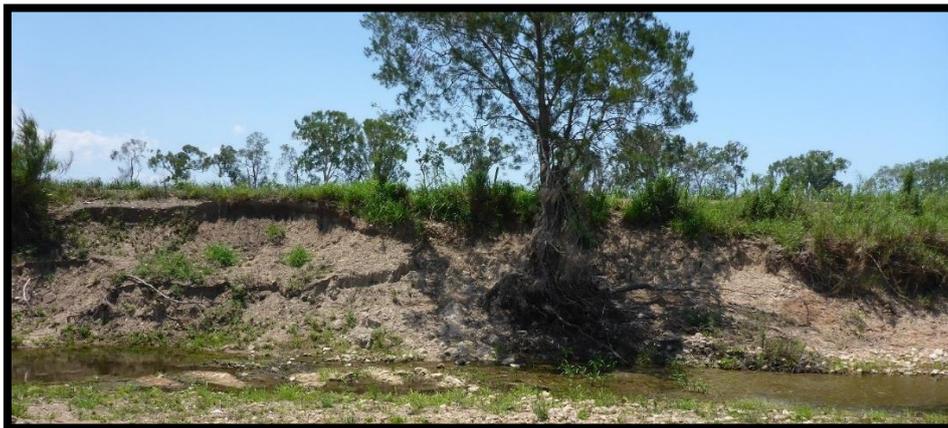
Figure 1: Erosion at WH1, Nov 17

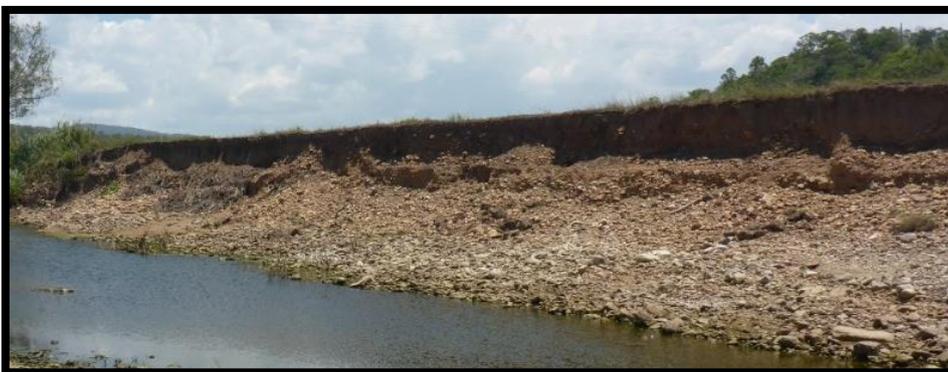
Figure 2: Erosion at WH3, Nov 17

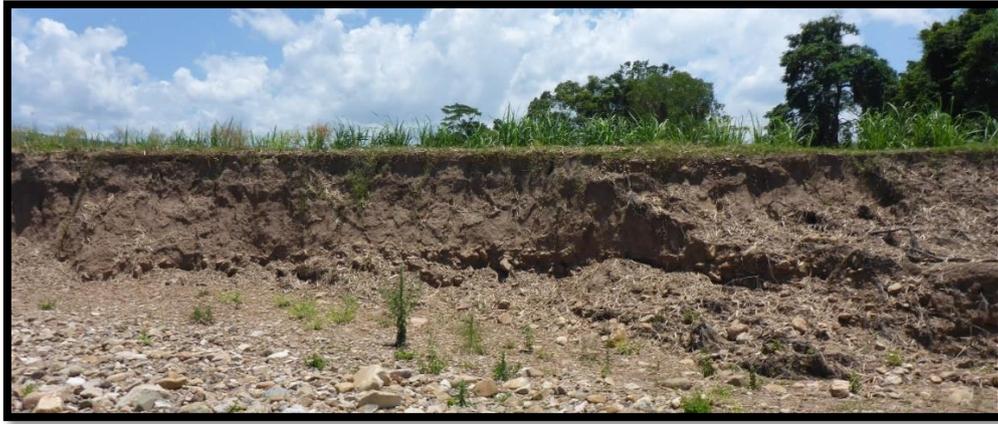
Banks at the sites were approximately 4-5m high with the upper 1-2m of the bank vertical or near vertical and composed predominantly of silty clay. The lower banks consisted largely of gravel, cobbles and sediment, which were unconsolidated and likely to be mobilised in the next large flow event.

Figure 3: WH4 Bank, Nov 17

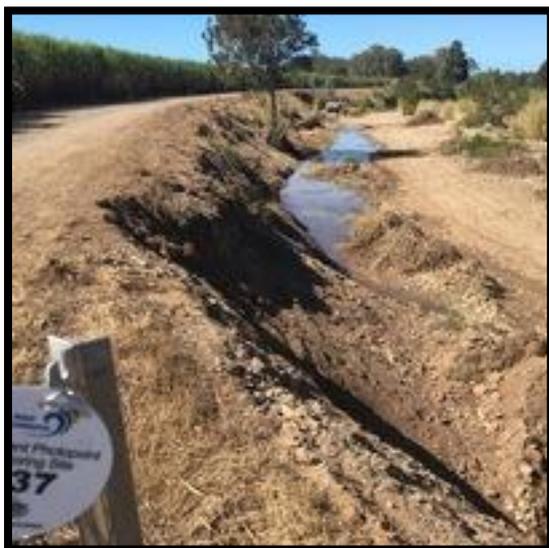
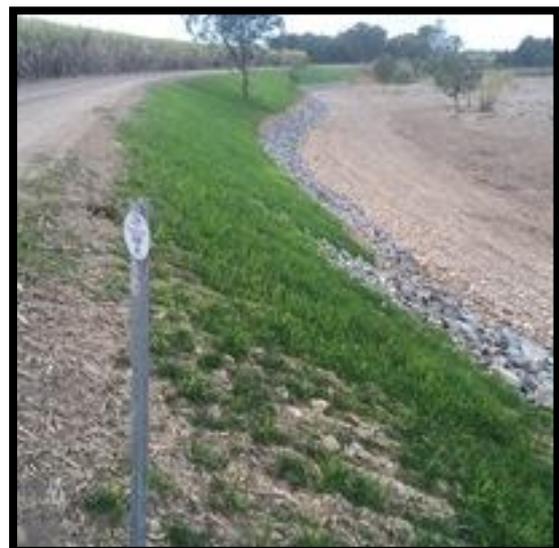
Figure 4: WH1 photopoint 137 pre (left) and post works (right)

In consultation between Reef Catchments, the landholder and the fluvial geomorphologists an option was decided upon to create a benched rock toe constructed using a combination of imported quarry rock and available bed material. The rock was to be placed against the existing bank and keyed in to the bank and bed. Topsoil was placed over rock beaching to assist with revegetation. Hydromulch has been applied to sites to stabilise sediments quickly and the sites revegetated with native plants.

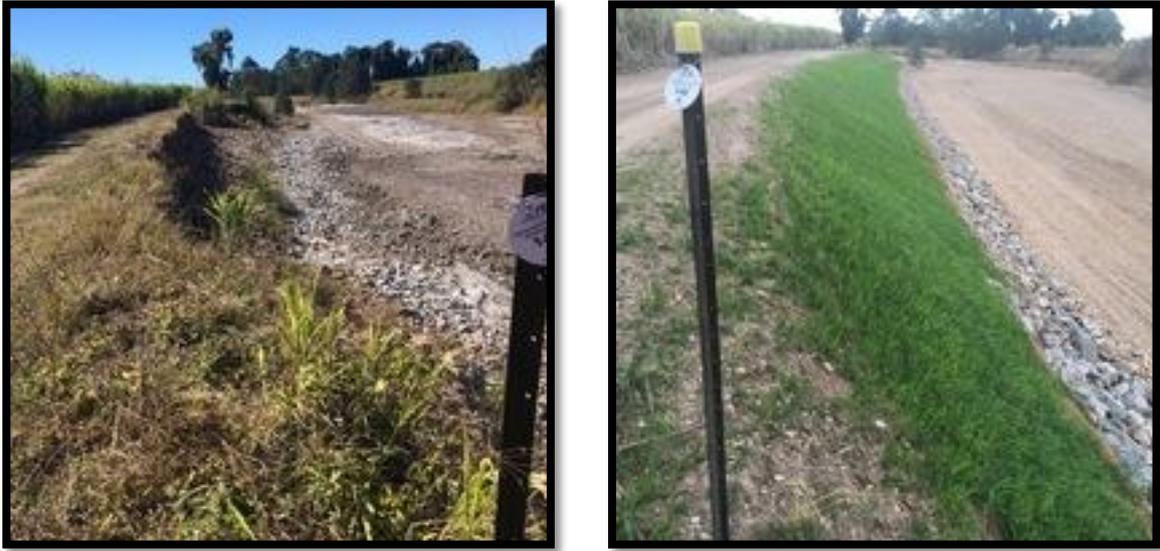
Figure 5: WH3 photopoint 149 pre (left) and post works (right)
