**STABILITY ASSESSMENT:**

O'Connell River

May 2014

Alluvium (2014). O'Connell River Stability Assessment. Report P414005\_R01 by Alluvium Consulting Australia for Reef Catchments

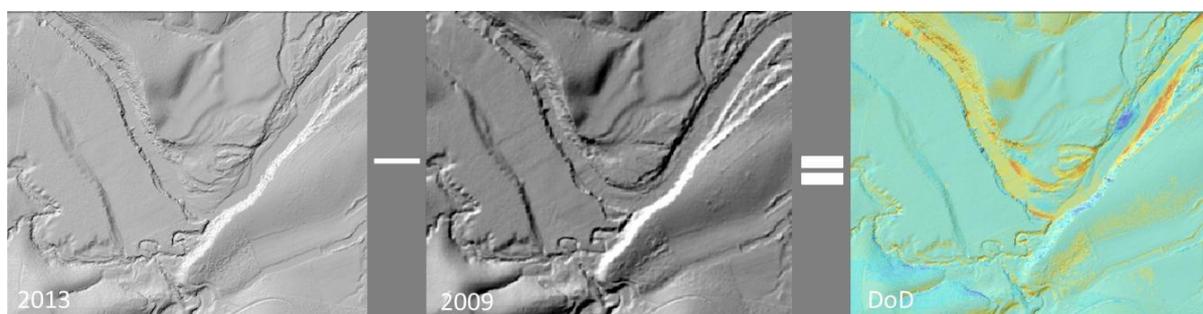
**Figure 5.** Example of how DEM of Difference (DoD) is created from two LiDAR datasets. In the DoD at the far right yellow and orange displays a drop in elevation indicating erosion has occurred. Blue displays an increase in elevation indicating deposition.

LiDAR data was commissioned by Reef Catchments in early 2014. From this data a Digital Elevation Model (DEM) was created with a one metre grid size. The 2014 DEM could then be compared to a 2010 LiDAR data derived DEM supplied by the Queensland state government. From the 2010 and 2014 DEMs a DEM of Difference (DoD) was developed (Figure 5). A DoD identifies changes in ground surface elevation from two LiDAR datasets captured at different points in time. From the DoD the volume of sediment eroded from the bed or banks at a specific location or the distance of bank migration can be estimated.

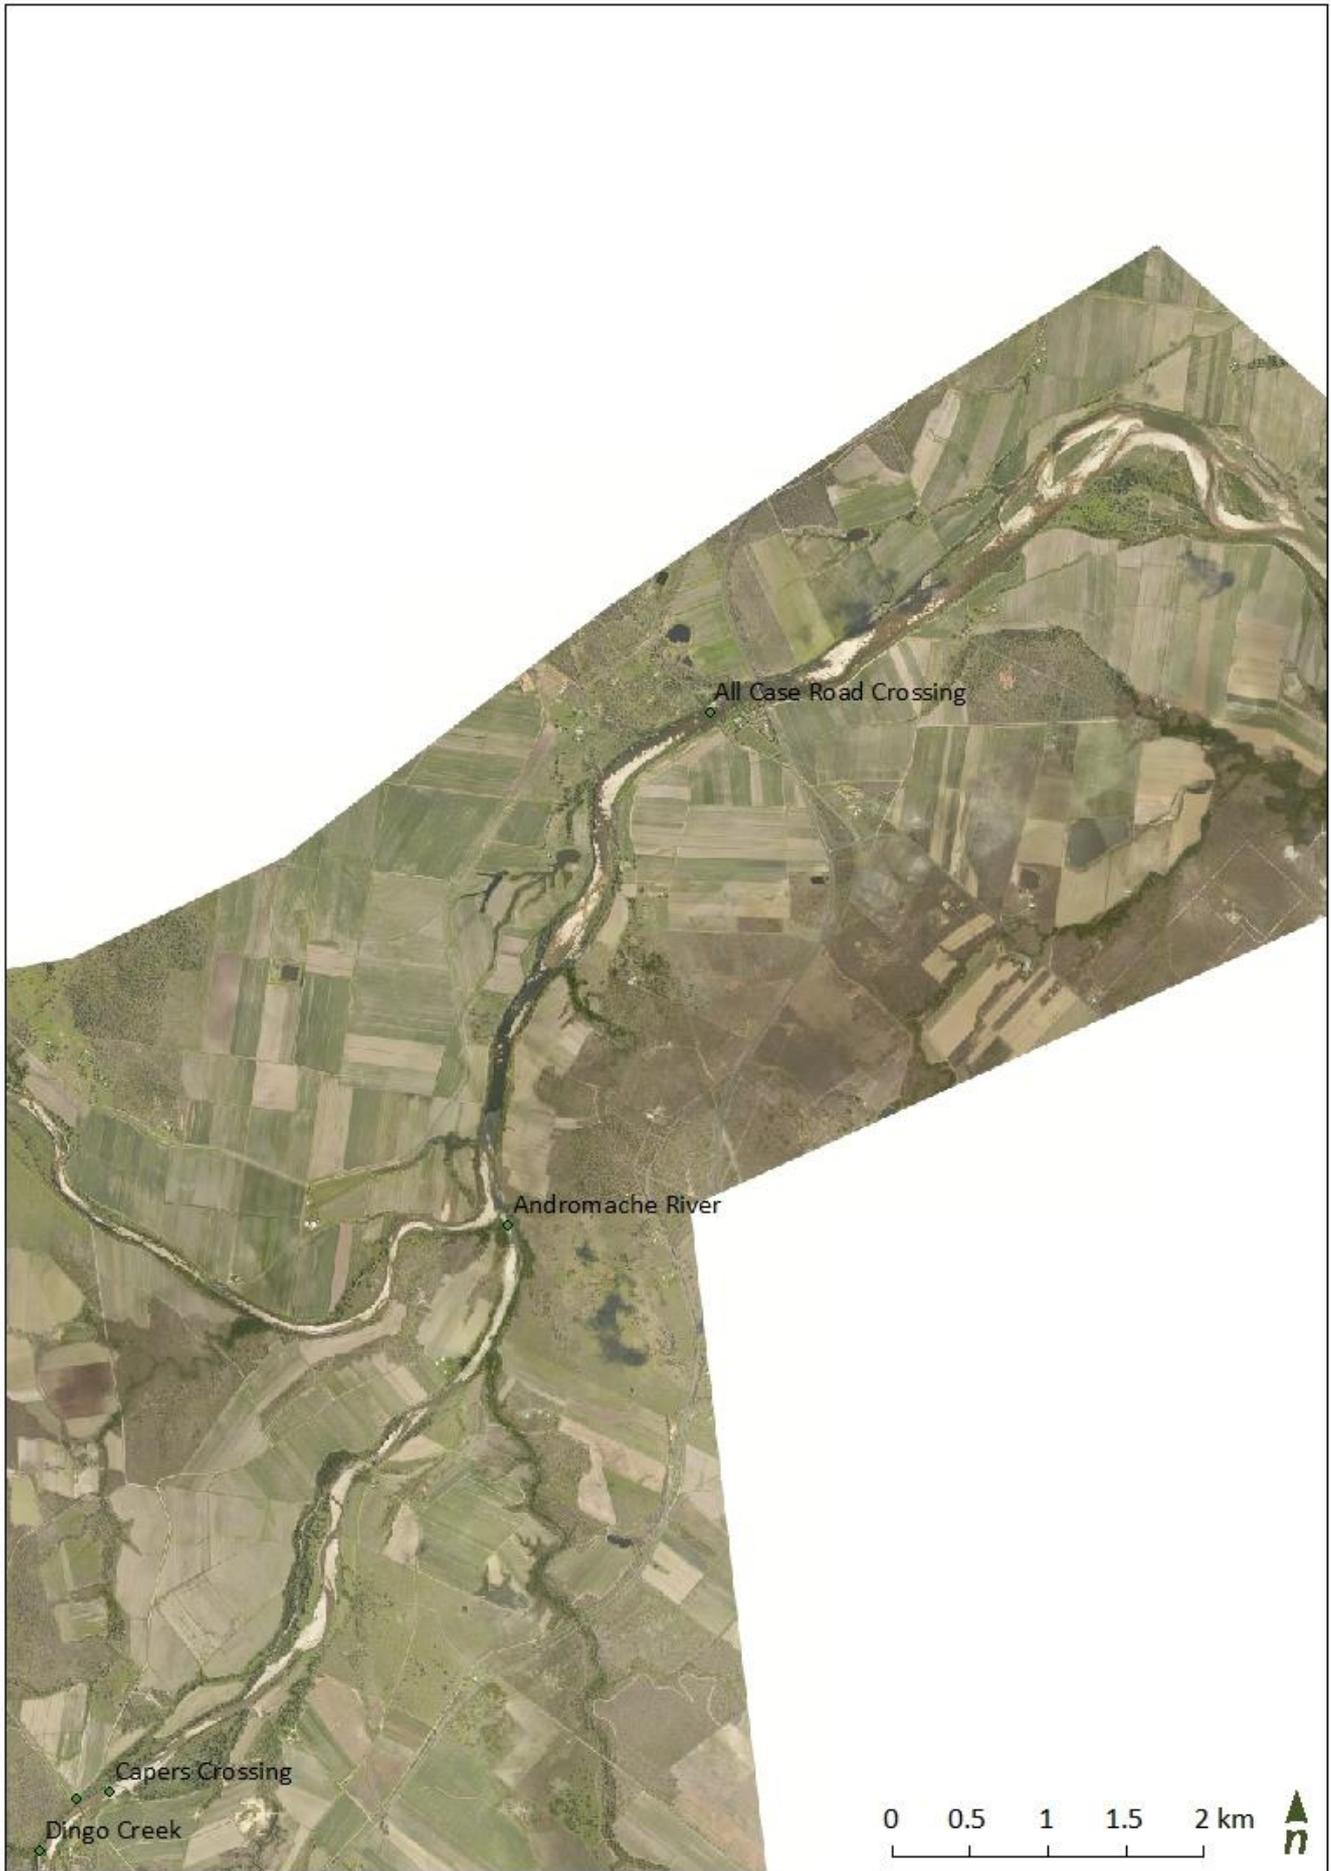
**Figure 11.** Aerial imagery captured in 2014 of Reach 1

Reach 1 extends from the Capers Crossing to the mouth of the O'Connell River at Laguna Quays (Figure 11). The channel abuts active floodplain, terraces and the bedrock valley margins throughout this reach (Figure 12). The terraces and floodplains are predominately used for sugarcane cultivation. The system is a gravel bed stream at the upstream end of the reach and transition to predominantly sandy bed system closer to its mouth. Floodplain deposits consist of a mix of sand, silts and clays. Key findings from the stability assessment include:

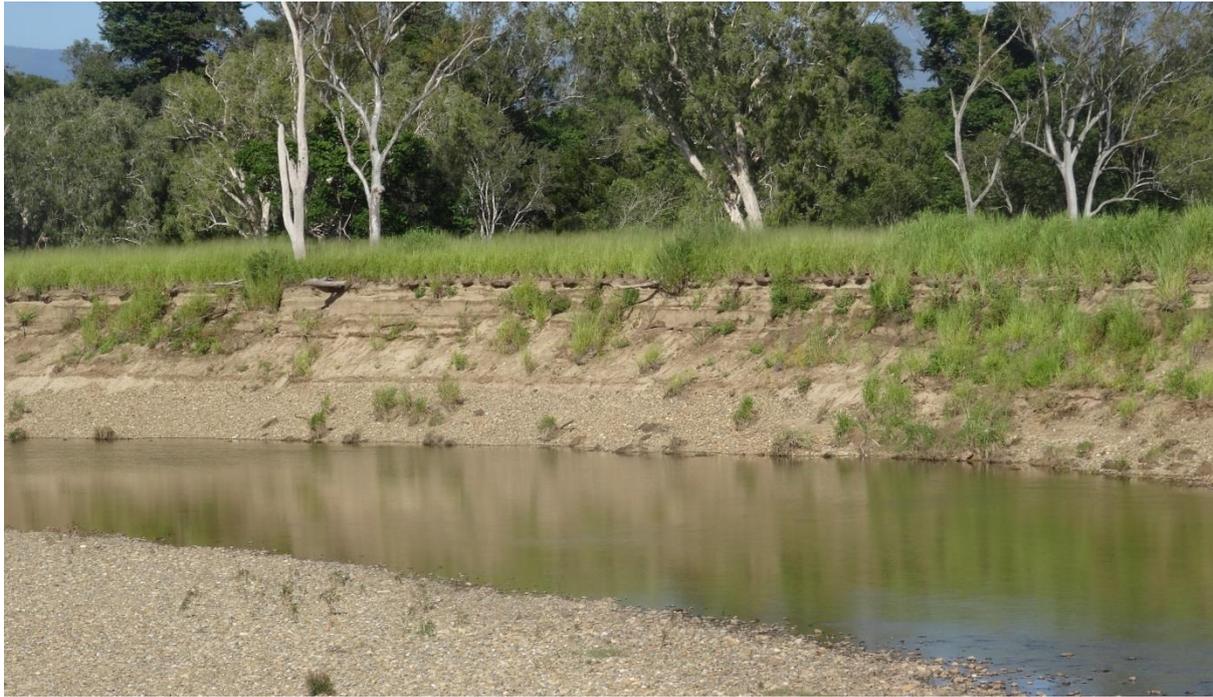
**Figure 14.** Looking across river toward left bank which has undergone meander migration. Approximately 65,000 m<sup>3</sup> of sediment was eroded from this bank between 2010 and 2014. The bank substrate was sandy with some fines.

We found Reach 1 to have released significantly more sediment from major stream bank erosion than other reaches. This large volume of sediment was derived from only four sites. The banks in Reach 1 are high (6-8 m) and when mass failure occurs (as a result of toe scour and/or pre-weakening) large volumes of sediment are released. The sediment only has a short distance to travel before it is discharged into the marine environment. The peak event stream power in Reach 1 is within the reference values and as a consequence we have confidence that a revegetation program with only limited structural interventions can be implemented with a high likelihood of success. Given the scale of the erosion and the importance of reducing sediment release in this reach the structural intervention will need to be designed to an appropriate standard to support the vegetation during the establishment phase.

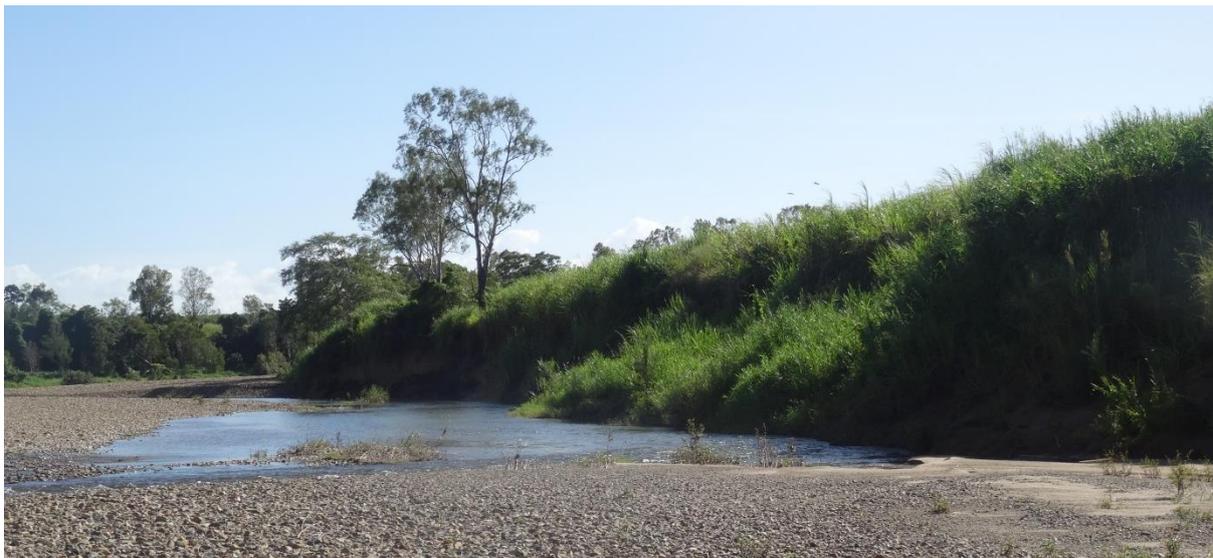
**Figure 15.** Looking downstream along the eroded right bank. Approximately 20,000 m<sup>3</sup> of sediment was eroded from the bank between 2010 and 2014. The bank substrate had a higher clay content than the opposite bank.

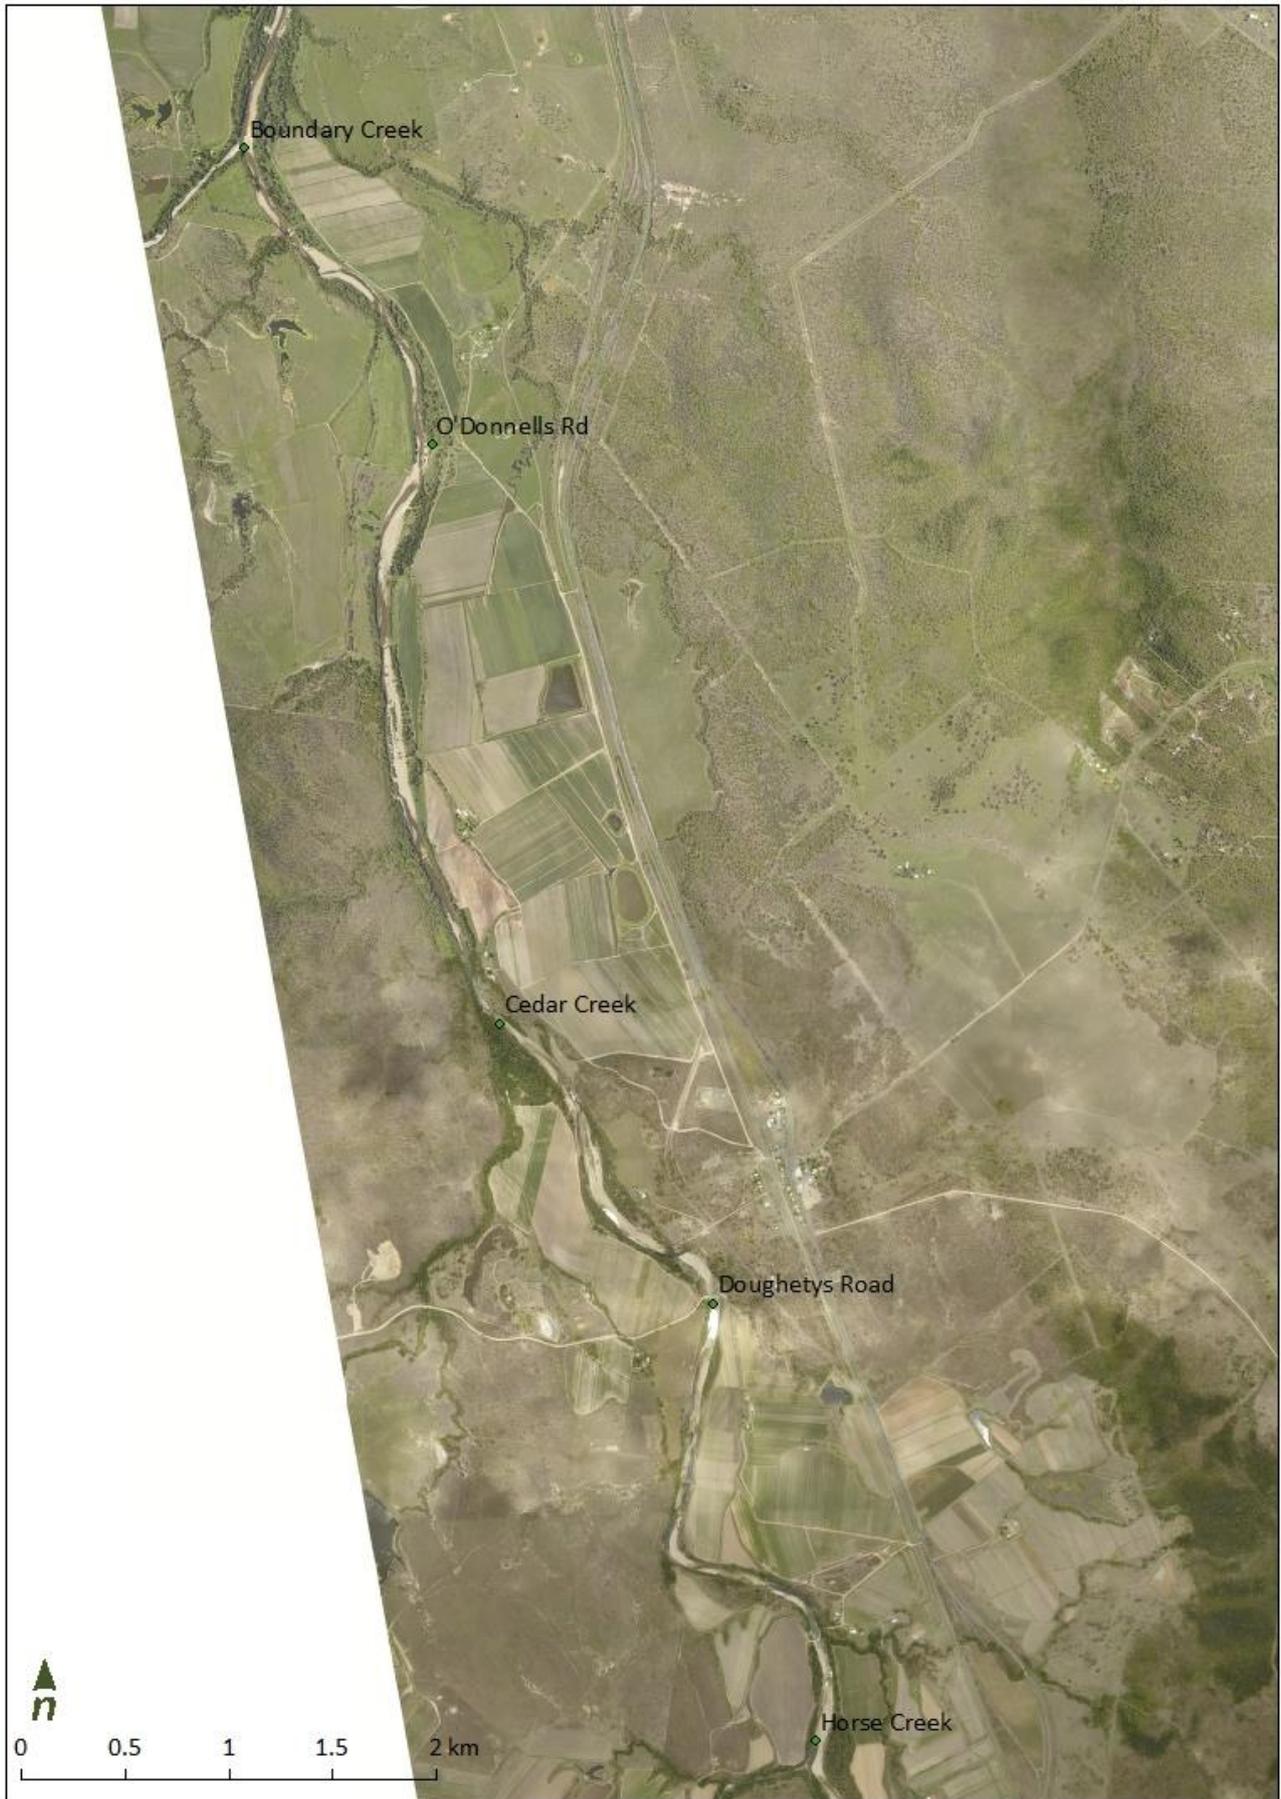
**Figure 18.** Aerial imagery captured in 2014 of Reach 3

Reach 3 extends from Horse Creek to two hundred metres downstream of the Boundary Creek confluence (Figure 18). The floodplain is typically several hundred metres wide with a low sinuosity cobble bed channel. There are some localised areas where the floodplain width is limited and the channel is confined by terraces or the valley margin (Figure 19). The floodplain and terraces are predominately used for sugarcane cultivation however there are also some small areas used for grazing. Key findings from the stability assessment include:

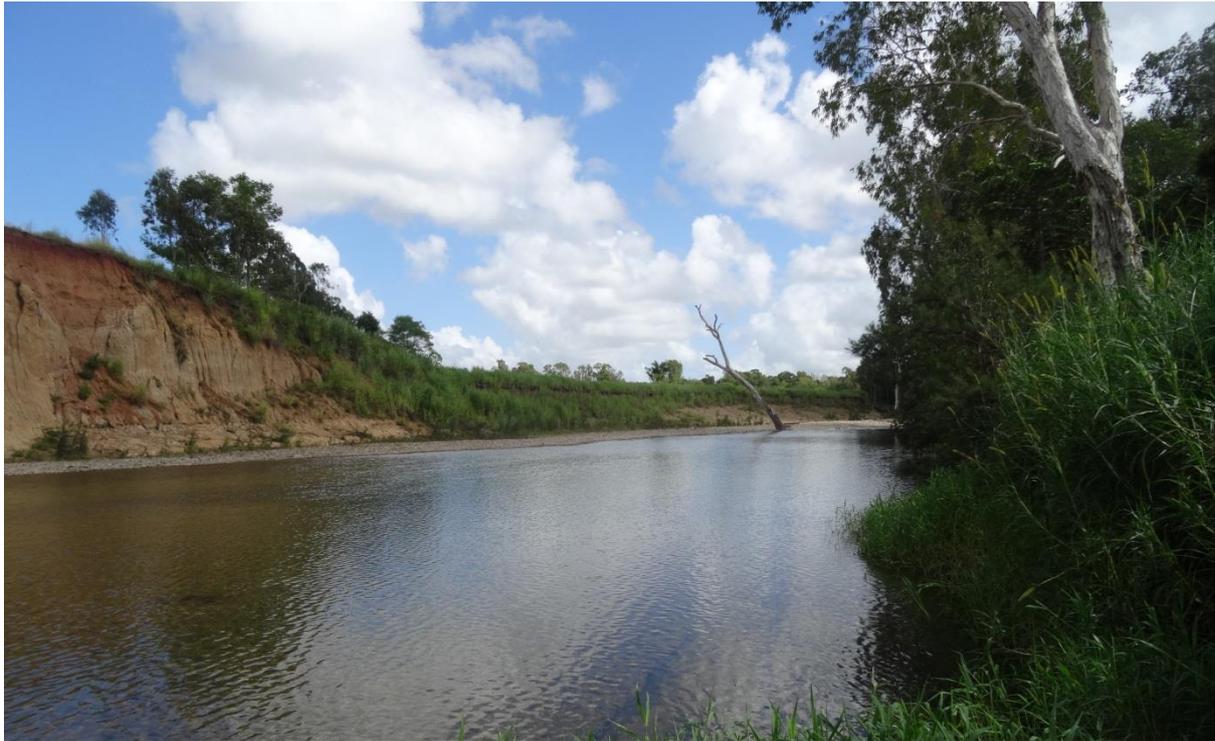
**Figure 23.** Looking across at the left bank immediately upstream of the Boundary Creek confluence – terrace to the left of the image and active floodplain to the right. This site has contributed 9,000 m<sup>3</sup> of sediment loss between 2010 and 2014.

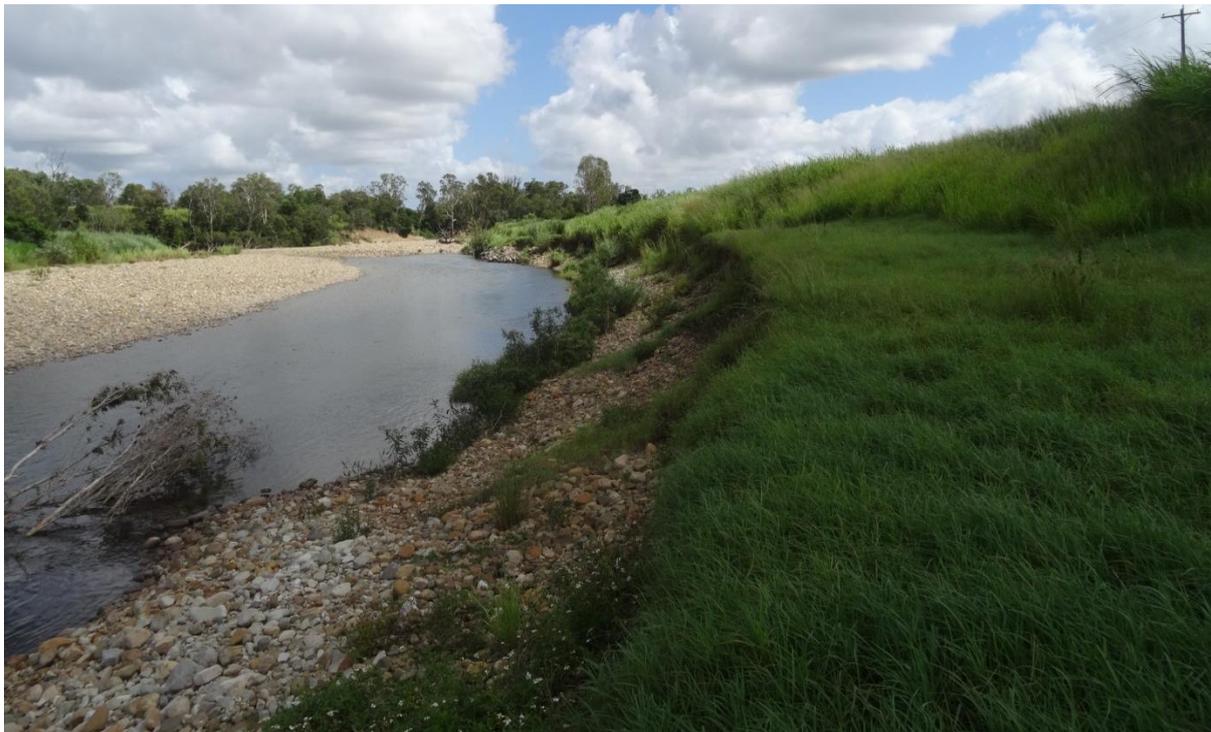
**Figure 24.** Looking downstream along the right bank located 1.5 km upstream of the Boundary Creek confluence. Site is subject to meander migration. This site has contributed 3,000 m<sup>3</sup> of sediment loss between 2010 and 2014.

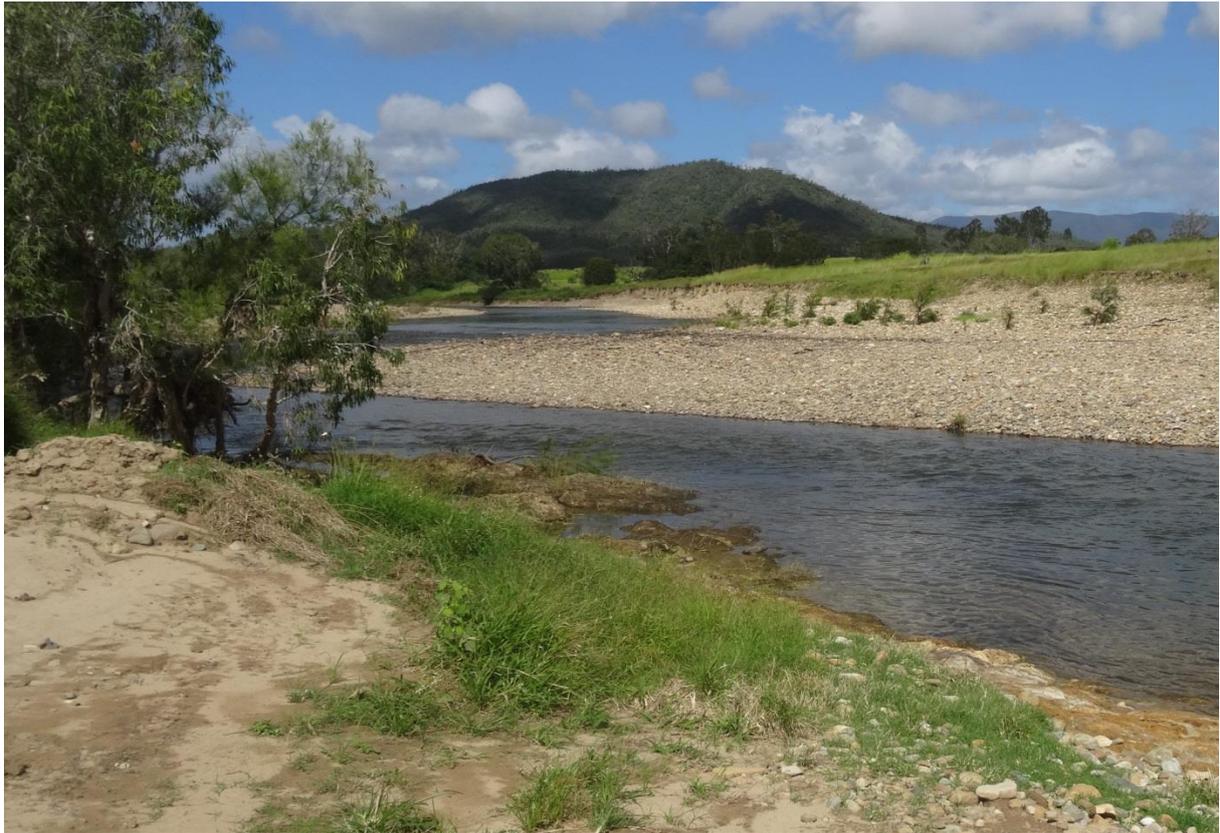
**Figure 25.** Looking across at the right bank near O'Donnells Road. Site is subject to meander migration. This site has contributed 3,000 m<sup>3</sup> of sediment loss between 2010 and 2014.

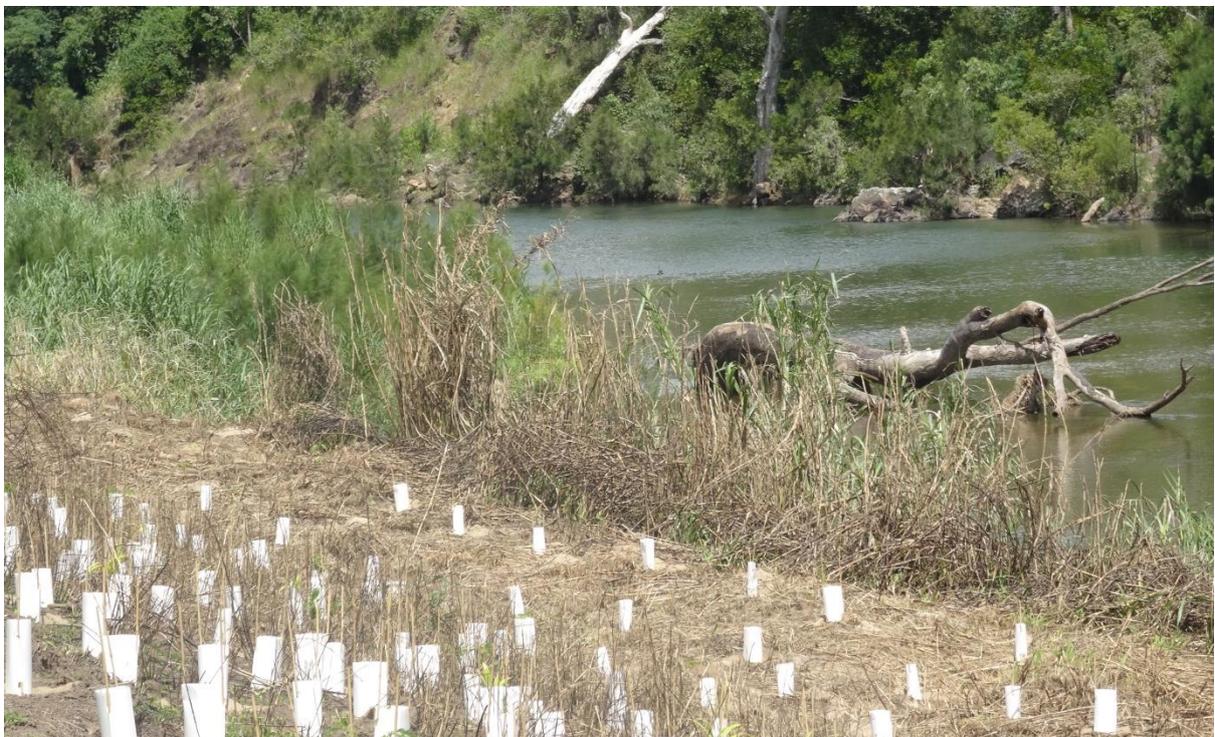
**Figure 26.** Section of floodplain which has recently been revegetated by Reef Catchments in Reach 3

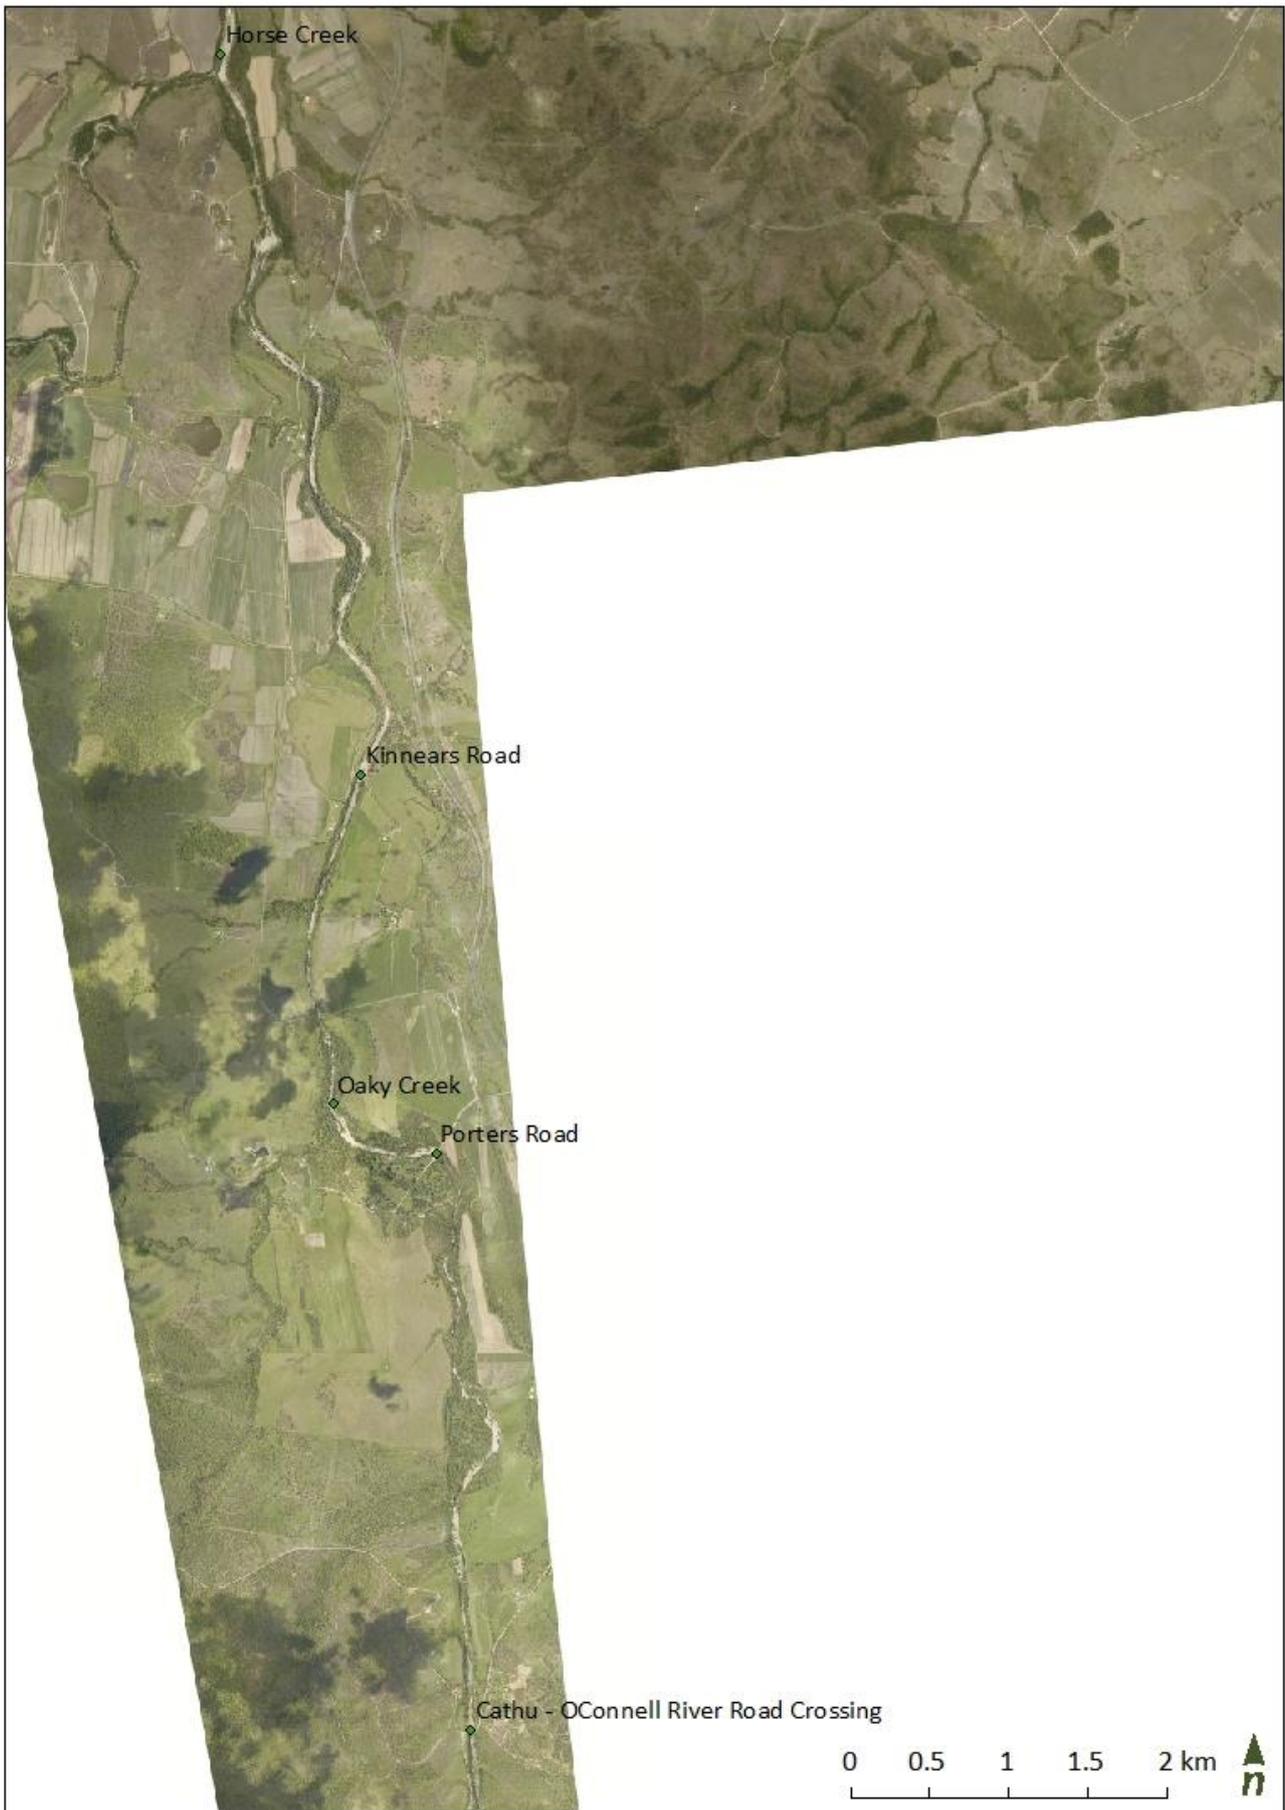
**Figure 27.** Aerial imagery captured in 2014 of Reach 4

Reach 4 extends from Cathu – O’Connell River Road crossing to the Horse Creek confluence (Figure 27). The floodplain within this reach is variable but can be up to 800 m wide (Figure 28). The channel also abuts terraces or the valley margins in a number of locations. The channel has a low sinuosity and a cobble bed. The floodplain and terraces are predominately used for sugarcane cultivation at the downstream end of the reach, while grazing is more prevalent at the upstream end. This change in land use is likely a reflection of the greater proportion of fine grained sediments in the downstream floodplains. Key findings from the stability assessment include:

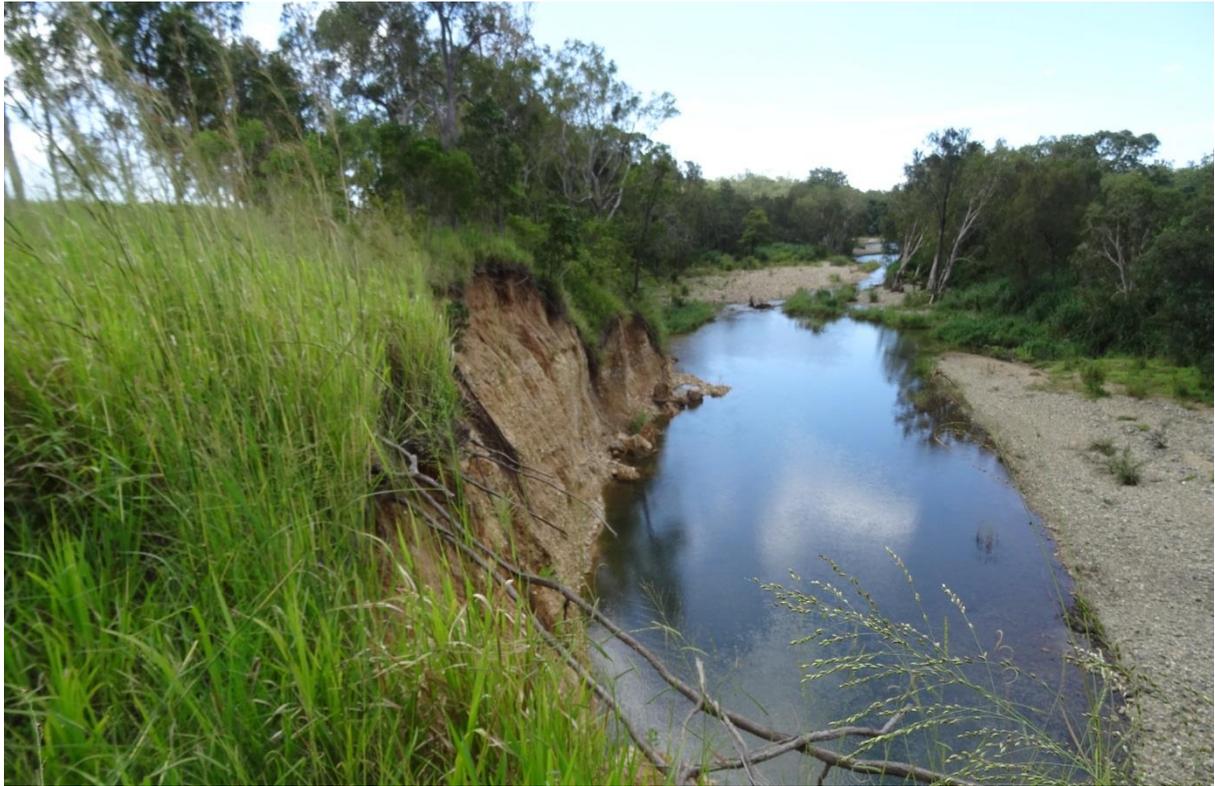
**Figure 33.** Near vertical terrace along the outside of a meander downstream of Kinnears Road. This site contributed 6,000 m<sup>3</sup> of sediment between 2010 and 2014.

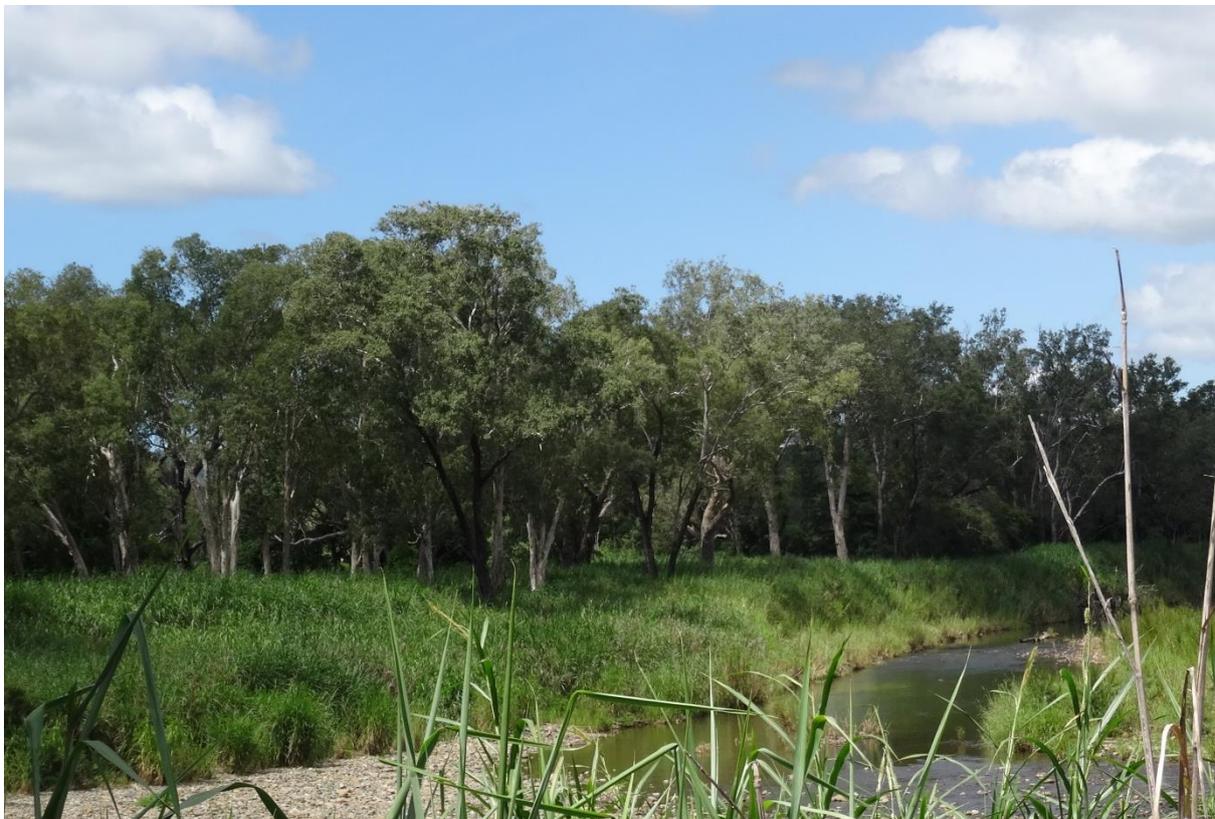
**Figure 34.** Looking across at the right bank opposite the Horse Creek confluence – meander migration of this bank has resulted in 3000 m<sup>3</sup> of sediment loss between 2010 -2014. Grass has grown over the eroding river bank since the recent erosion.

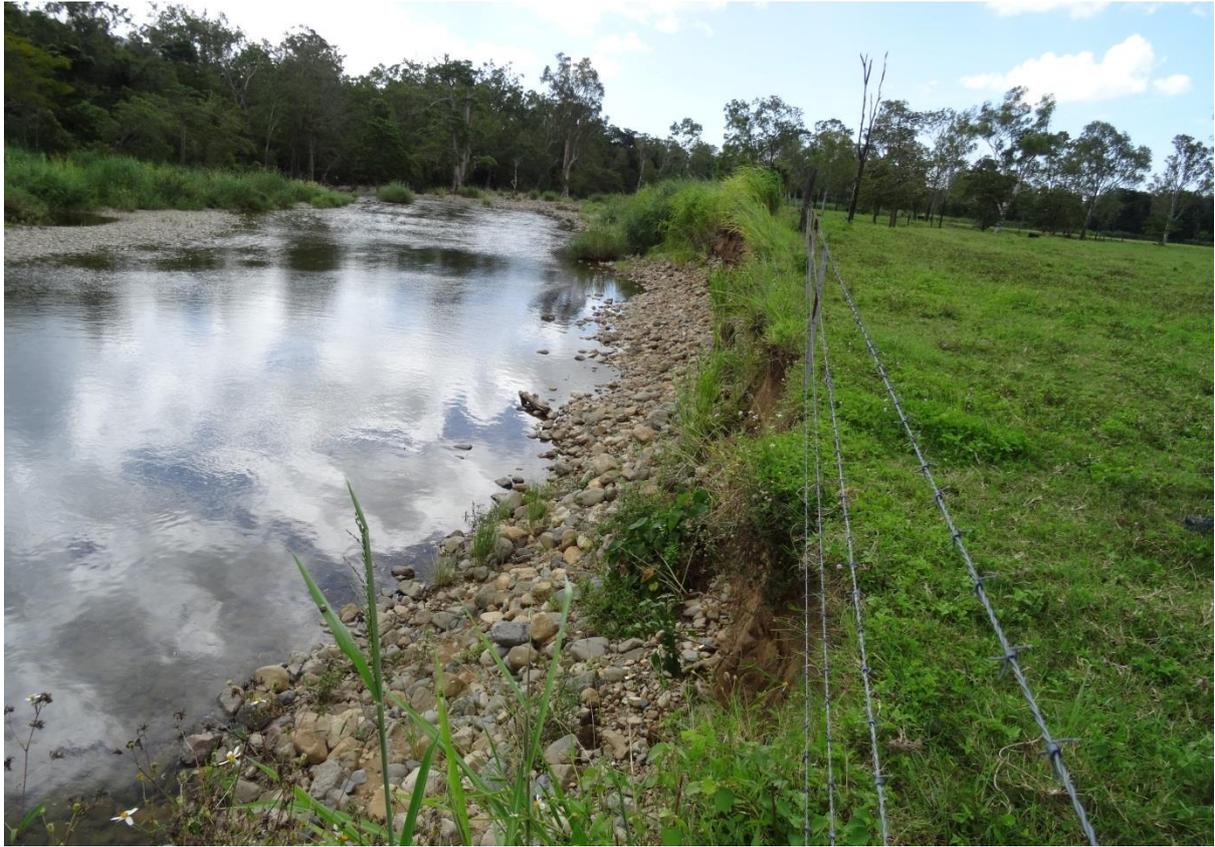
**Figure 35.** Eroding floodplain section downstream of Cathu –O’Connell River Road. This site has contributed 3,500 m<sup>3</sup> of sediment loss between 2010 and 2014.

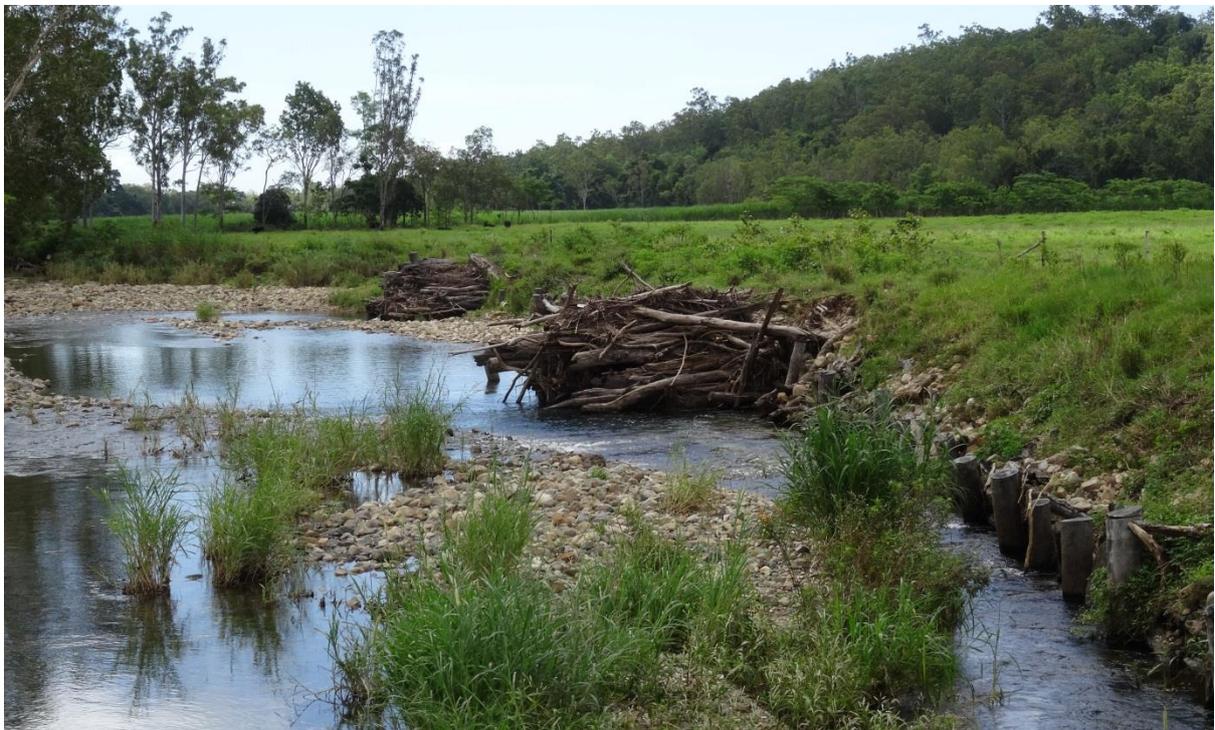
- Active floodplain areas without significant remnant riparian vegetation are likely to be significant sources of sediment in future flood events.
- Engineered log jams recently constructed by Reef Catchments near the upstream extent of the reach have reduced the rate of bank erosion, promoted some deposition and created scour holes for fish habitat (Figure 36).

**Figure 36.** Engineered Log Jams near the upstream extent of Reach 4

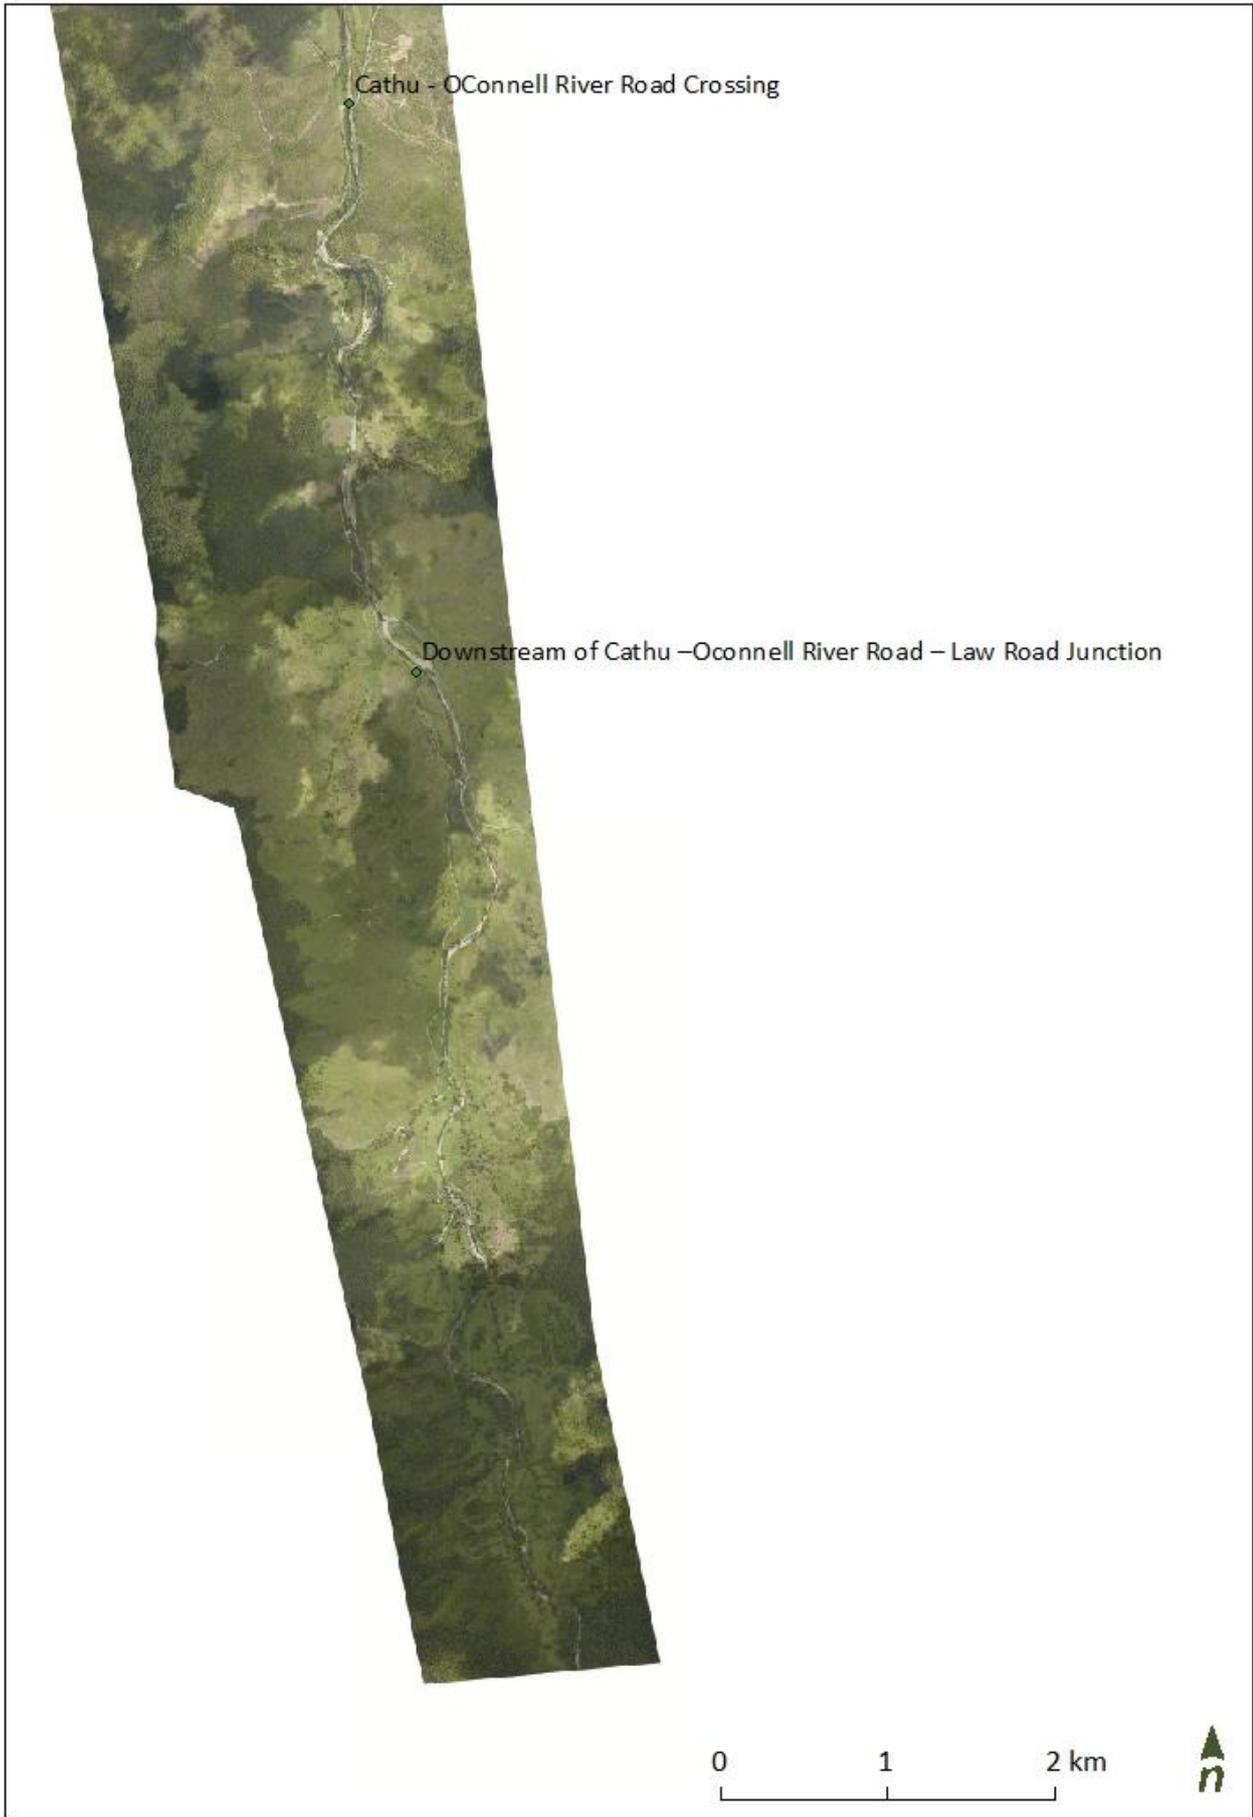
**Figure 37.** Aerial imagery captured in 2014 of Reach 5

Reach 5 extends from the headwaters to Cathu-O'Connell River Road (Figure 37). The system is partly confined however still has a floodplain several hundred metres wide in most locations (Figure 38). The system is a cobble bed stream with a high degree of bedrock control. Floodplain deposits have a high fraction of coarse sediment. Many of the floodplains in this area are used for grazing. Key findings from the stability assessment include:

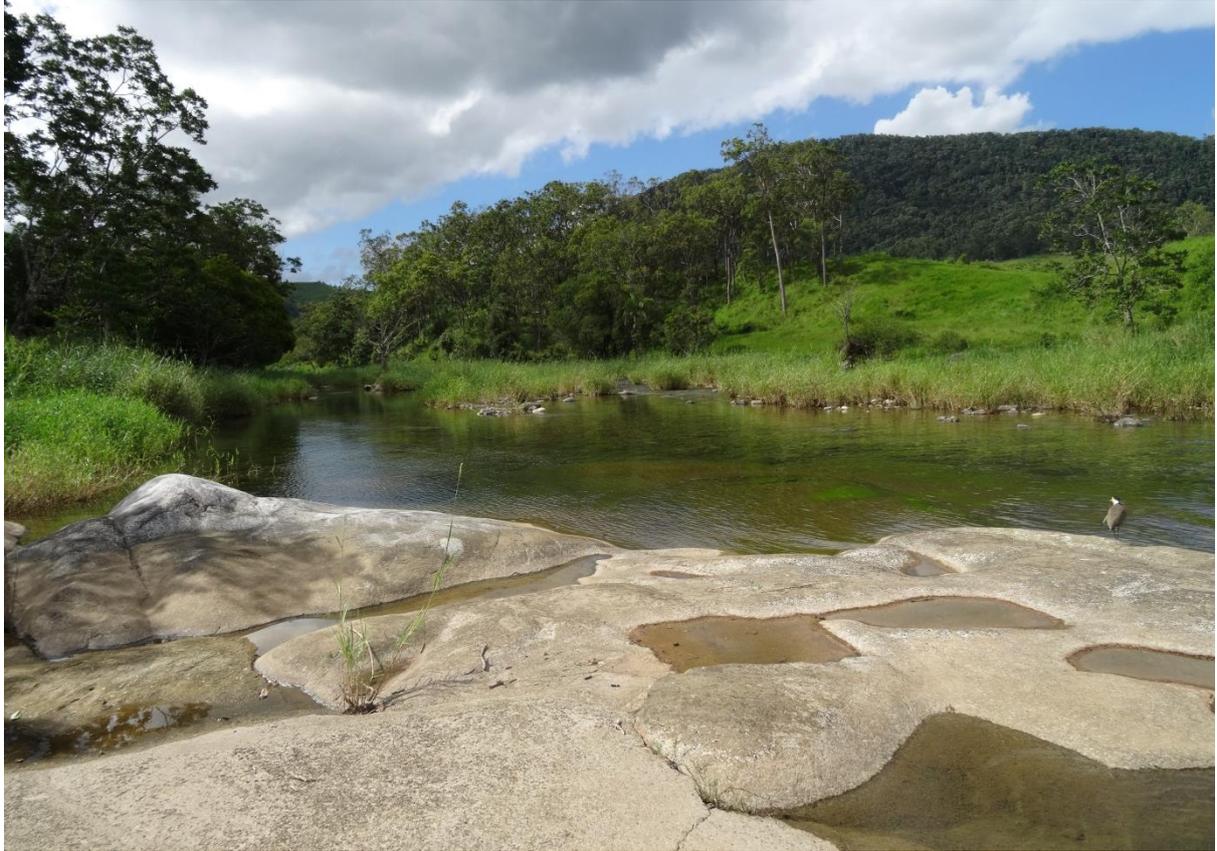
**Figure 40.** *Bedrock controls within the channel in Reach 5*

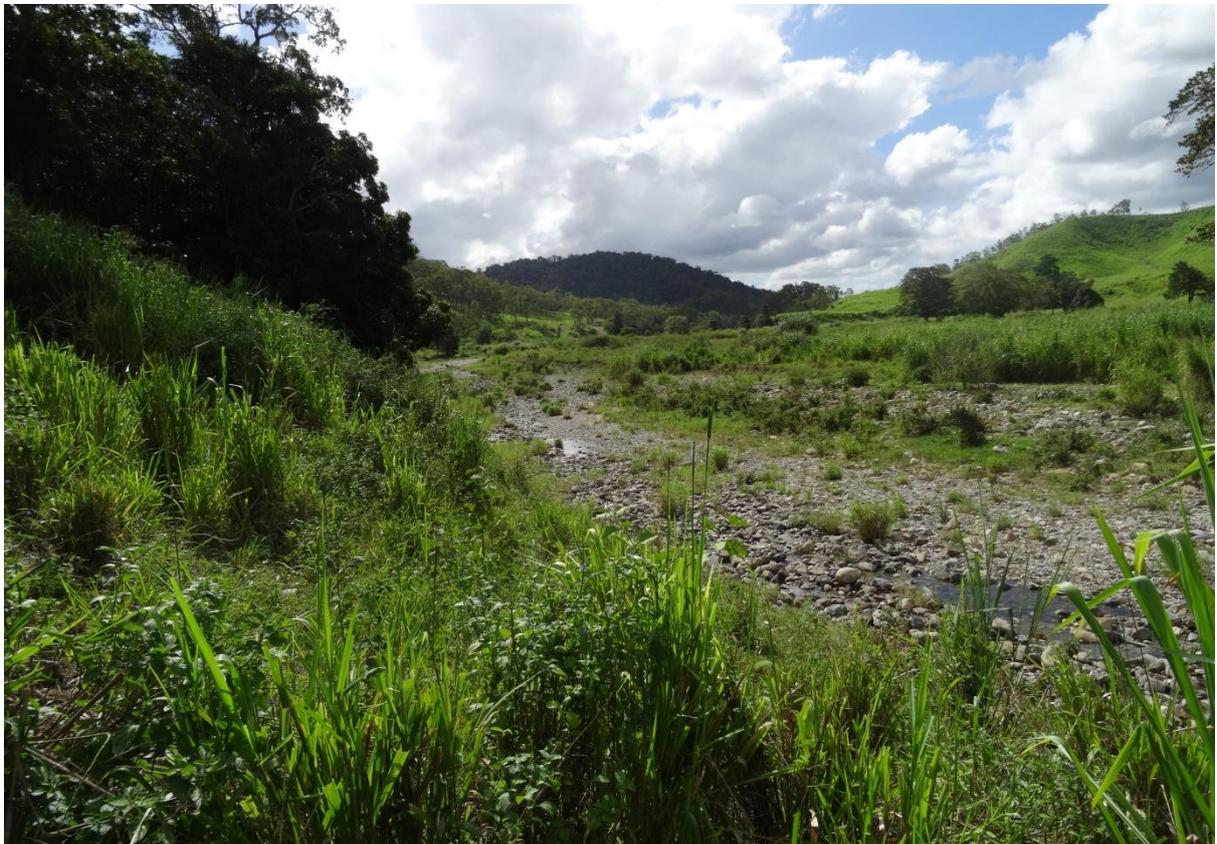
**Figure 41.** *Looking downstream along the cutoff path near the junction of of Cathu -O'Connell River Road and Law Road*
