## 2021 Fish Barrier Prioritisation – Mackay Whitsunday Region

Final Report

February 2022

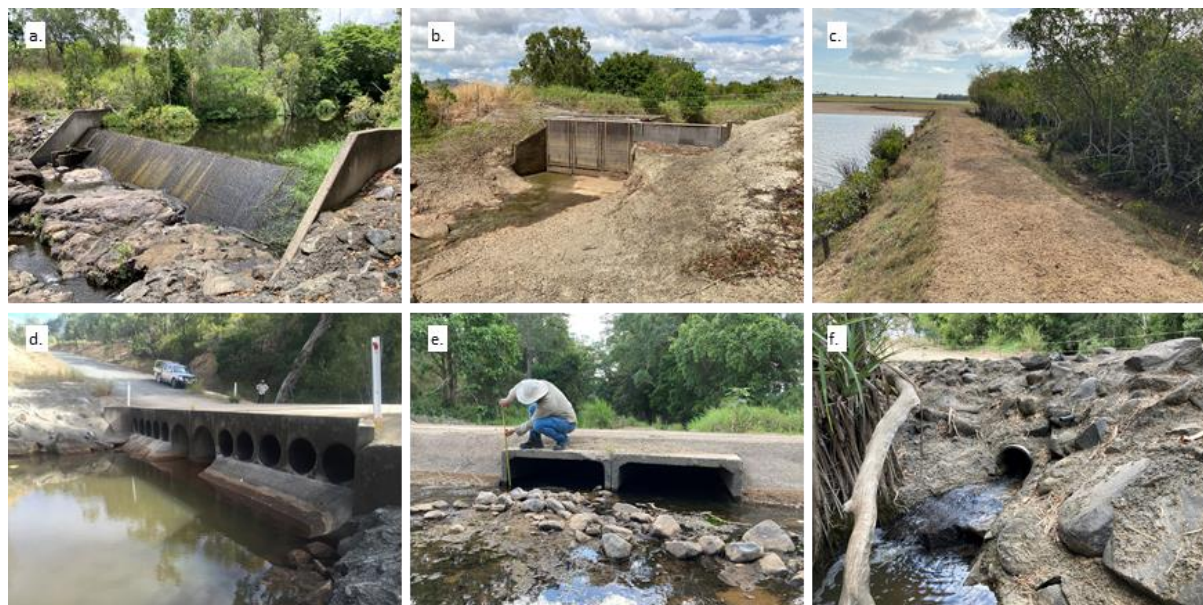
**Figure 1. Barrier structures:** a. irrigation supply weir (McGregor Creek), b. tidal floodgates (Constant Creek Tributary) c. Earth bund (Constant Creek floodplain), d. Pipe culvert causeway (Daintry Creek), e. box culvert causeway (Carmila Creek), f. Perched pipe culvert causeway (Gibson Creek).

Barriers impact fish communities in many ways, with large structures (e.g., dams) forming complete blockages, whereas small or medium structures (e.g., causeways, weirs), present partial or temporary barriers, restricting passage during some flow conditions. Even small vertical drops downstream of road crossings and culvert aprons ( $\geq 200$  mm) are sufficient to form significant barriers for many fish, particularly juvenile and small-bodied species. Often single structures possess multiple-barrier types.

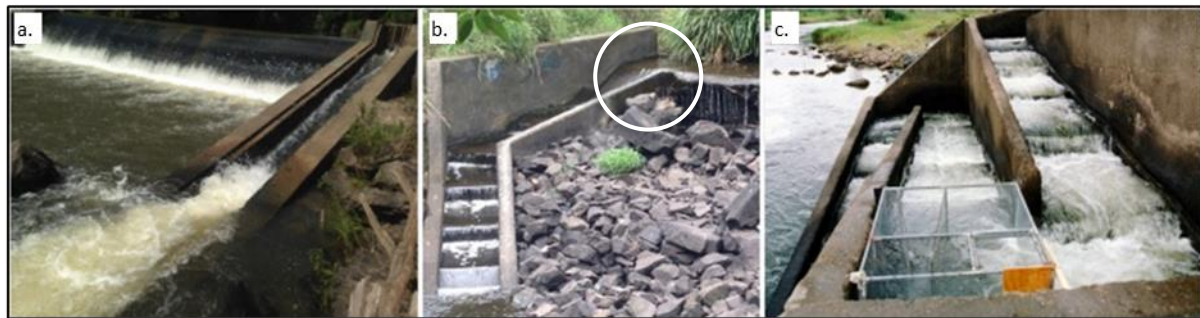
**Figure 2.** Examples of early fishways based northern hemisphere designs exhibiting hydraulic conditions greater than the swimming abilities of most native freshwater fish species. a. Denil fishway on Luscombe Weir (Albert River, QLD). b. Pool and weir fishway located on the Bremer River (Berrys Weir). The exit of this style of fishway has a 600 mm high drop and velocities during base flows of 3.3 m/sec. c. Pool and weir fishway located on Marian Weir (Pioneer River, QLD).

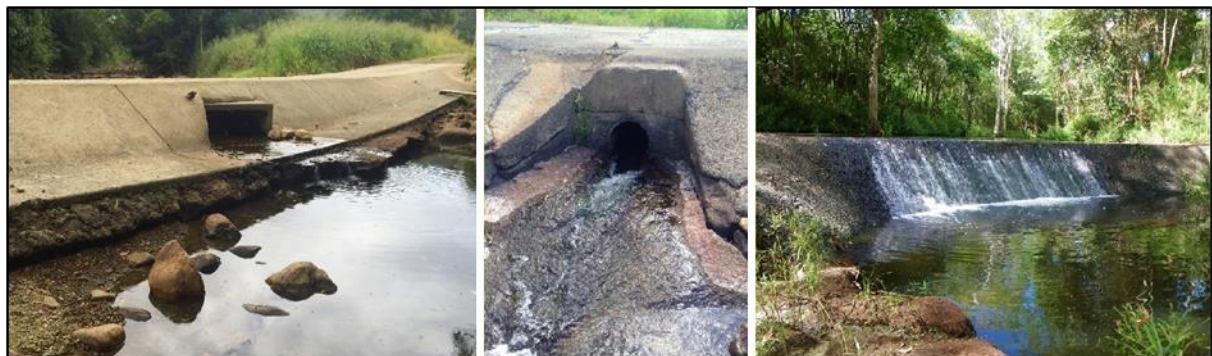
Figure 3. Left to right: Culvert causeway displaying a water surface drop, shallow water surface (through culvert and on apron) and velocity barrier (during medium- high flow conditions) exacerbated due to a culvert diameter <60% of stream width; Pipe causeway displaying velocity and behavioural barriers (insufficient lighting in pipe) and water surface drop barrier.

- Water surface drop – Vertical drops, off or within a structure. For example, the downstream side of weirs and causeway aprons (Figure 3).
- Turbulence – The motion of water having local velocities and pressures that fluctuate randomly. This is often observed downstream of causeway aprons and weirs (Figure 2), without proper provision of pool depth. Turbulence is most often encountered during medium and high flow conditions.

- Water Depth – Shallow water depth of 5 mm - 100 mm depending on species, life-stage and morphology. Larger bodied demersal species are most affected. Shallow water is often experienced during low flow conditions through culverts and across aprons and spillways (Figure 3)

- Low Light – Darkness, shadows and reduced light conditions inside culverts/pipes, and under low bridges can present a phycological barrier for some species (Figure 3).

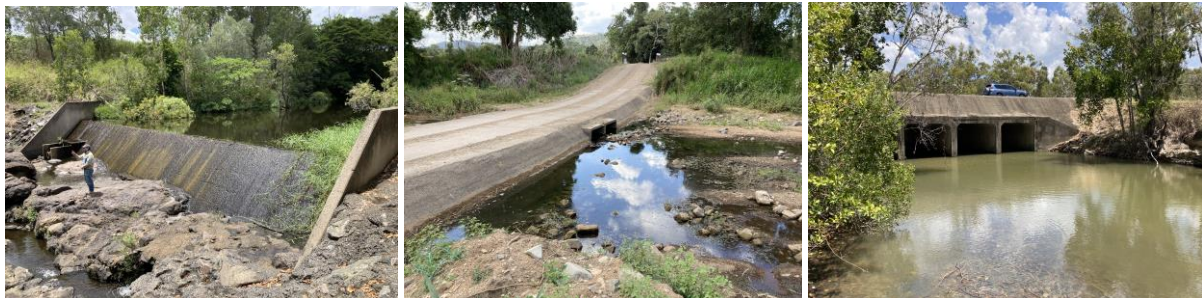
Figure 4. Examples of low (left), medium (mid) and high (right) passability fish barriers.

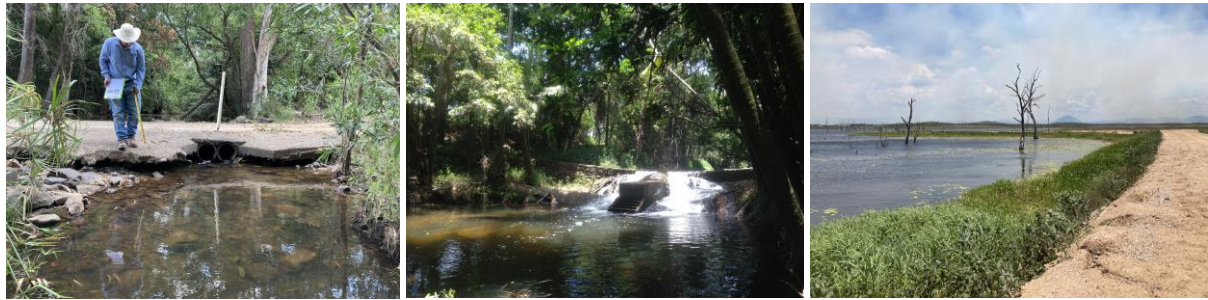
**Figure 10.** Examples of typical fish barriers validated during ground truthing. Road causeway - left, weir - middle and bund - right.

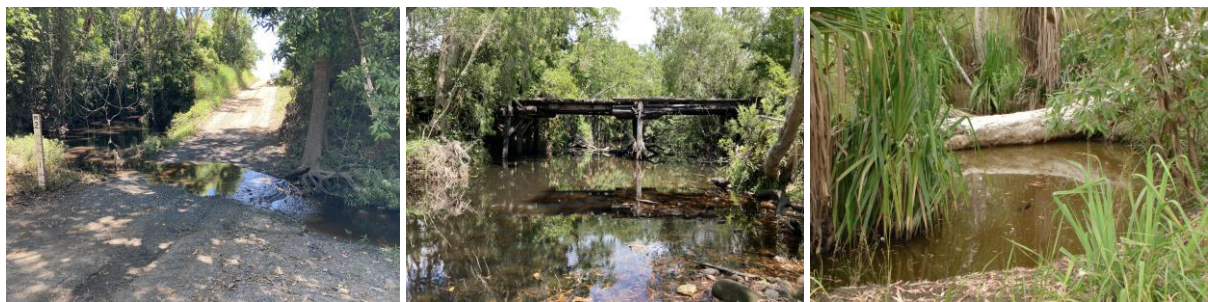
**Figure 11.** Typical non-fish barriers validated during ground truthing. Bed level causeway - left, bridge - middle, fallen tree - right.

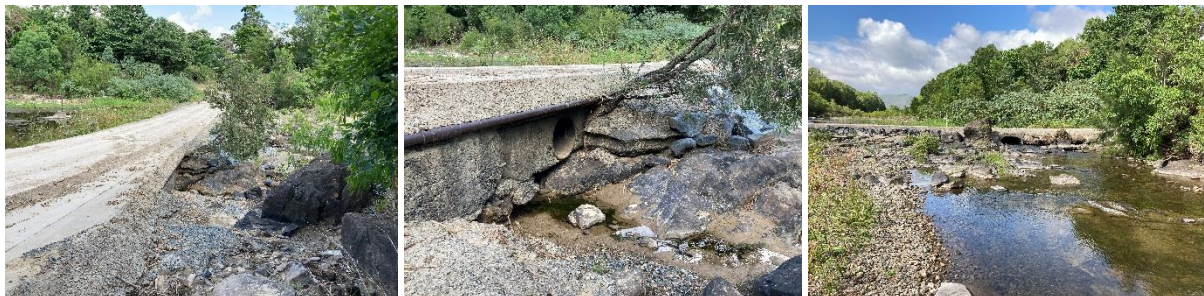
**Figure 14. Staffords Rd causeway on the O'Connell R. looking west across the causeway (left) and showing the small pipe (mid) and box (right) culverts incorporated into this structure.**

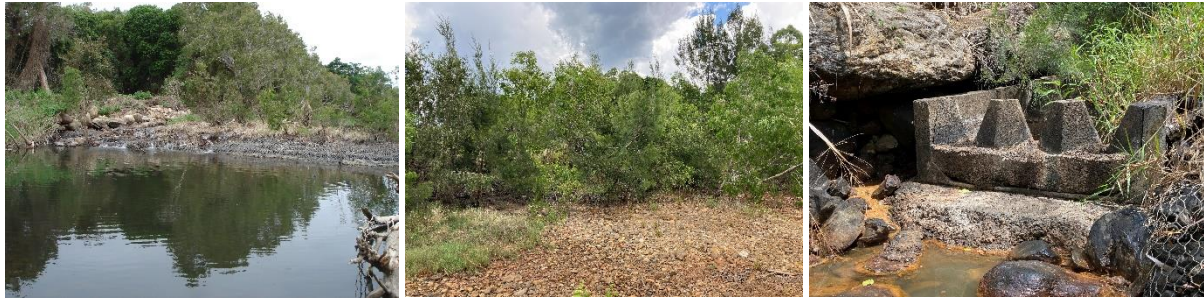
**Figure 15. Flaggy Rock Creek Weir in 2007 (left) and 2021 (mid). Extensive vegetation has established on the crest of the weir which would assist with fish passage when flow is overtopping the crest. During low flows fish passage is significantly impacted as the fishway outlet is 0.5 m above the tailwater level.**

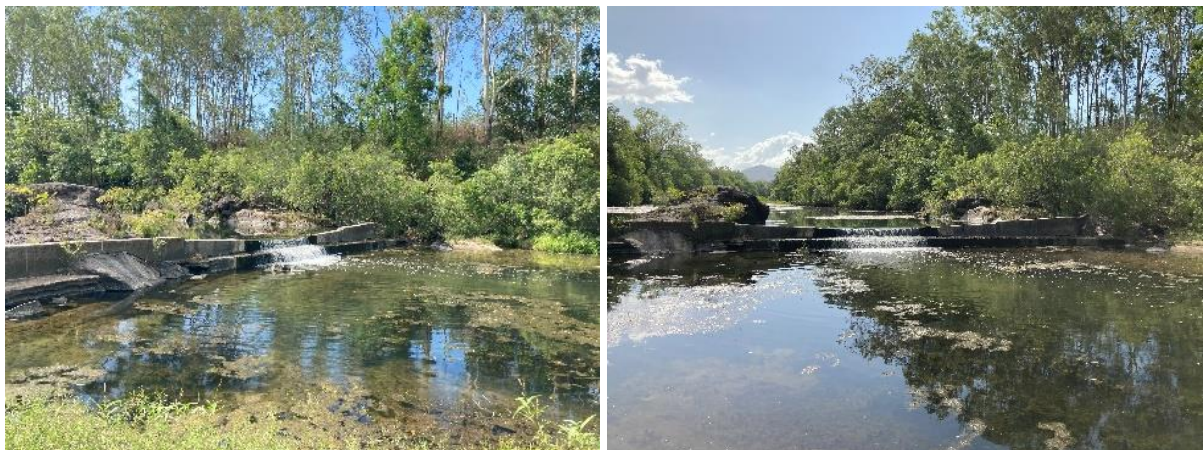
**Figure 16. The Andromache R gauging weir under low flow conditions.**

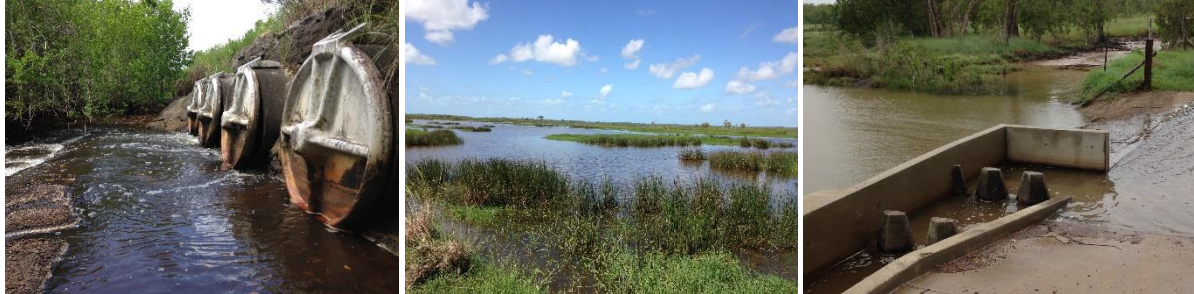
**Figure 17. The floodgates on pond 2 of Marklands Wetlands (left), typical habitat within the wetland complex (middle), and the cone fishway constructed in 2015 on the large Pond 3 (right).**

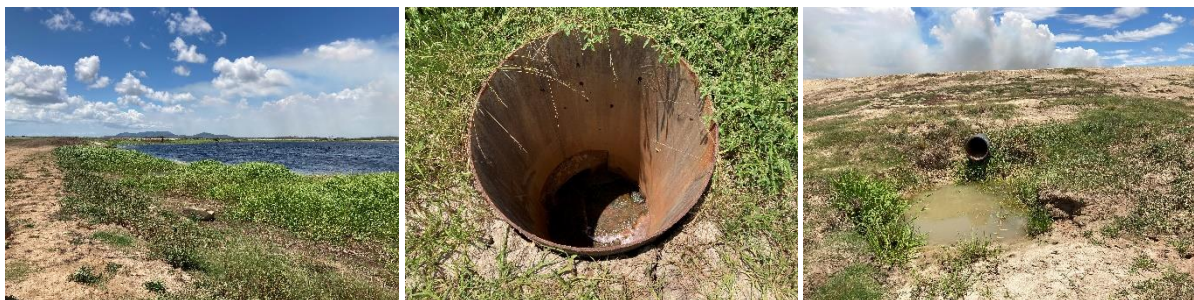
**Figure 18. Looking across the dam wall (left) of Thompson Creek upstream wetland and the inlet (middle) and outlet (right) of the stand pipe which currently passes low flows.**

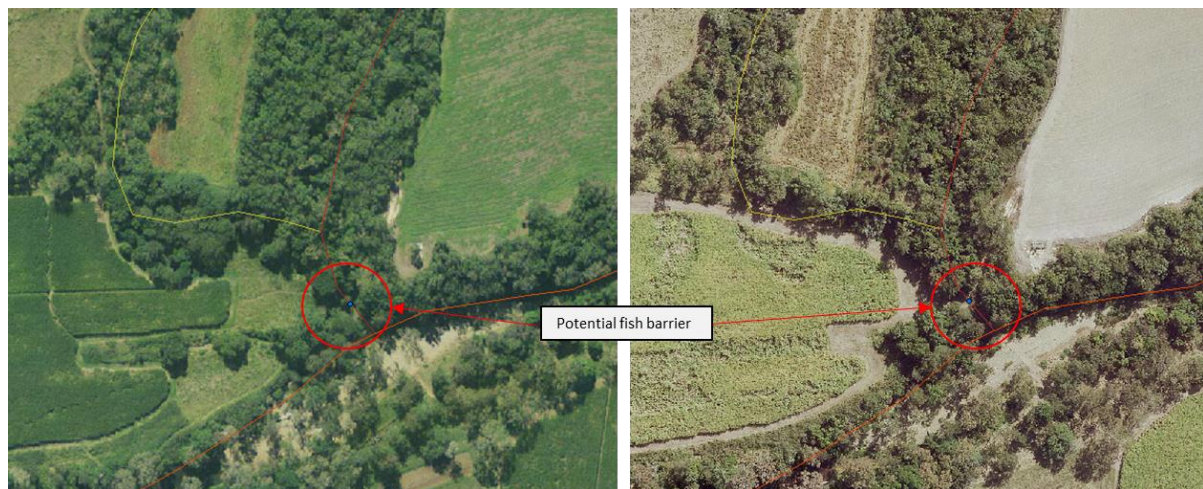
**Figure 19. The higher resolution (20 cm) of the 2019 imagery on the right allowed for better identification of potential fish barriers compared to the lower resolution (50 cm) 2013 imagery used for the 2015 fish barrier prioritisation.**

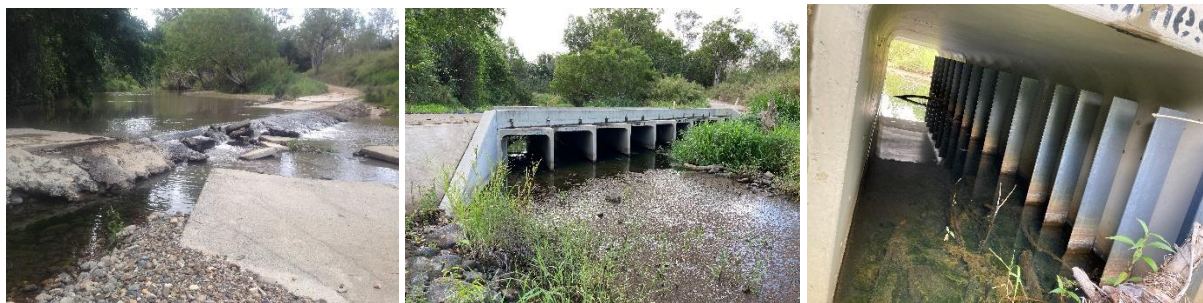
**Figure 21. Streeters Rd causeway on Carmila Creek, prior to the upgrade (left) and after replacement with a fish friendly causeway (mid). Note the combine aperture of the culverts and floor depth. Vertical baffles were also installed on the outer cell walls to reduce velocity during higher flows (right).**

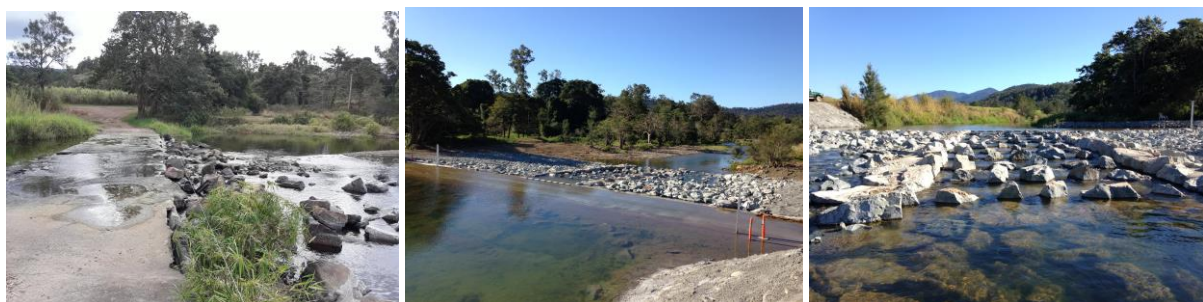
**Figure 22. Clews Rd causeway on Murray Creek, prior to the upgrade (left) and after the causeway was rebuilt following flood damage (mid). Note that all flows pass over the causeway and fish passage is provided by the full width rock ramp on the downstream side. During high flows the entire fishway is engaged and under low flow conditions the flow is concentrated to the central pool and ridge low flow channel (right).**

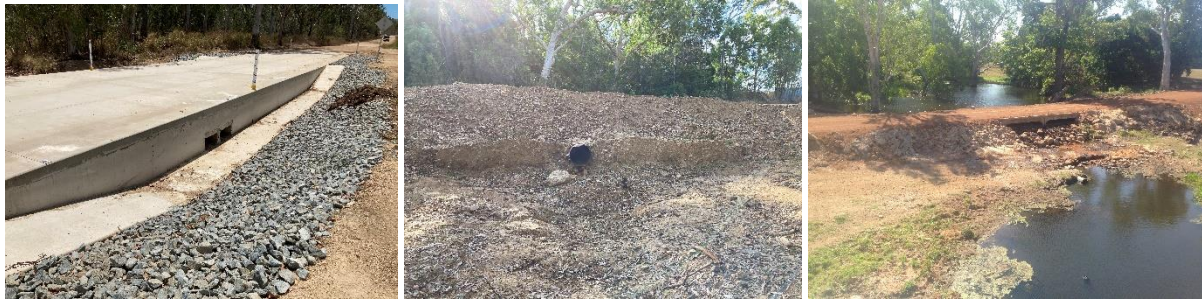
**Figure 23. Recently constructed/upgraded causeways which do not meet current statutory requirements for fish passage in Queensland waterways.**

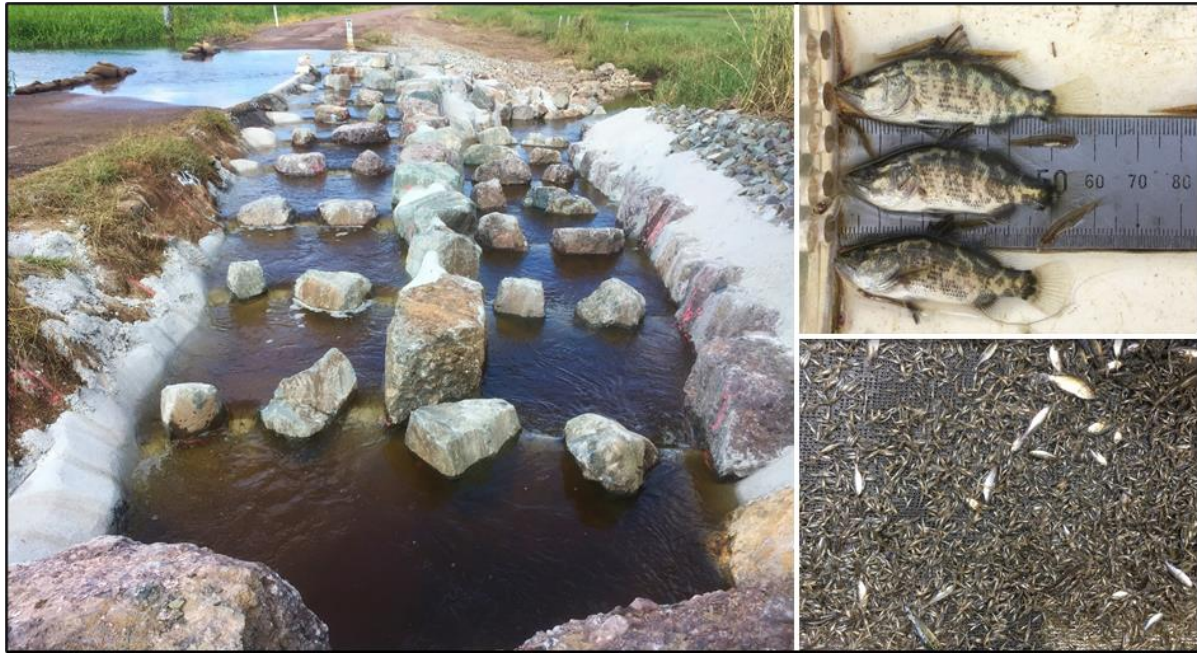
**Figure 25.** A rock ramp fishway constructed to remediate a road causeway (water surface drop) on Tedlands wetlands in Koumala, central QLD (left). Young of the year barramundi recruits captured successfully ascending the fishway during post-const construction monitoring (top right). This is the typical size of juvenile barramundi undertaking life-cycle dependant migrations from saltwater to freshwater. Thousands of juvenile empire gudgeon (and a few barramundi) recorded in a single trap set successfully ascending the fishway (bottom right). These empire gudgeon and barramundi were migrating from saltwater to freshwater.

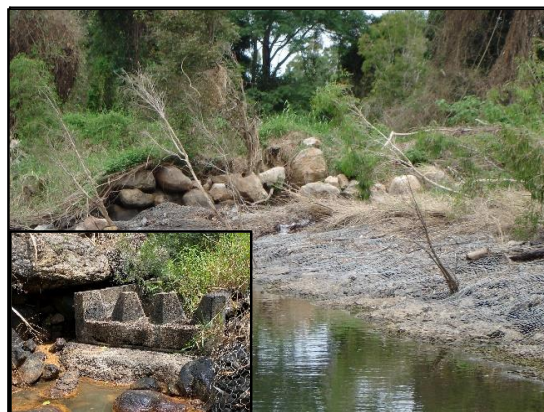
Overall Priority	Rank 2 - 2021	Rank 2 - 2015
Barrier ID	160	
Stream Name	Flaggy Rock Creek	
Location	754479.8796 E	7569970.701 N
Barrier Type	Weir	
Barrier Name	Flaggy Rock Weir	
Remediation Approach	Extension of existing fishway	
Approx. Cost	\$75-100k

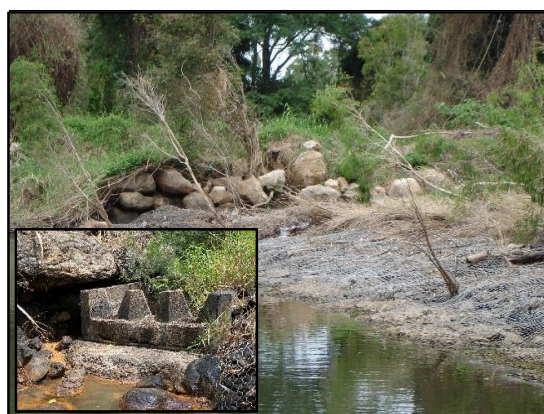
Overall Priority	Rank 2 - 2021	Rank 2 - 2015
Barrier ID	160	
Stream Name	Flaggy Rock Creek	
Location	754479.8796 E	7569970.701 N
Barrier Type	Weir	
Barrier Name	Flaggy Rock Weir	
Remediation Approach	Extension of existing fishway	
Approx. Cost	\$75-100k

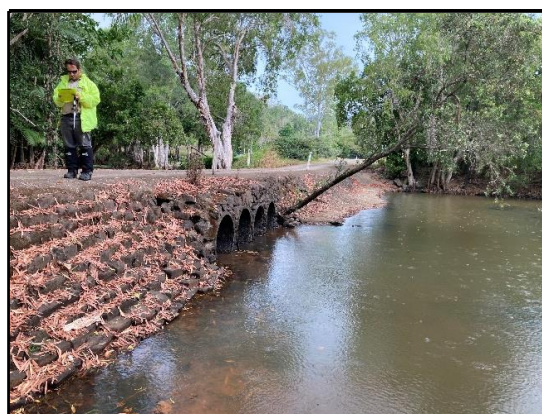
Overall Priority	Rank 4 2021	Not assessed - 2015
Barrier ID	9384	
Stream Name	Marklands Wetlands	
Location	733655.553 E	7618610.32 N
Barrier Type	Floodgates	
Barrier Name	marklands floodgates	
Remediation Approach	Rock ramp bypass	
Approx. Cost	\$60-80k

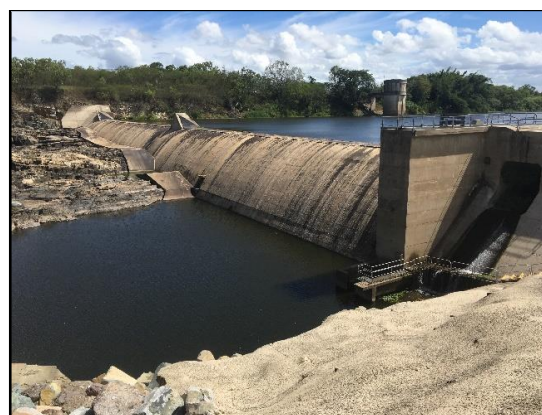
Overall Priority	Rank 6 - 2021	Rank 7 - 2015
Barrier ID	9096	
Stream Name	Jolimont Creek	
Location	695331.8752 E	7679103.951 N
Barrier Type	Weir/causeway	
Barrier Name	Ellwoods (Jolimont) Weir	
Remediation Approach	Rock ramp & Culverts	
Approx. Cost	\$500k

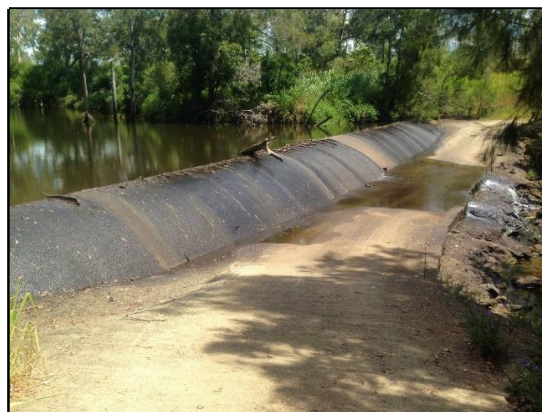
Overall Priority	Rank 8 - 2021	Not assessed - 2015
Barrier ID	446	
Stream Name	West Hill Creek	
Location	746729.4327 E	7586680.122 N
Barrier Type	Causeway	
Barrier Name	Private Causeway	
Remediation Approach	Bed level/culverts	
Approx. Cost	\$100-150k

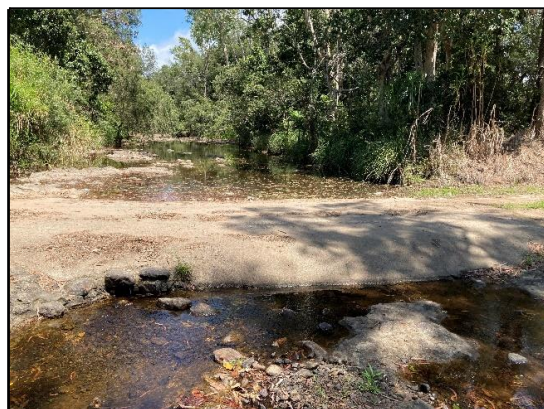
Overall Priority	Rank 8 - 2021	Rank 4 - 2015
Barrier ID	523	
Stream Name	Marion Creek	
Location	748457.2963 E	7597161.294 N
Barrier Type	Causeway	
Barrier Name	Private Causeway	
Remediation Approach	Culverts	
Approx. Cost	\$150-200k

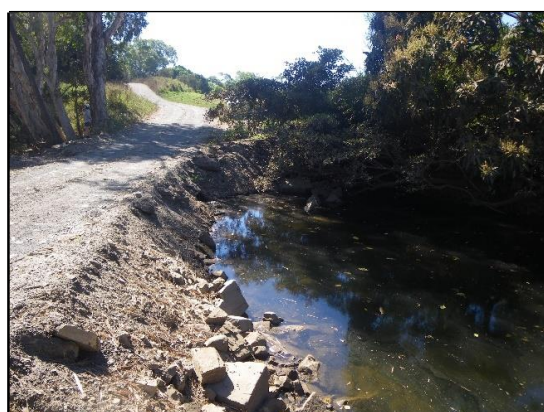
Overall Priority	Rank 8 - 2021	Not assessed - 2015
Barrier ID	2583	
Stream Name	Frenchmans Creek	
Location	715576.3249 E	7644417.06 N
Barrier Type	Causeway	
Barrier Name	Private Causeway	
Remediation Approach	Culverts	
Approx. Cost	\$150-200k

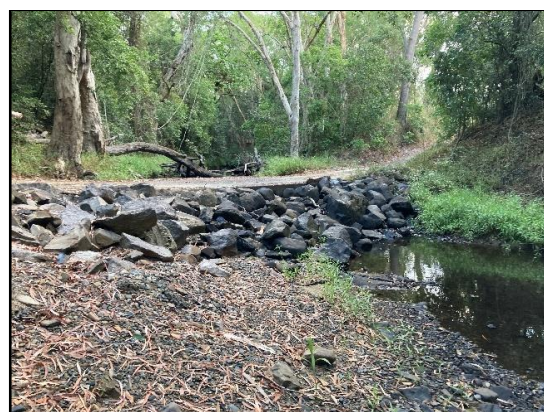
Overall Priority	Rank 8 - 2021	Rank 11 - 2015
Barrier ID	2736	
Stream Name	Carmila Creek	
Location	747950.3179 E	7574969.797 N
Barrier Type	Weir	
Barrier Name	Carmila Gauging Weir	
Remediation Approach	Removal/rock ramp	
Approx. Cost	\$100-150k

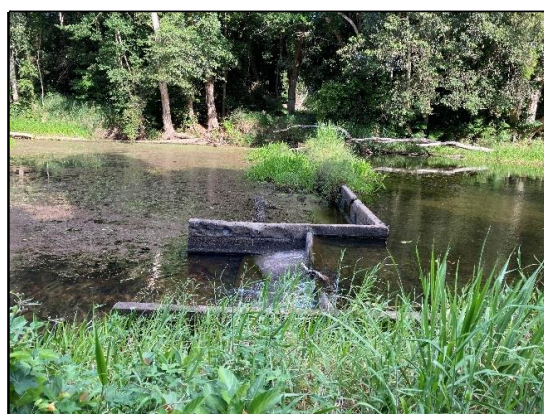
Overall Priority	Rank 8 - 2021	Rank 13 - 2015
Barrier ID	7541	
Stream Name	Mares Nest Creek	
Location	650093.4649 E	7723403.278 N
Barrier Type	Causeway	
Barrier Name	Station Rd	
Remediation Approach	Culverts	
Approx. Cost	\$500-750k

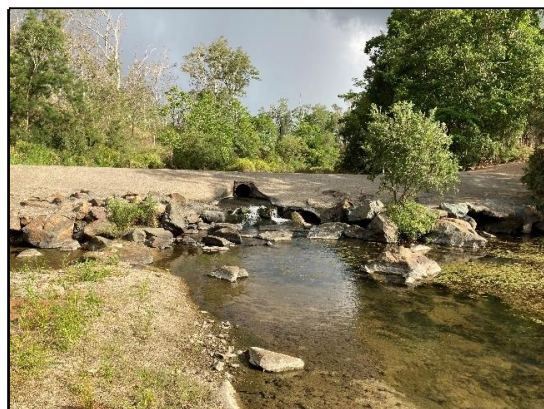
Overall Priority	Rank 13 - 2021	Rank 25 - 2015
Barrier ID	258	
Stream Name	Carmila Creek	
Location	744871.932 E	7573503.629 N
Barrier Type	Causeway	
Barrier Name	Jacksons Crossing Rd	
Remediation Approach	Bed level/culverts	
Approx. Cost	\$100-300k

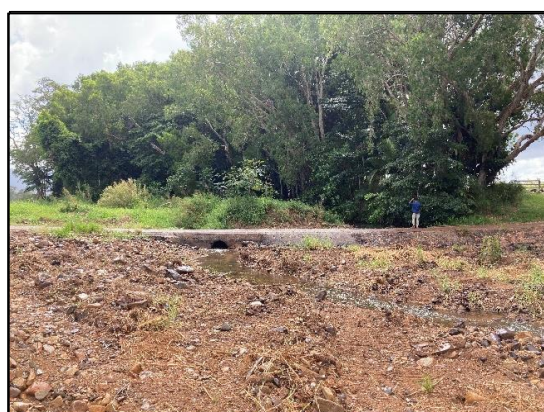
Overall Priority	Rank 13 - 2021	Rank 34 - 2015
Barrier ID	1526	
Stream Name	Plane Creek	
Location	732658.5614 E	7629832.039 N
Barrier Type	Causeway	
Barrier Name	Brooks Rd	
Remediation Approach	Culverts/bridge	
Approx. Cost	\$1.2-2M

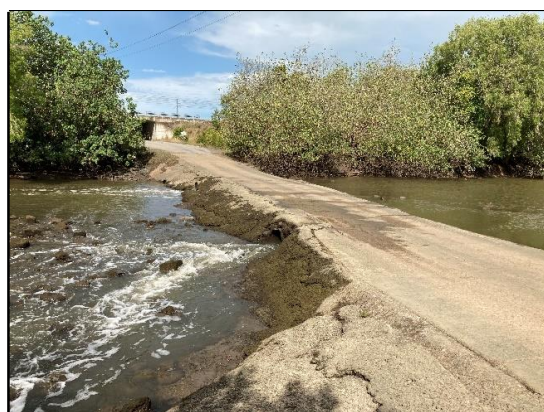
Overall Priority	Rank 13 - 2021	Rank 43 - 2015
Barrier ID	6439	
Stream Name	Duck Creek	
Location	630827.8328 E	7774513.098 N
Barrier Type	Causeway	
Barrier Name	Mookara Rd	
Remediation Approach	Culverts	
Approx. Cost	\$500-750k

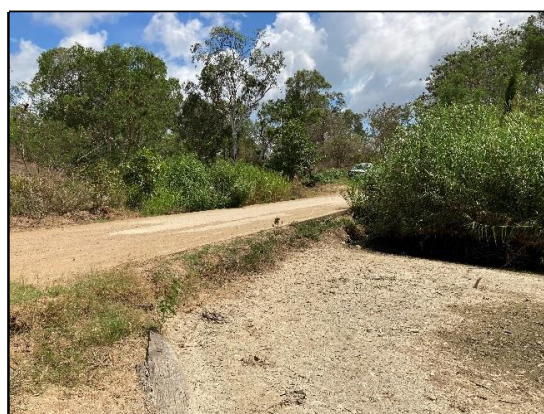
Overall Priority	Rank 17 - 2021	Rank 32 - 2015
Barrier ID	2735	
Stream Name	Sandy Creek	
Location	709803.9551 E	7645044.105 N
Barrier Type	Weir	
Barrier Name	Sandy Gauging Weir	
Remediation Approach	Removal/rock ramp	
Approx. Cost	\$250-750k

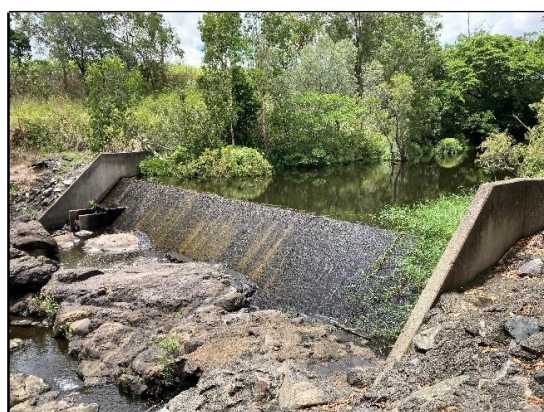
Overall Priority	Rank 17 - 2021	Rank 18 - 2015
Barrier ID	5444	
Stream Name	Reliance Creek	
Location	718594.1457 E	7671253.093 N
Barrier Type	Causeway	
Barrier Name	Neils Rd	
Remediation Approach	Baffles	
Approx. Cost	\$5-10k

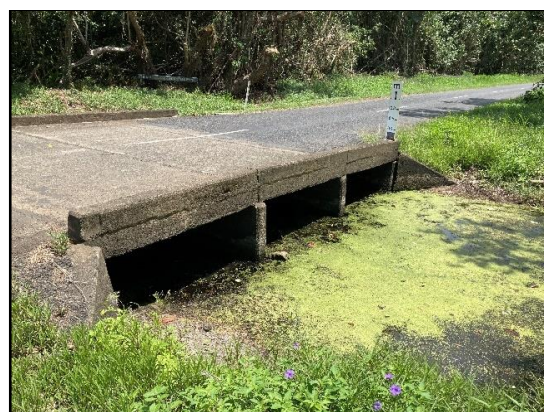
Overall Priority	Rank 17 - 2021	Not assessed - 2015
Barrier ID	6365	
Stream Name	Proserpine River	
Location	666188.9929 E	7745457.937 N
Barrier Type	Causeway	
Barrier Name	Biggs Rd	
Remediation Approach	Refurbish existing fishway	
Approx. Cost	\$200-250k

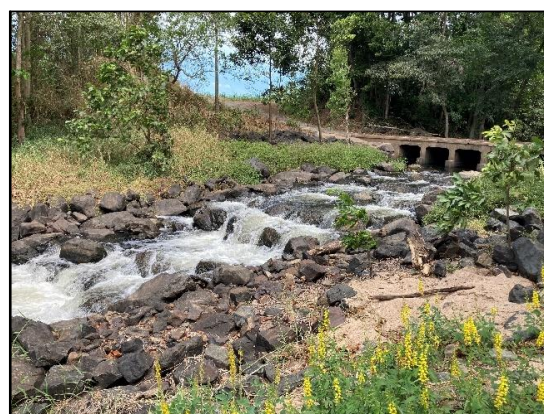
Overall Priority	Rank 17 - 2021	Rank 61 - 2015
Barrier ID	6952	
Stream Name	Saltwater Creek	
Location	746729.4327 E	7742857.371 N
Barrier Type	Causeway	
Barrier Name	Ceda Creek Falls Rd	
Remediation Approach	Culverts	
Approx. Cost	\$300-500k

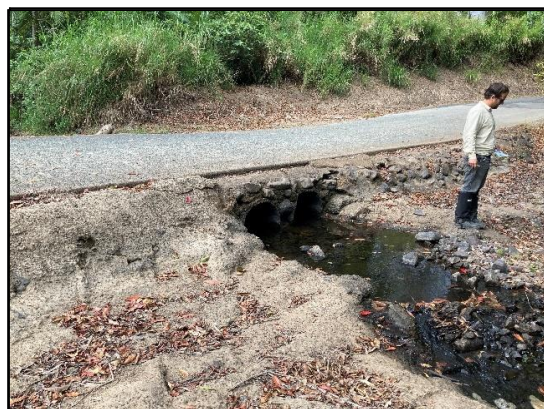
Overall Priority	Rank 17 - 2021	Not assessed - 2015
Barrier ID	8062	
Stream Name	Gibson Creek	
Location	667207.6688 E	7719426.831 N
Barrier Type	Weir/causeway	
Barrier Name	Gibson Ck Weir	
Remediation Approach	Rock ramp	
Approx. Cost	\$100-150k

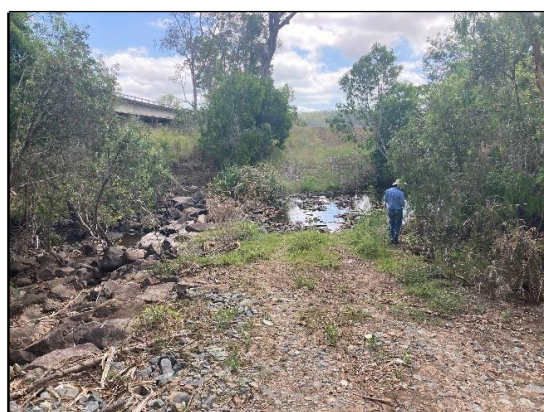
Overall Priority	Rank 17 - 2021	Rank 18 - 2015
Barrier ID	7335	
Stream Name	Lethebrook Creek	
Location	663754.2173 E	7739271.302 N
Barrier Type	Causeway	
Barrier Name	Private Causeway	
Remediation Approach	Culverts	
Approx. Cost	\$200-300k

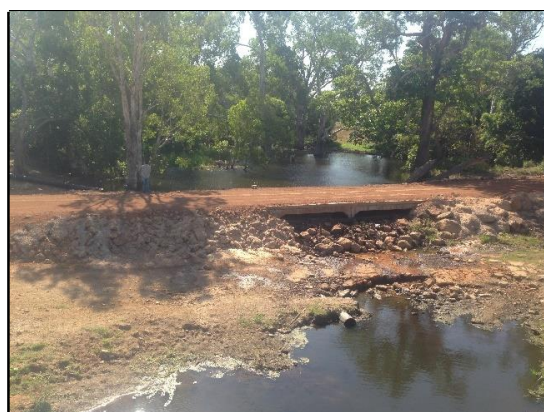
Overall Priority	Rank 17 - 2021	Rank 26 - 2015
Barrier ID	9005	
Stream Name	Maquarie Creek	
Location	692599.5223 E	7676323.486 N
Barrier Type	Weir	
Barrier Name	Maquarie Ck Weir	
Remediation Approach	Rock ramp	
Approx. Cost	\$300-500k

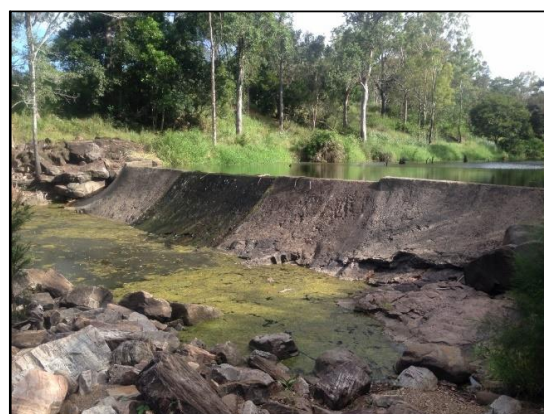
Overall Priority	Rank 25 - 2021	Not assessed - 2015
Barrier ID	1446	
Stream Name	Elizabeth Creek	
Location	733129.8635 E	7626000.588 N
Barrier Type	Causeway	
Barrier Name	Private Causeway	
Remediation Approach	Bed level/culverts	
Approx. Cost	\$100-300k

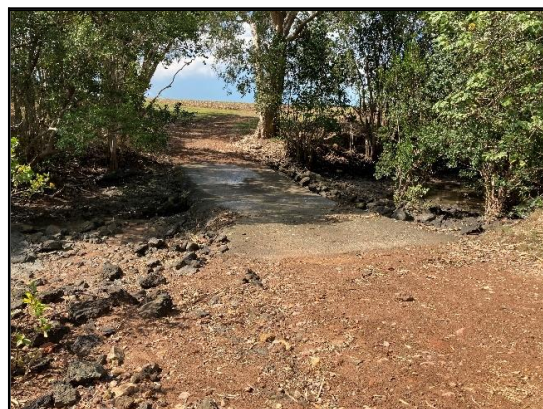
Overall Priority	Rank 25 - 2021	Not assessed - 2015
Barrier ID	1544	
Stream Name	Plane Creek	
Location	730428.0783 E	7629200.652 N
Barrier Type	Weir	
Barrier Name	Plane Ck Lower Weir	
Remediation Approach	Rock ramp	
Approx. Cost	\$400-600k

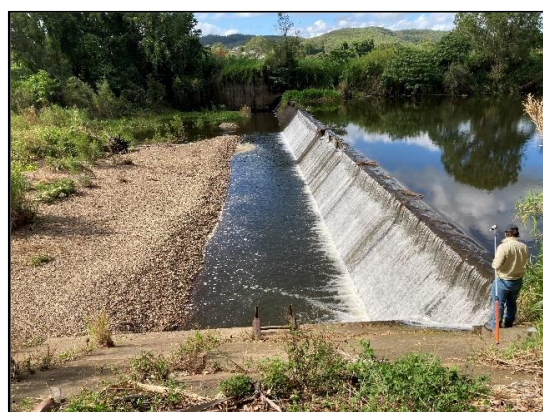
Overall Priority	Rank 25 - 2021	Rank 4 - 2015
Barrier ID	5955	
Stream Name	Constant Creek	
Location	706598.2199 E	7671337.48 N
Barrier Type	Weir/causeway	
Barrier Name	Freds Weir	
Remediation Approach	Rockramp/culverts	
Approx. Cost	\$300-500k

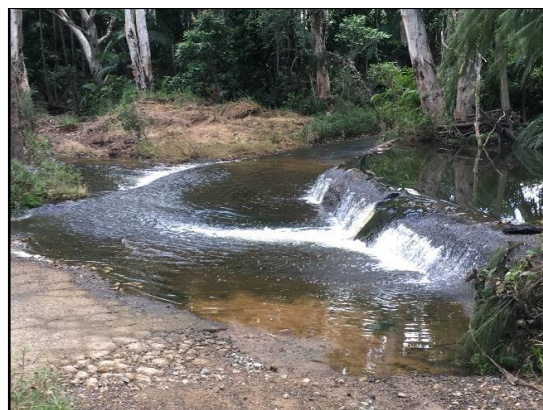
Overall Priority	Rank 25 - 2021	Not assessed - 2015
Barrier ID	6366	
Stream Name	Gregory River	
Location	664813.7315 E	7757042.761 N
Barrier Type	Causeway	
Barrier Name	Patullo Rd	
Remediation Approach	Refurbish existing fishway	
Approx. Cost	\$80-120k

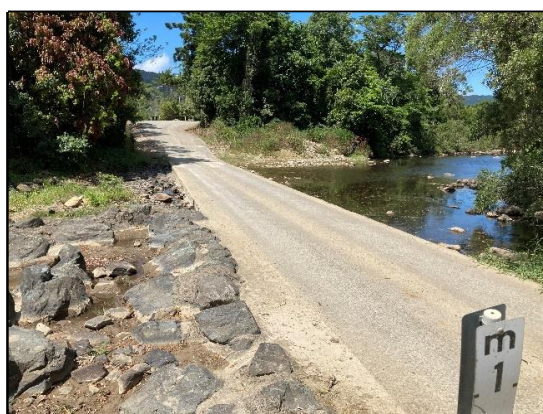
Overall Priority	Rank 25 - 2021	Not assessed - 2015
Barrier ID	6369	
Stream Name	O'Connell River	
Location	666561.13 E	7706059.892 N
Barrier Type	Causeway	
Barrier Name	Ellis Rd	
Remediation Approach	Rock ramp/Culverts	
Approx. Cost	\$150 (fishway) \$750k (Culverts)

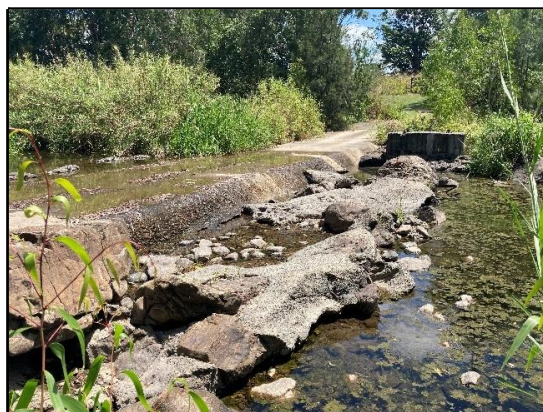
Overall Priority	Rank 25 - 2021	Rank 26 - 2015
Barrier ID	9014	
Stream Name	Maquarie Creek	
Location	690873.3261 E	7674700.027 N
Barrier Type	Causeway	
Barrier Name	McKay Rd	
Remediation Approach	Culverts	
Approx. Cost	\$500-750k

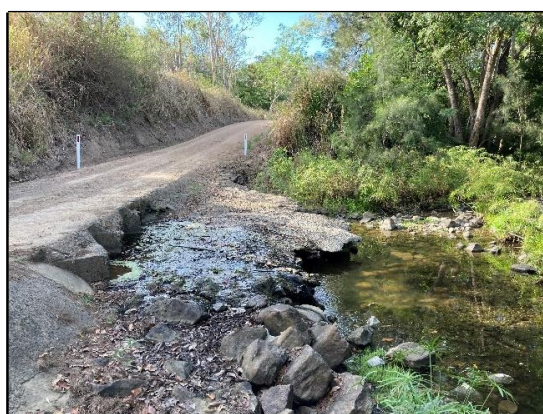
Overall Priority	Rank 25 - 2021	Rank 18 - 2015
Barrier ID	9097	
Stream Name	Jolimont Creek	
Location	696277.3675 E	7677720.959 N
Barrier Type	Causeway	
Barrier Name	Narpie Rd	
Remediation Approach	Baffles & FFSP	
Approx. Cost	\$5-100k

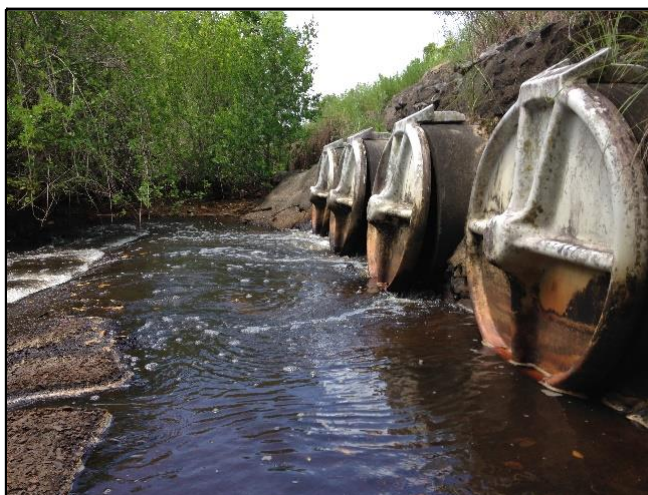
Wetland Barrier Rank	1	
Stream Barrier Rank	4	
Barrier ID	9384	
Stream Name	Marklands Wetlands	
Location	733655.553 E	7618610.32 N
Barrier Type	Floodgates	
Barrier Name	Marklands Floodgates	
Remediation Approach	Rock ramp bypass	
Approx. Cost	\$60-80k

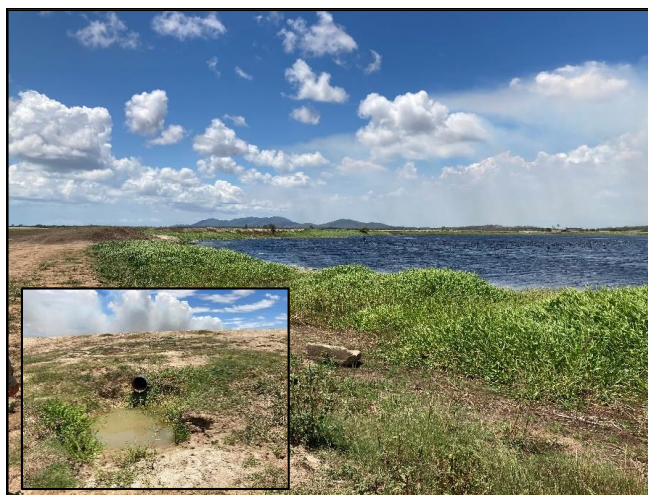
Wetland Barrier Rank	2	
Stream Barrier Rank	65	
Barrier ID	9648	
Stream Name	Thompson Creek	
Location	667470.6949 E	7730729.102 N
Barrier Type	Dam	
Barrier Name	Upstream Wetland	
Remediation Approach	Rock ramp spillway	
Approx. Cost	\$100-200k

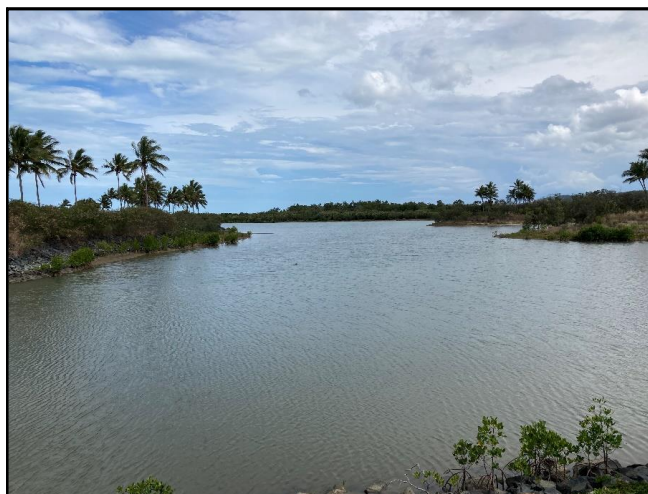
Wetland Barrier Rank	3	
Stream Barrier Rank	65	
Barrier ID	9756	
Stream Name	Laguna Quays	
Location	675427.1226 E	7720459.689 N
Barrier Type	Floodgates	
Barrier Name	Marklands Floodgates	
Remediation Approach	Remove floodgates	
Approx. Cost	\$20-40k

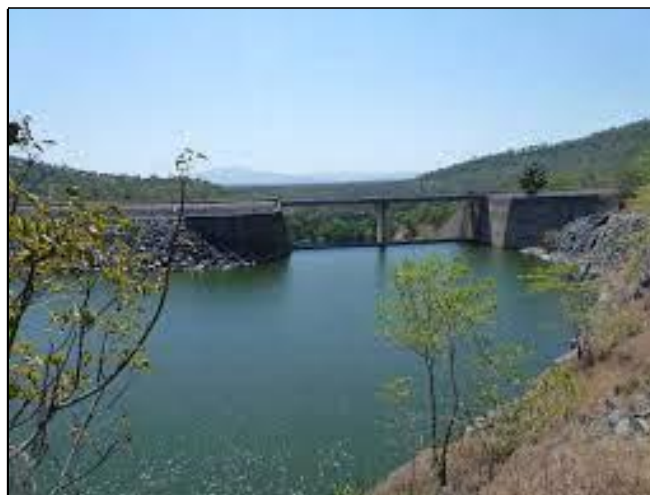
<b>Wetland Barrier Rank</b>	<b>4</b>	
<b>Stream Barrier Rank</b>	77	
<b>Barrier ID</b>	7187	
<b>Stream Name</b>	Proserpine River	
<b>Location</b>	644343.9609 E	7747129.804 N
<b>Barrier Type</b>	Dam	
<b>Barrier Name</b>	Peter Faust Dam	
<b>Remediation Approach</b>	Fishlift	
<b>Approx. Cost</b>	10M+

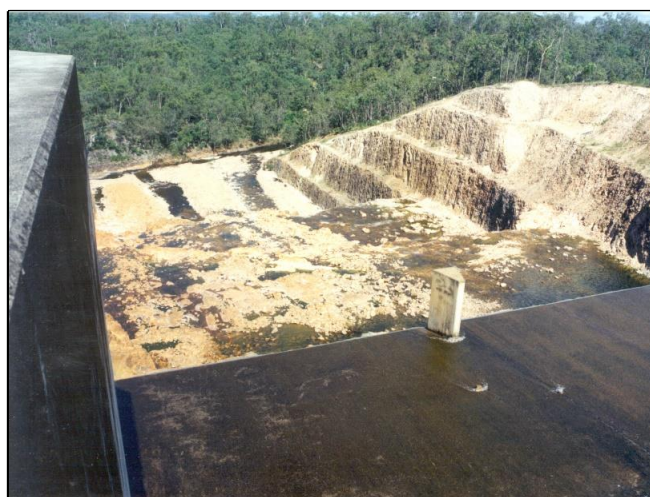
<b>Wetland Barrier Rank</b>	<b>6</b>	
<b>Stream Barrier Rank</b>	100	
<b>Barrier ID</b>	9389	
<b>Stream Name</b>	Elizabeth Creek	
<b>Location</b>	733307.4418 E	7625307.371 N
<b>Barrier Type</b>	Bund	
<b>Barrier Name</b>	Shmidtkes Wetland	
<b>Remediation Approach</b>	Rock ramp bypass	
<b>Approx. Cost</b>	\$100-150k

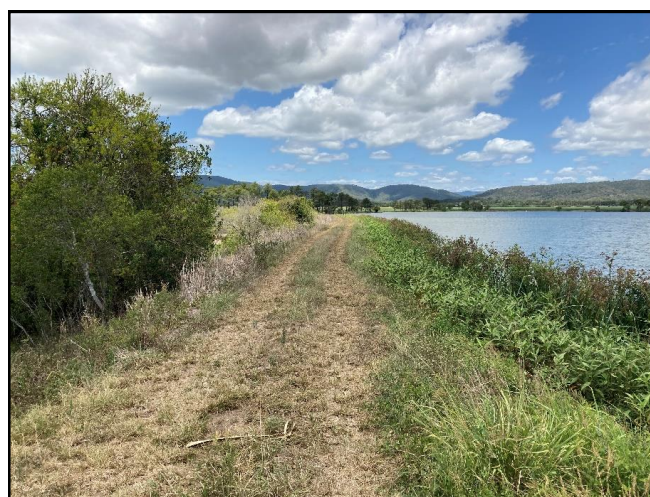
<b>Wetland Barrier Rank</b>	<b>7</b>	
<b>Stream Barrier Rank</b>	90	
<b>Barrier ID</b>	9376	
<b>Stream Name</b>	Rocky Dam Creek Trib	
<b>Location</b>	735406.2105 E	7614482.961 N
<b>Barrier Type</b>	Bund	
<b>Barrier Name</b>	Downstream Dam	
<b>Remediaiton Aproach</b>	Rock ramp bypass	
<b>Approx. Cost</b>	\$100-200k

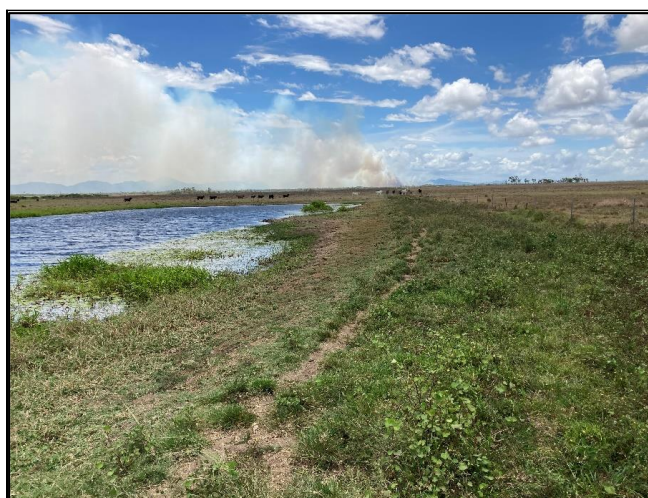
<b>Wetland Barrier Rank</b>	<b>7</b>	
<b>Stream Barrier Rank</b>	90	
<b>Barrier ID</b>	9583	
<b>Stream Name</b>	Billie Creek	
<b>Location</b>	669568.9811 E	7728970.088 N
<b>Barrier Type</b>	Bund	
<b>Barrier Name</b>	Downstream Bund	
<b>Remediaiton Aproach</b>	Rock ramp bypass	
<b>Approx. Cost</b>	\$60-80k

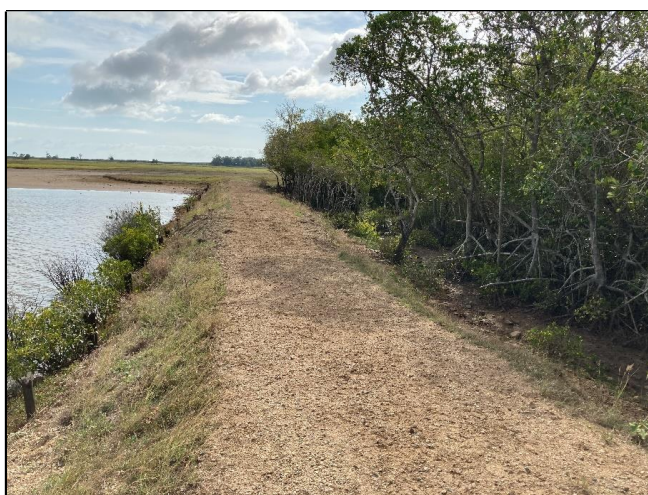
<b>Wetland Barrier Rank</b>	<b>7</b>	
<b>Stream Barrier Rank</b>	100	
<b>Barrier ID</b>	9689	
<b>Stream Name</b>	Constant Creek Trib	
<b>Location</b>	707500.8224 E	7677634.672 N
<b>Barrier Type</b>	Bund	
<b>Barrier Name</b>	Pitkin Bunds	
<b>Remediaiton Aproach</b>	Rock ramp bypass	
<b>Approx. Cost</b>	\$60-80k

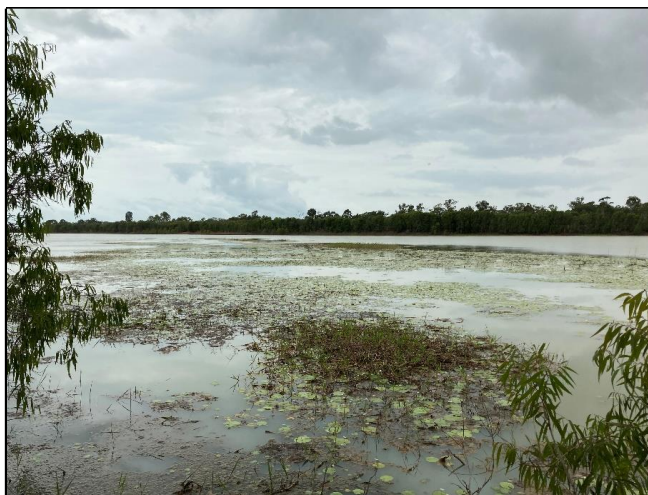
<b>Wetland Barrier Rank</b>	<b>7</b>	
<b>Stream Barrier Rank</b>	90	
<b>Barrier ID</b>	191	
<b>Stream Name</b>	Flaggy Rock Creek Trib	
<b>Location</b>	754248.9845 E	7570100.382 N
<b>Barrier Type</b>	Dam	
<b>Barrier Name</b>	Private Dam	
<b>Remediation Approach</b>	Rock ramp bypass	
<b>Approx. Cost</b>	\$100-200k

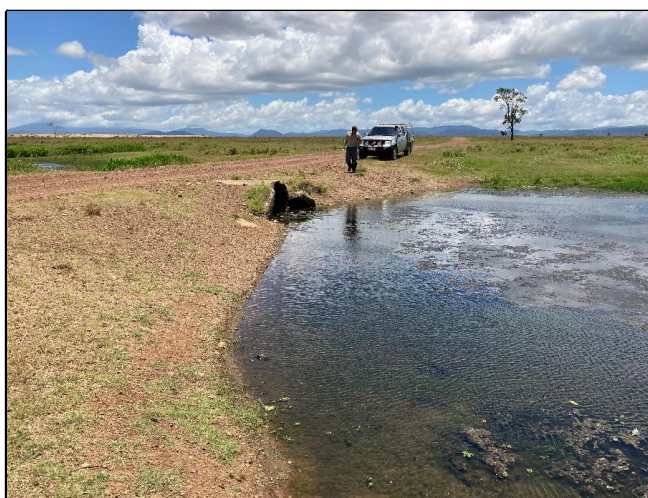
<b>Wetland Barrier Rank</b>	<b>11</b>	
<b>Stream Barrier Rank</b>	77	
<b>Barrier ID</b>	9581	
<b>Stream Name</b>	Billie Creek	
<b>Location</b>	667384.1176 E	7729772.193 N
<b>Barrier Type</b>	Causeway	
<b>Barrier Name</b>	Private Causeway	
<b>Remediation Approach</b>	Bed level/culverts	
<b>Approx. Cost</b>	\$60-100k

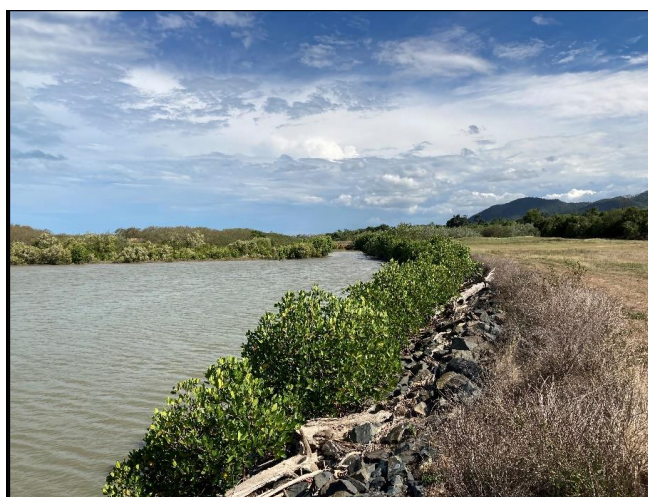
<b>Wetland Barrier Rank</b>	<b>11</b>	
<b>Stream Barrier Rank</b>	90	
<b>Barrier ID</b>	9692	
<b>Stream Name</b>	Laguna Quays	
<b>Location</b>	674608.5829 E	7720870.258 N
<b>Barrier Type</b>	Bund	
<b>Barrier Name</b>	Middle Wetland	
<b>Remediation Approach</b>	Rock ramp bypass	
<b>Approx. Cost</b>	\$60-100k

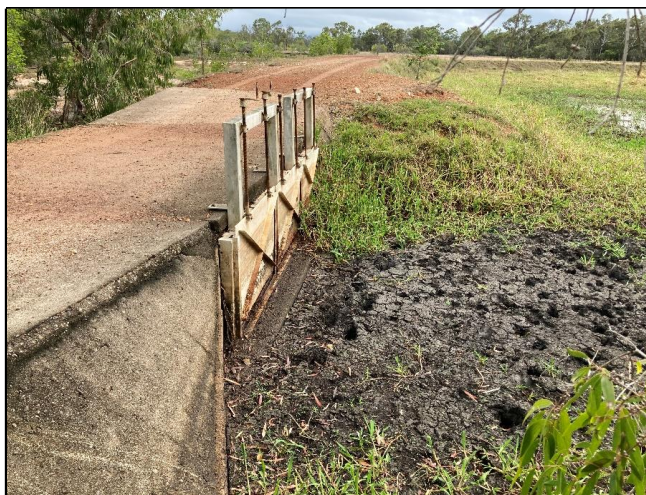
<b>Wetland Barrier Rank</b>	<b>11</b>	
<b>Stream Barrier Rank</b>	109	
<b>Barrier ID</b>	344	
<b>Stream Name</b>	Blind Creek	
<b>Location</b>	753416.3108 E	7578580.28 N
<b>Barrier Type</b>	Floodgates	
<b>Barrier Name</b>	Private floodgates	
<b>Remediation Approach</b>	Rock ramp bypass	
<b>Approx. Cost</b>	\$60-80k

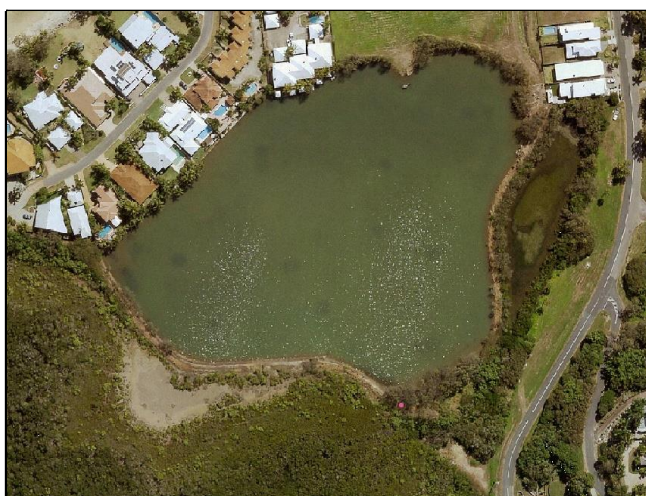
<b>Wetland Barrier Rank</b>	<b>14</b>	
<b>Stream Barrier Rank</b>	100	
<b>Barrier ID</b>	9697	
<b>Stream Name</b>	Dolphin Heads	
<b>Location</b>	726926.4985 E	7672147.042 N
<b>Barrier Type</b>	Bund	
<b>Barrier Name</b>	Dolphin Heads Lagoon	
<b>Remediation Approach</b>	Rock ramp bypass	
<b>Approx. Cost</b>	\$80-150k

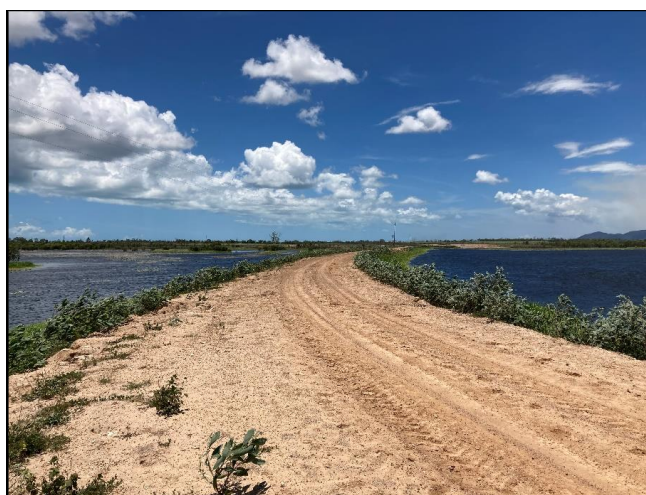
<b>Wetland Barrier Rank</b>	<b>14</b>	
<b>Stream Barrier Rank</b>	104	
<b>Barrier ID</b>	9584	
<b>Stream Name</b>	Billie Creek	
<b>Location</b>	668455.0277 E	7728426.129 N
<b>Barrier Type</b>	Dam	
<b>Barrier Name</b>	Private Dam	
<b>Remediation Approach</b>	Rock ramp bypass	
<b>Approx. Cost</b>	\$100-200k

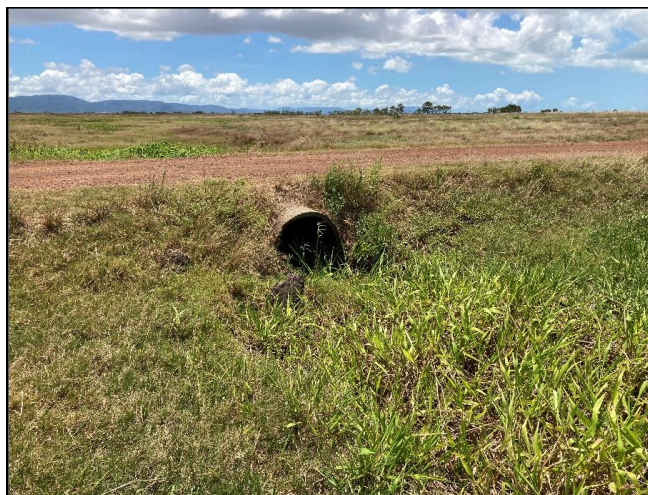
<b>Wetland Barrier Rank</b>	<b>16</b>	
<b>Stream Barrier Rank</b>	90	
<b>Barrier ID</b>	9647	
<b>Stream Name</b>	Thompson Creek	
<b>Location</b>	667541.7479 E	7730886.539 N
<b>Barrier Type</b>	Causeway	
<b>Barrier Name</b>	Private Causeway	
<b>Remediation Approach</b>	Bed level/culverts	
<b>Approx. Cost</b>	\$60-100k

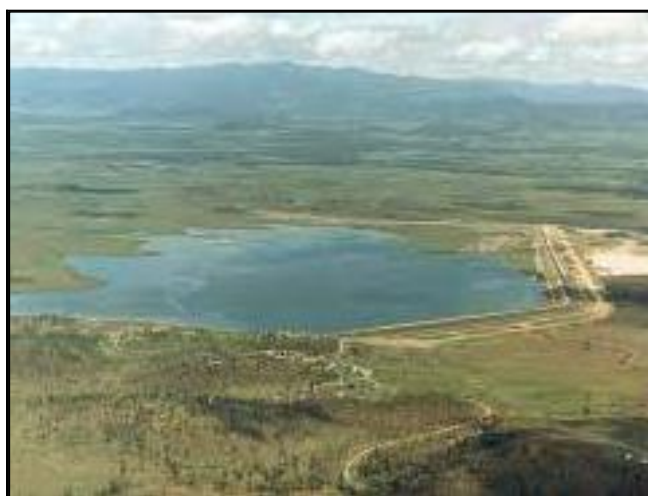
<b>Wetland Barrier Rank</b>	<b>16</b>	
<b>Stream Barrier Rank</b>	109	
<b>Barrier ID</b>	3077	
<b>Stream Name</b>	Sandy Creek	
<b>Location</b>	697239.2442 E	7653650.455 N
<b>Barrier Type</b>	Dam	
<b>Barrier Name</b>	Kinchant Dam	
<b>Remediation Approach</b>	Fishlift	
<b>Approx. Cost</b>	\$5M+
