## 2021 Fish Barrier Prioritisation – Mackay Whitsunday Region

Final Report

February 2022

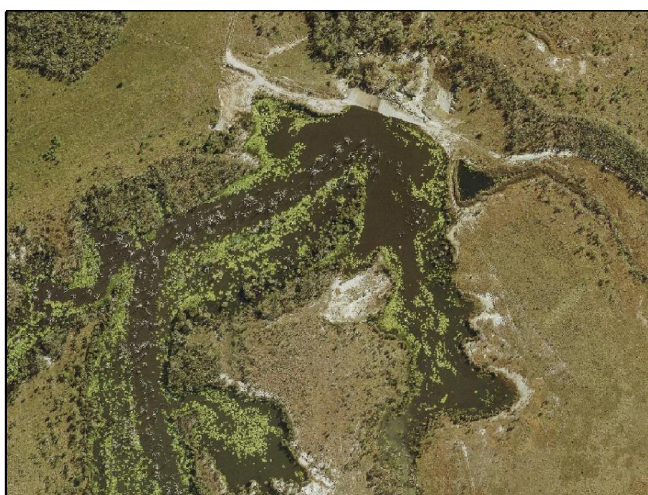
<b>Wetland Barrier Rank</b>	<b>18</b>	
<b>Stream Barrier Rank</b>	48	
<b>Barrier ID</b>	9509	
<b>Stream Name</b>	Ten Mile Creek	
<b>Location</b>	653191.9202 E	7758517.471 N
<b>Barrier Type</b>	Dam	
<b>Barrier Name</b>	Private Dam	
<b>Remediation Approach</b>	Rock ramp bypass	
<b>Approx. Cost</b>	\$500-700k

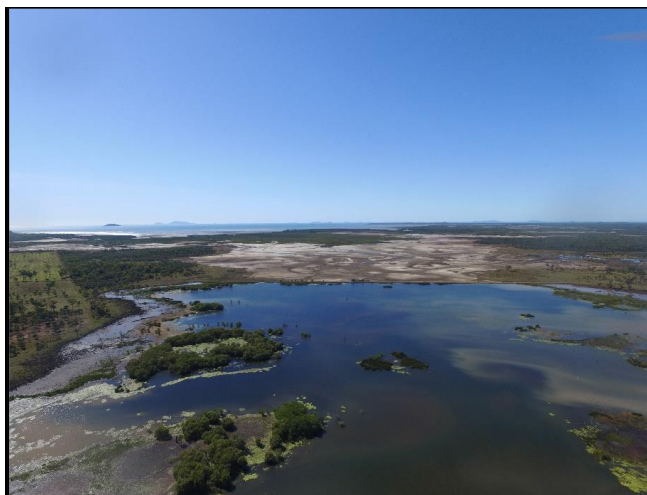
<b>Wetland Barrier Rank</b>	<b>18</b>	
<b>Stream Barrier Rank</b>	109	
<b>Barrier ID</b>	9369	
<b>Stream Name</b>	Loyds Wetland	
<b>Location</b>	744716.2521 E	7614806.031 N
<b>Barrier Type</b>	Bund	
<b>Barrier Name</b>	Loyds Wetland	
<b>Remediaiton Aproach</b>	Rock ramp bypass	
<b>Approx. Cost</b>	\$60-80k

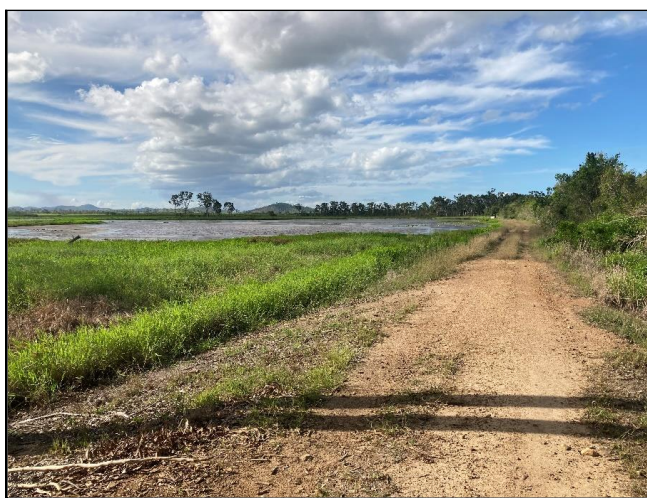
<b>Wetland Barrier Rank</b>	<b>20</b>	
<b>Stream Barrier Rank</b>	120	
<b>Barrier ID</b>	9622	
<b>Stream Name</b>	Murray Creek Trib	
<b>Location</b>	689815.2133 E	7691170.417 N
<b>Barrier Type</b>	Bund	
<b>Barrier Name</b>	Private Bund	
<b>Remediaiton Aproach</b>	Rock ramp bypass	
<b>Approx. Cost</b>	\$80-100k

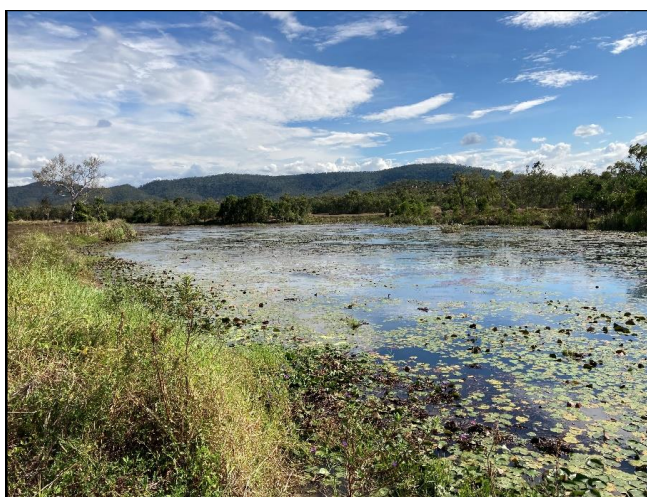
<b>Wetland Barrier Rank</b>	<b>21</b>	
<b>Stream Barrier Rank</b>	86	
<b>Barrier ID</b>	9600	
<b>Stream Name</b>	Laguna Quays	
<b>Location</b>	674158.3037 E	7721191.858 N
<b>Barrier Type</b>	Bund	
<b>Barrier Name</b>	North Wetland	
<b>Remediaiton Aproach</b>	Rock ramp bypass	
<b>Approx. Cost</b>	\$60-80k

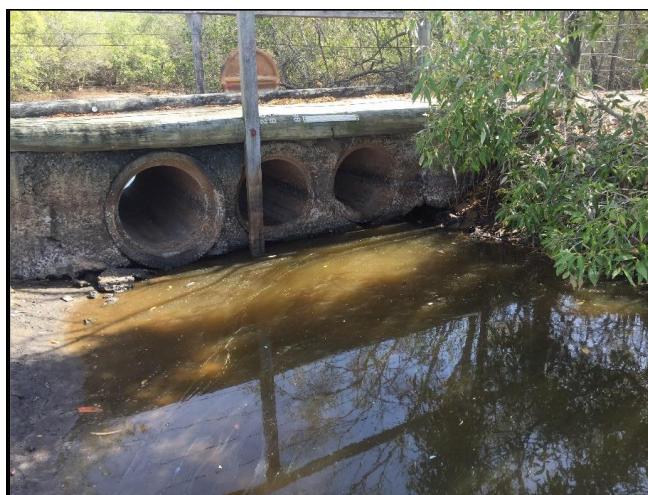
<b>Wetland Barrier Rank</b>	<b>22</b>	
<b>Stream Barrier Rank</b>	86	
<b>Barrier ID</b>	6464	
<b>Stream Name</b>	Walkabout Wetlands	
<b>Location</b>	728238.3966 E	7666442.621 N
<b>Barrier Type</b>	Causeway	
<b>Barrier Name</b>	Walkabout Wetlands	
<b>Remediation Approach</b>	Pedestrian Bridge	
<b>Approx. Cost</b>	\$40-60k

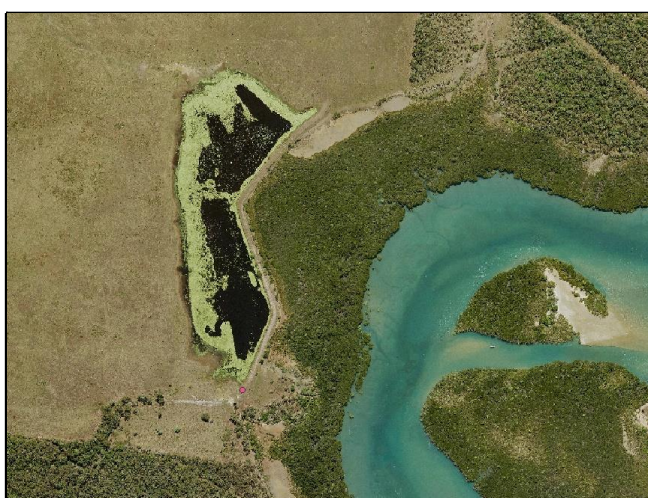
<b>Wetland Barrier Rank</b>	<b>22</b>	
<b>Stream Barrier Rank</b>	109	
<b>Barrier ID</b>	9402	
<b>Stream Name</b>	Louisa Creek Trib	
<b>Location</b>	733977.6855 E	7646158.644 N
<b>Barrier Type</b>	Bund	
<b>Barrier Name</b>	Dudgeon Point Eastern Wetland	
<b>Remediation Approach</b>	Rock ramp bypass	
<b>Approx. Cost</b>	\$80-150k

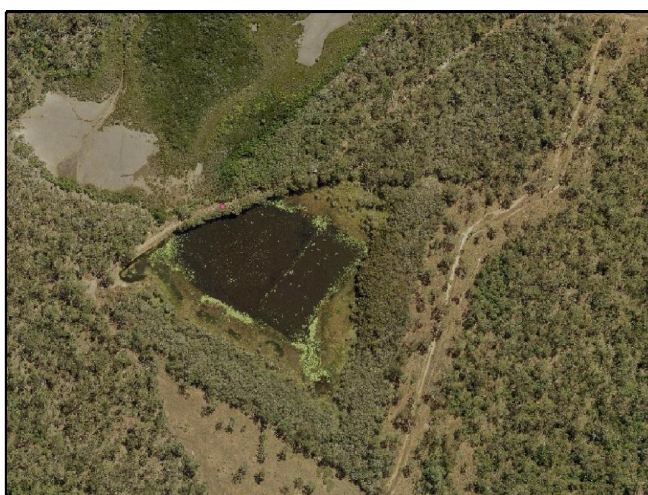
<b>Wetland Barrier Rank</b>	<b>24</b>	
<b>Stream Barrier Rank</b>	109	
<b>Barrier ID</b>	9404	
<b>Stream Name</b>	Sandy Creek Trib	
<b>Location</b>	731441.0999 E	7646129.143 N
<b>Barrier Type</b>	Bund	
<b>Barrier Name</b>	Dudgeon Point Western Wetland	
<b>Remediation Approach</b>	Rock ramp bypass	
<b>Approx. Cost</b>	\$80-150k

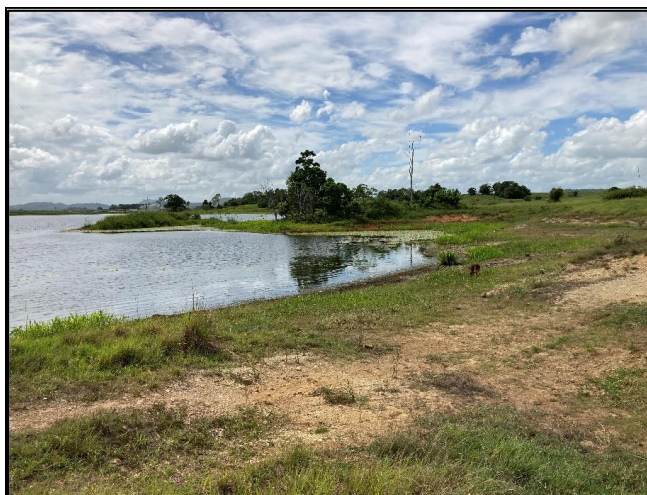
<b>Wetland Barrier Rank</b>	<b>24</b>	
<b>Stream Barrier Rank</b>	133	
<b>Barrier ID</b>	6273	
<b>Stream Name</b>	Constant Creek Trib	
<b>Location</b>	707149.5264 E	7680154.522 N
<b>Barrier Type</b>	Dam	
<b>Barrier Name</b>	Private Dam	
<b>Remediation Approach</b>	Rock ramp bypass	
<b>Approx. Cost</b>	\$100-200k

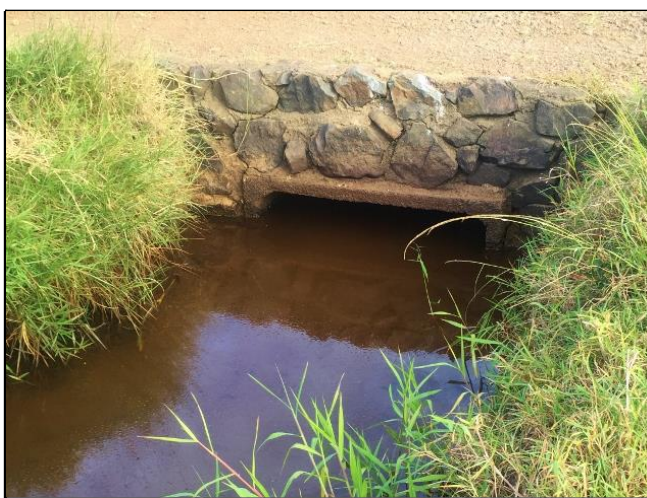
<b>Wetland Barrier Rank</b>	<b>26</b>	
<b>Stream Barrier Rank</b>	70	
<b>Barrier ID</b>	1064	
<b>Stream Name</b>	Tedlands Wetlands	
<b>Location</b>	738939.897 E	7610893.096 N
<b>Barrier Type</b>	Causeway	
<b>Barrier Name</b>	Private causeway	
<b>Remediation Approach</b>	Culverts	
<b>Approx. Cost</b>	\$50-80k

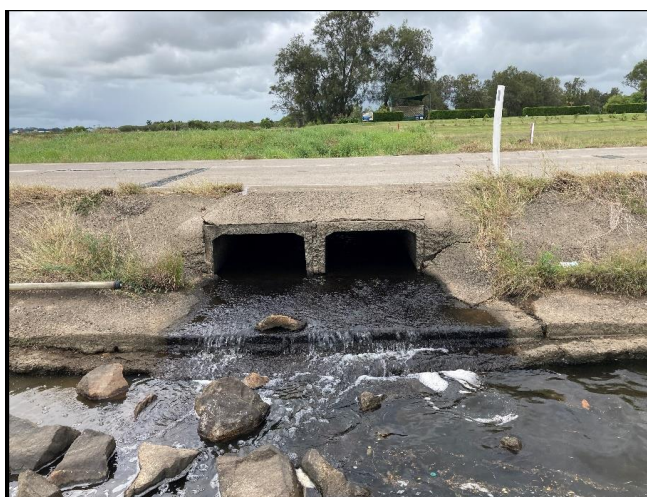
<b>Wetland Barrier Rank</b>	<b>26</b>	
<b>Stream Barrier Rank</b>	90	
<b>Barrier ID</b>	9476	
<b>Stream Name</b>	McCreadys Creek	
<b>Location</b>	724952.3474 E	7666498.388 N
<b>Barrier Type</b>	Causeway	
<b>Barrier Name</b>	Golflinks Rd	
<b>Remediation Approach</b>	Culverts	
<b>Approx. Cost</b>	\$1-2M

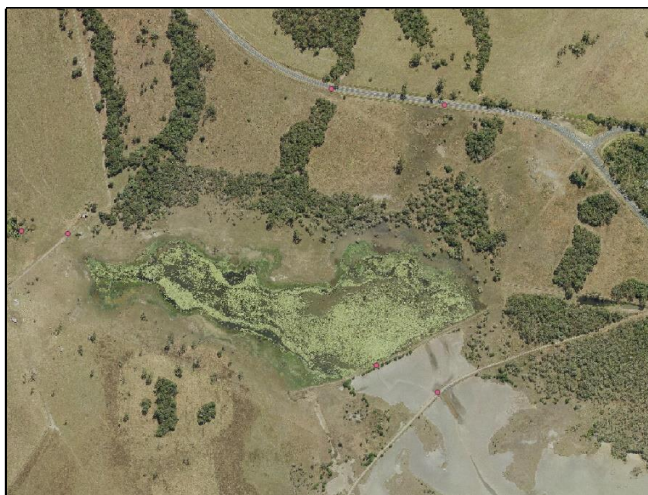
<b>Wetland Barrier Rank</b>	<b>26</b>	
<b>Stream Barrier Rank</b>	109	
<b>Barrier ID</b>	9391	
<b>Stream Name</b>	Oonooie Wetlands	
<b>Location</b>	735421.6044 E	7626472.715 N
<b>Barrier Type</b>	Bund	
<b>Barrier Name</b>	Private bund	
<b>Remediation Approach</b>	Refurbish existing fishway	
<b>Approx. Cost</b>	\$60-80k

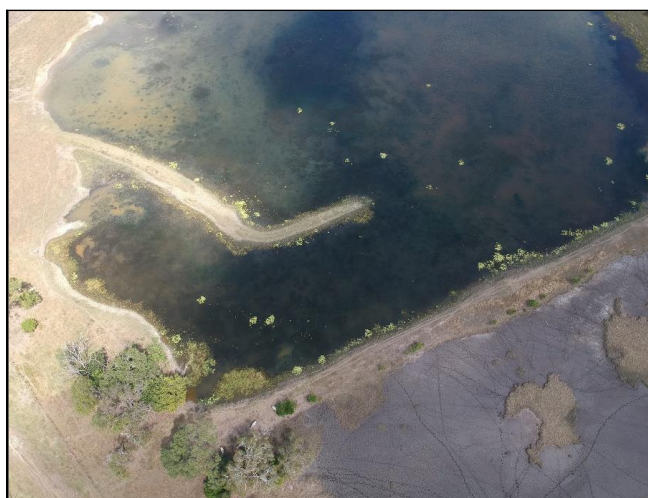
<b>Wetland Barrier Rank</b>	<b>26</b>	
<b>Stream Barrier Rank</b>	120	
<b>Barrier ID</b>	9419	
<b>Stream Name</b>	Bradford's (Macs) Wetland	
<b>Location</b>	725459.8424 E	7643512.242 N
<b>Barrier Type</b>	Bund	
<b>Barrier Name</b>	Macks Truck Stop	
<b>Remediation Approach</b>	Rock ramp bypass	
<b>Approx. Cost</b>	\$60-80k

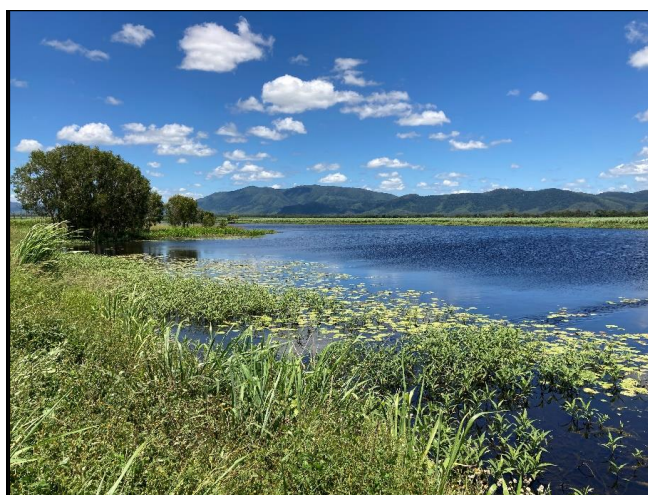
<b>Wetland Barrier Rank</b>	<b>26</b>	
<b>Stream Barrier Rank</b>	133	
<b>Barrier ID</b>	9377	
<b>Stream Name</b>	Rocky Dam Trib	
<b>Location</b>	735127.3296 E	7614322.167 N
<b>Barrier Type</b>	Bund	
<b>Barrier Name</b>	Upstream Wetland	
<b>Remediation Approach</b>	Rock ramp bypass	
<b>Approx. Cost</b>	\$80-100k
