Macs & Alligator Creek Wetlands Fish Community Assessment 2023

June 2023

Josh Potter & Matt Moore

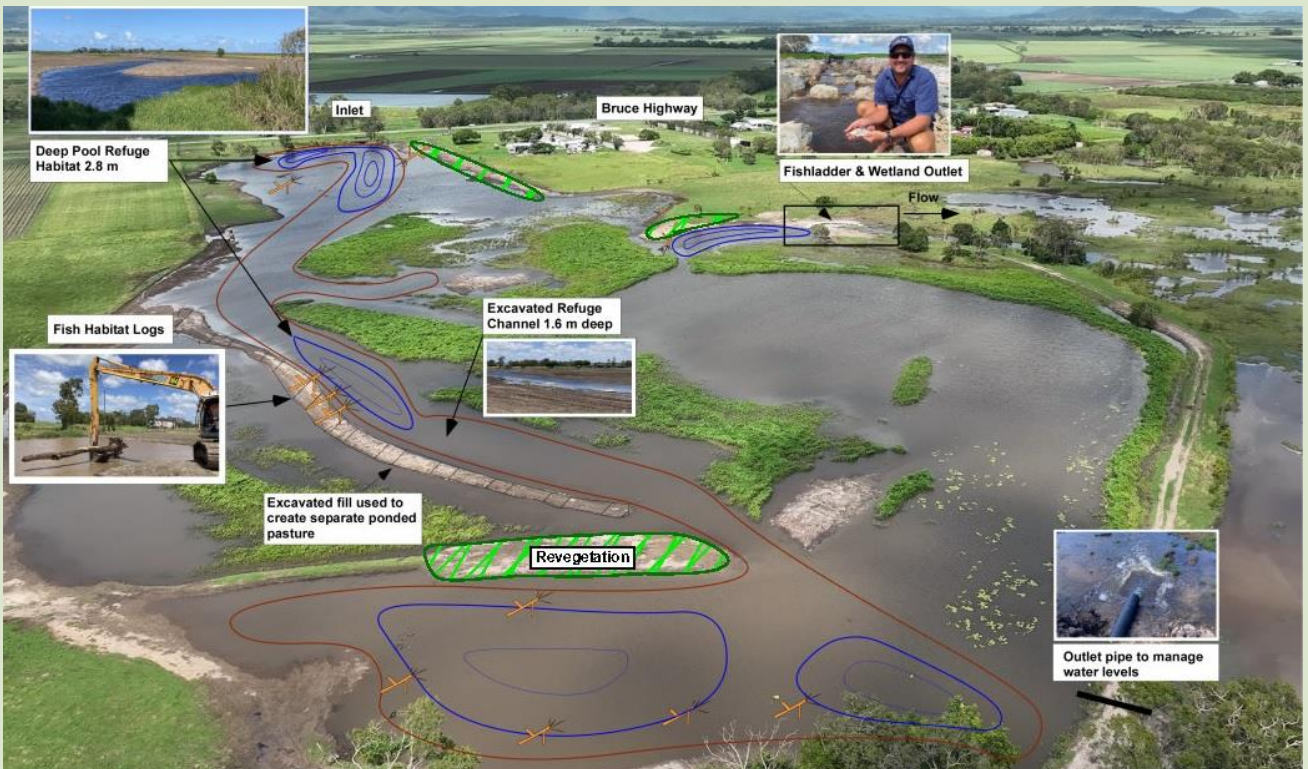
Cover image: From top, left to right; Showing the suite of rehabilitation works that occurred at Macs wetland in 2022 (main image), a 300 mm long tarpon recorded during electrofishing surveys in June 2023 (bottom left). The wetland was completely dry during rehabilitation works in late 2022, so this tarpon has migrated into the wetland via the rock ramp fishway as a juvenile and grown to a sub-adult in 6 months. A selection of fish species recorded during post rehabilitation surveys, including striped scat (diadromous), spangled perch, empire gudgeon (diadromous), bony bream, fly-specked hardyhead and Olive perchlett (center image). A sub-adult giant herring which had successfully migrated into the lowland wetland as a juvenile and grown into a subadult. Giant herring utilise lowland wetlands as nursery habitats before migrating back to marine waters to spawn.

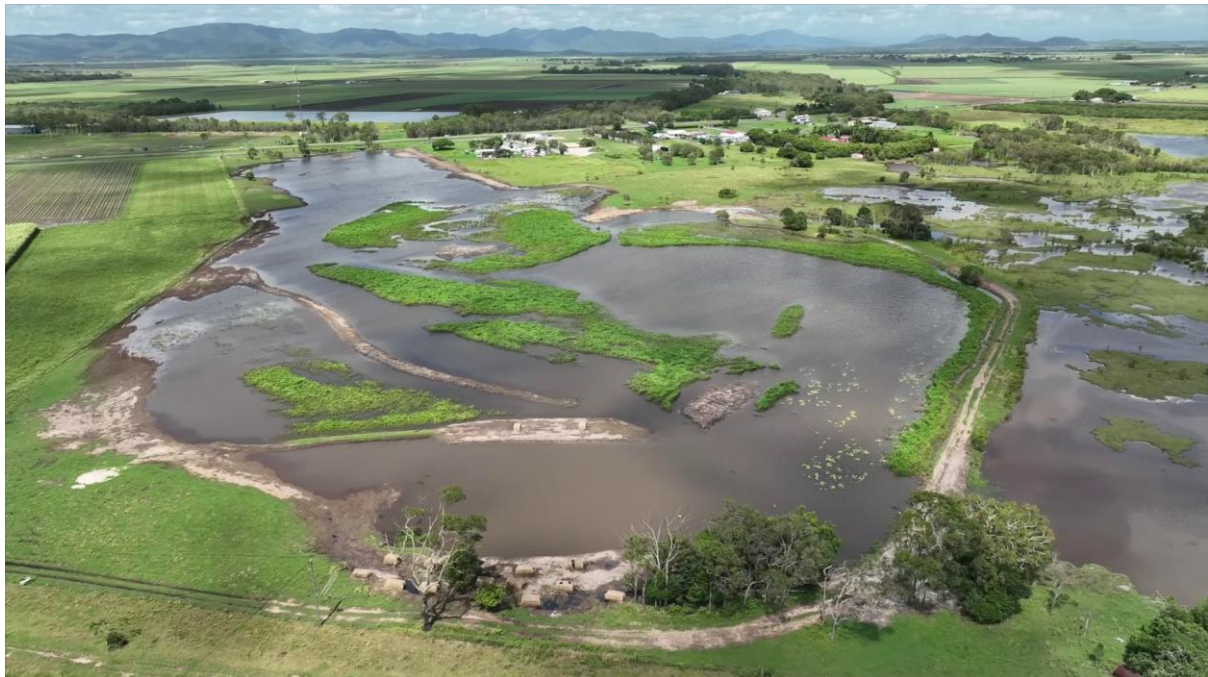
Figure 2: Drone captured photo of Macs wetland, facing West.

Before the remediation works, both wetlands often completely dried up or suffered from anoxic conditions as a direct result of excessive hymenachne growth. This shallow, hot and low dissolved oxygen environment impacted fish community condition and overall aquatic ecosystem health. To mitigate this, deep pool refuge habitats (>2.5 m) and channels (>1.2 m) were excavated throughout the wetlands in December 2022. The construction of deep pool refugia has multiple benefits. The deep pools assist with mediating water temperatures, particularly in tropical environments, provide water during the dry season, and reduces the prevalence and growth of invasive aquatic weeds, particularly hymenachne. Hymenachne is a semi-aquatic grass species which is capable of setting roots within the substrate in wetlands less than 1.5 m in depth. If left unmanaged, hymenachne can form floating rafts allowing this invasive species to occupy deeper wetlands up to 3 m in depth e.g., Tedlands wetlands (550 ha) at Koumala, central QLD. Furthermore, the landholder is implementing control measures including a rotational grazing strategy that allows livestock to feed on the hymenachne periodically during the dry season when water levels are reduced, and intermittently spraying herbicides as a control measure. Included as part of the remediation works, large woody debris' were installed within the wetlands to provide habitat complexity, and for fish and other aquatic fauna to seek shelter and food resources.

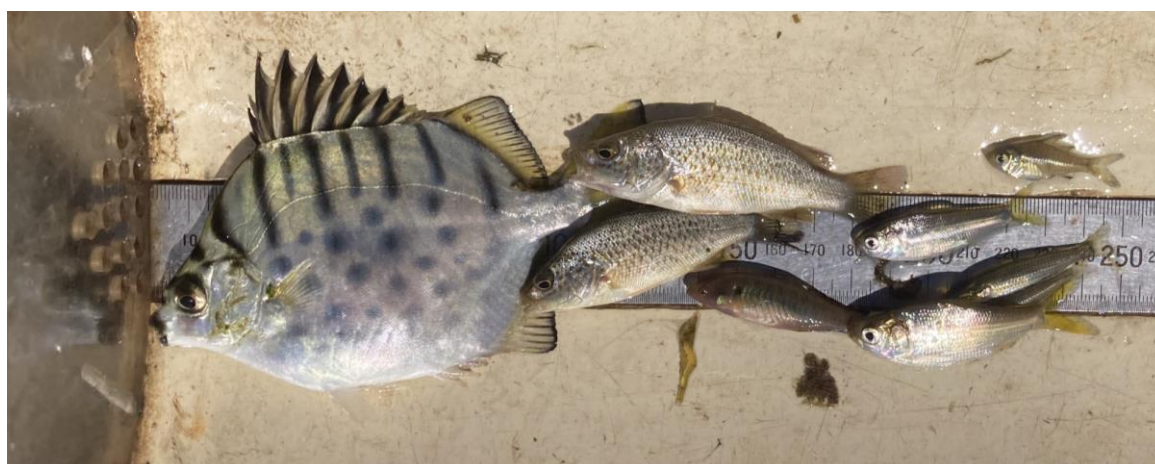
Figure 4: Some of the fish species captured during Macs wetland fish community survey. Left to Right - Banded scat (*S. multifasciata*); Spangled perch (*L. unicolor*); Empire gudgeon (*H. compressa*); Bony bream (*N. erebi*); Fly-specked hardyhead (*C. stercusmuscarum*); Agassizi's glassfish (*A. agassizii*).

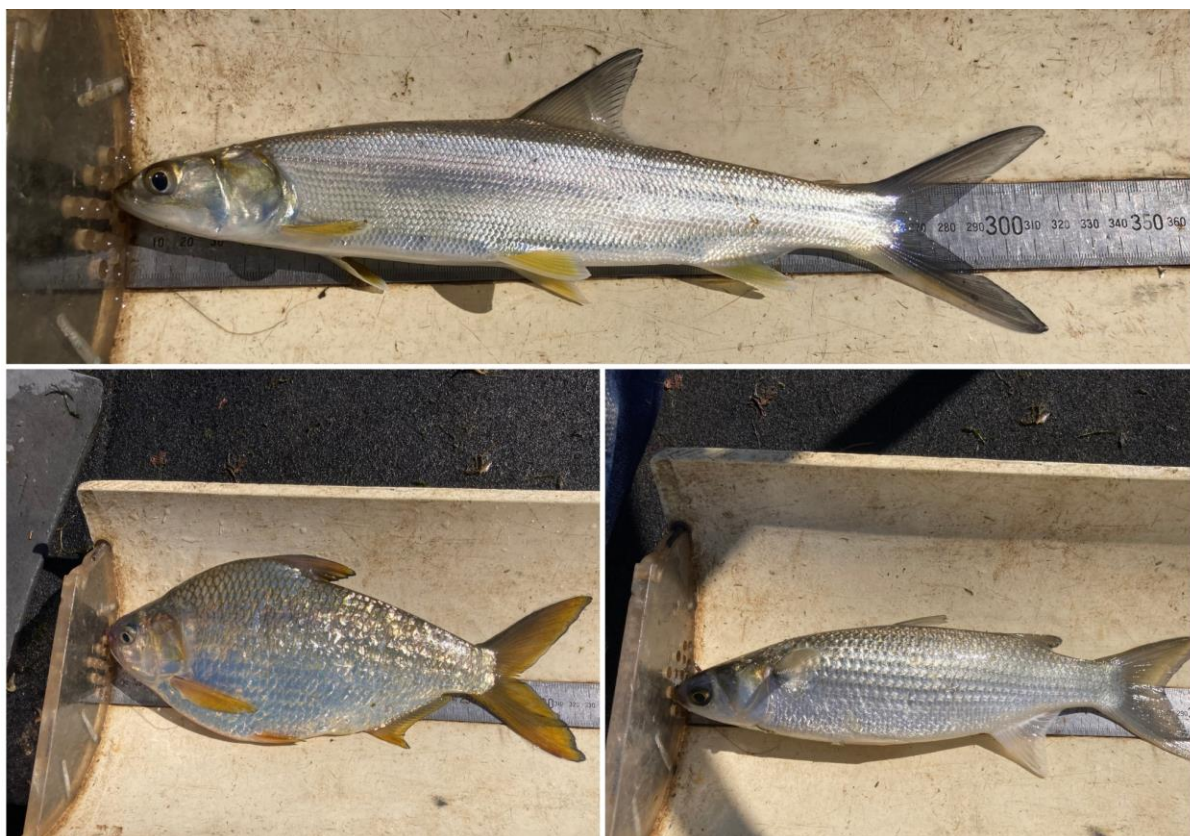
Figure 6: Largest fish captured during fish community monitoring. Top: giant herring (*E. hawaiiensis*); bottom left: bony bream (*N. erebi*); bottom right: Sea mullet (*M. cephalus*). All of the fish shown here were captured at Site 5 at Macs wetland.

The largest fish captured during post remediation monitoring was a giant herring (*Elops hawaiiensis*) with two individuals recorded at 272 mm and 290 mm. These diadromous fish have rarely been captured in the region during previous waterway and wetlands surveys. Giant herring utilise lowland wetlands as nursery habitats during their early life-history before migrating downstream to estuarine and near shore marine habitats associated with the Great Barrier Reef. Bony Bream (*N. erebi*) were the next largest fish and ranged from 45 mm and 288 mm in length, with a median size of 53 mm. The broad size range of these fish may indicate that they are successfully breeding in the wetland. A

juveniles. High growth rates were also noted, particularly for tarpon and giant herring. A giant herring recorded during fishway monitoring in April 2023 measured 72 mm. Giant herring breed in marine waters before migrating into freshwater wetlands as juveniles e.g. 72 mm. Two giant herring recorded during electrofishing surveys measured 272 and 290 mm. It's likely that these giant herring belong to the same cohort of fish recorded moving through the fishway. This would indicate rapid growth of approximately 50 mm per month (from 72 mm to 272 mm in 2 months).

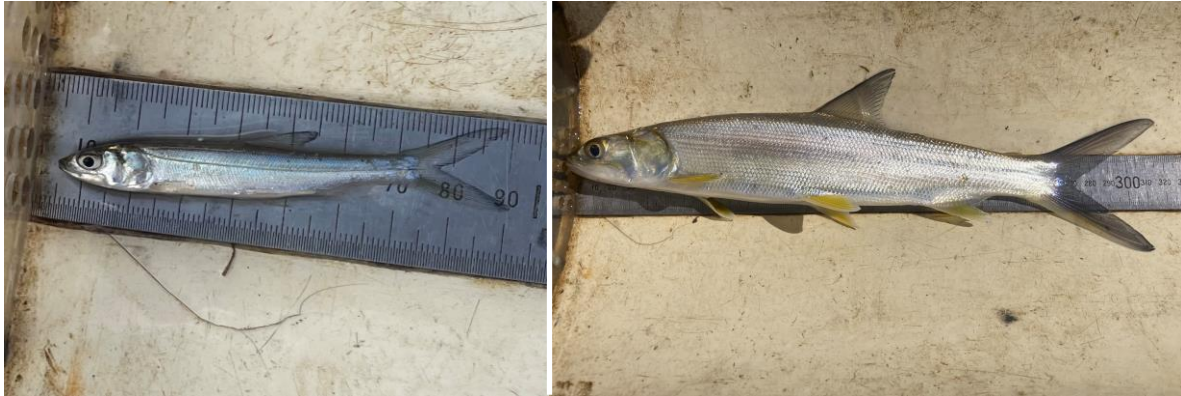
Figure 7. Showing juvenile giant herring. Left; 72 mm giant herring recorded successfully ascending the Macs wetland fishway in April 2023. Right, potentially a giant herring belonging to the same cohort recorded in the wetland during electrofishing surveys in late June 2023 now at 272 mm, representing a potential growth rate of approximately 50 mm per month. Giant herring cannot breed in the freshwater wetland and the wetland was completely dry in December 2022. The only way giant herring could access the wetland was via the fishway during the approximately 21 flow days across two events in January and April 2023.

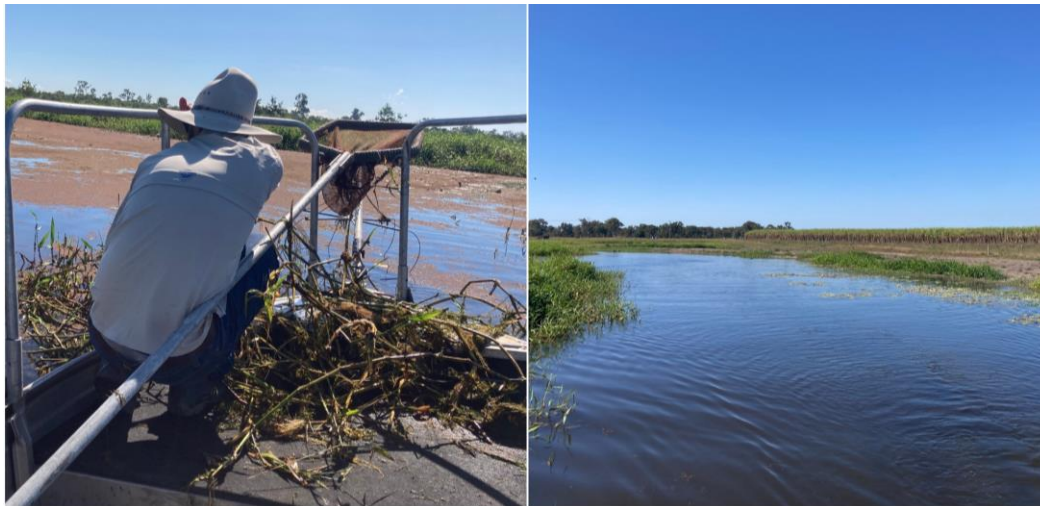
Figure 8: Left- Removing hymenachne from shallower sections of Macs wetland during electrofishing; Right- The deep channel excavated along the southern side of the wetland successfully prevented hymenachne from growing across.

Water quality, particularly dissolved oxygen levels (D.O), were within expected parameters considering current hymenachne extent within the wetland. Hymenachne biomass and extent is expected to reduce as grazing opportunities increase when the water levels gradually recede during the dry season. Despite this, the wetland still has the ability to self-sustain D.O levels due to the rehabilitation works creating favourable conditions for the growth of submergent aquatic macrophytes. Furthermore, the recently constructed deep open water refuge pools provide suitable conditions for wind waves to provide oxygen to the wetlands surface water layers via diffusion. This diffusion would not have been possible without the constructed refuge pools reducing the prevalence and extent of hymenachne. Prior to these deep refuge pools, the wetland was less than 800 mm in depth, and this allowed hymenachne to grow completely across the wetland, resulting in minimal to no open water areas, and inadequate conditions for the formation of wind waves.
