## Macs & Alligator Creek Wetlands Fishway Monitoring Report

June 2023

Reef Catchments Limited (RCL) contracted Catchment Solutions (CS) to undertake remediation works to improve aquatic connectivity and habitat at two wetland complexes. The wetlands are located in the lower Alligator Creek catchment on a property south of Mackay, central Queensland. In December 2022 fish passage was restored at two sites (Figure 1);

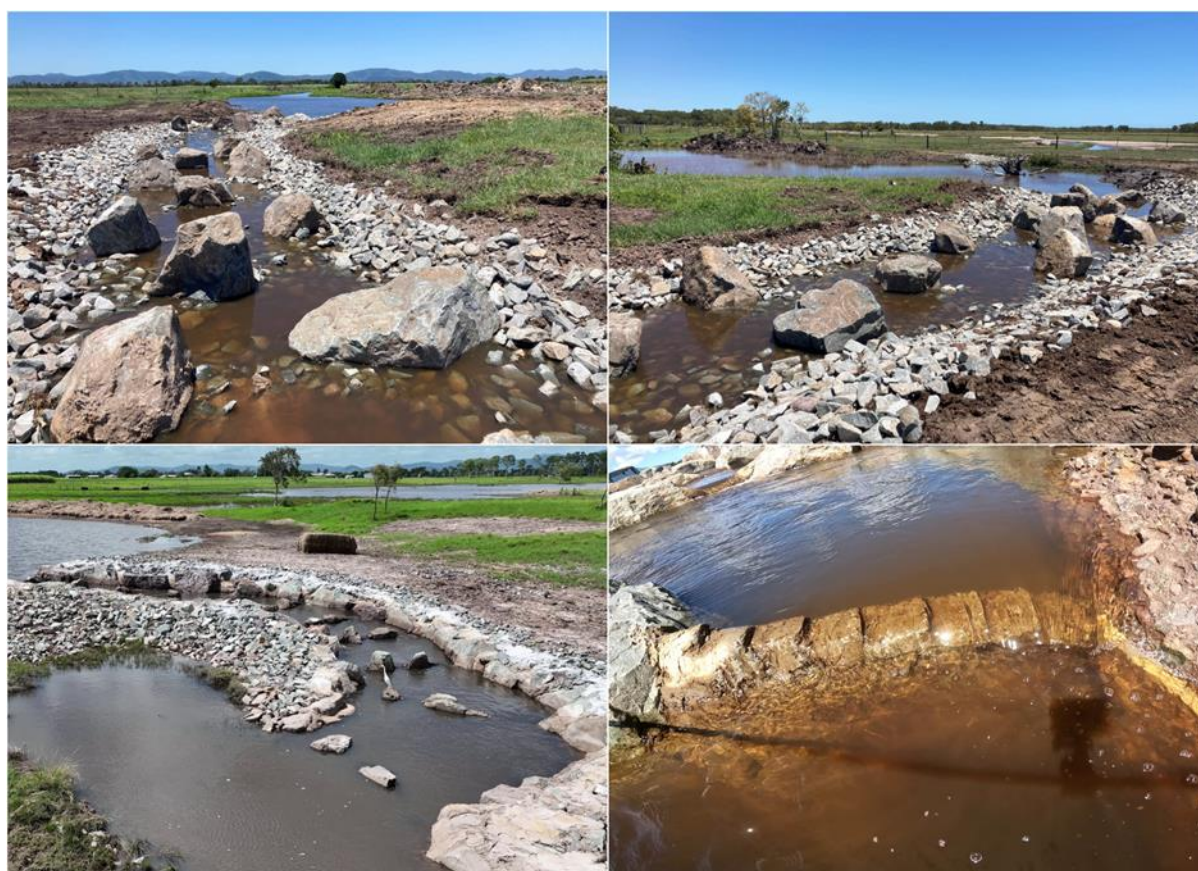
**Figure 2. Top - Looking upstream (left) & downstream (right) at Alligator Creek wetland fish passage works; Bottom - Showing Macs wetland rock ramp fishway (left) & the nursery slot (right) incorporated into the design.**

The nursery slot performed as intended with smaller fish, primarily empire gudgeon, observed utilising the shallow film of water to successfully ascend the fishway. The stepped increments of the nursery slot provide a range of flows and depths in the slot which allowed fish of different sizes and swimming abilities to ascend. In addition to trap sampling, remote video stations comprising Go Pros were used to capture footage of the nursery slot, where small empire gudgeon and crescent perch could be seen easily ascending through the slot. Empire gudgeon were observed migrating upstream through the edge slot with the shallowest film of water <8 mm. The shallow film of water in-conjunction with the surface roughness of the concrete creates friction resulting in a boundary layer of reduced velocity. Small fish, including 15 mm empire gudgeon were recorded ascending this shallow film of water.

The simple rock chute design on a 1:30 gradient with interspersed large boulders that were used to facilitate connectivity at the site provided passage for both small-bodied and larger-bodied fish, including juvenile diadromous species. The largest individual captured was a tarpon measuring 197 mm in length. The smallest species recorded was Agassizi's glassfish at 18 mm. Larger fish were in greater abundance than those recorded at Mac's wetland fishway. At the Alligator Creek site, 8% of fish measured were greater than 100 mm in length compared to only 1.35% at Mac's wetland fishway. However, all fish caught over 100 mm were tarpon, with most caught in a single trap set.

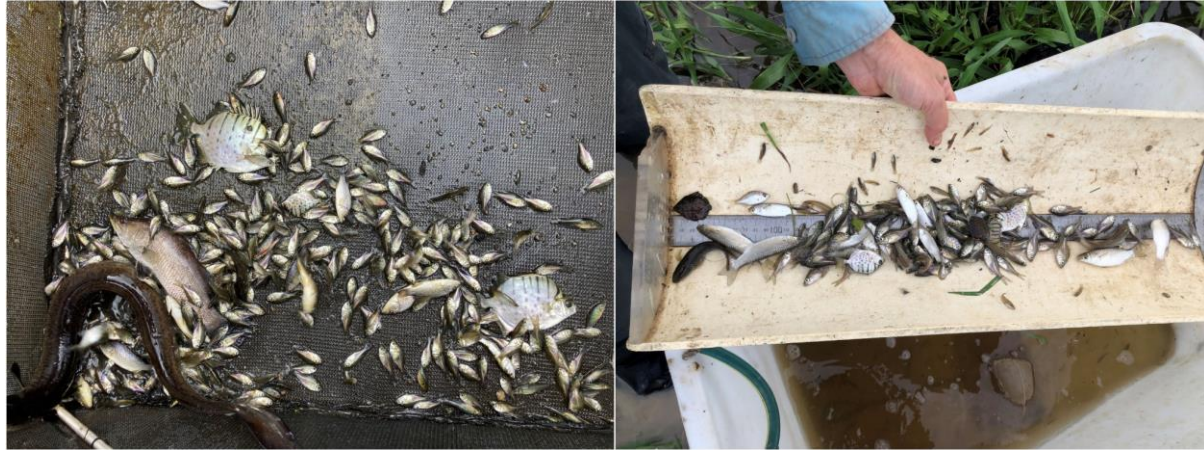
Figure 3. Showing a typical trap haul (left); Sorting fish species and measuring lengths (right)

Fishway trapping utilised purpose-built traps, with 10mm round bar and shade cloth (4.0 mm mesh size) covering the frame. Shade cloth wing walls prevented fish from swimming around the traps on either side. Sandbags and star pickets were used to secure the traps and wing walls in place. The trap consisted of a single cone entrance, with dimensions of 1.4 m x 1.0 m x 1.1 m. Traps were set and checked multiple times per day to minimise stress, potential predation, and fish escaping the trap. Catch rates were standardised using Catch Per Unit Effort (CPUE) with unit effort being reported in days. Sampling effort for the monitoring event is summarised in Table 1.

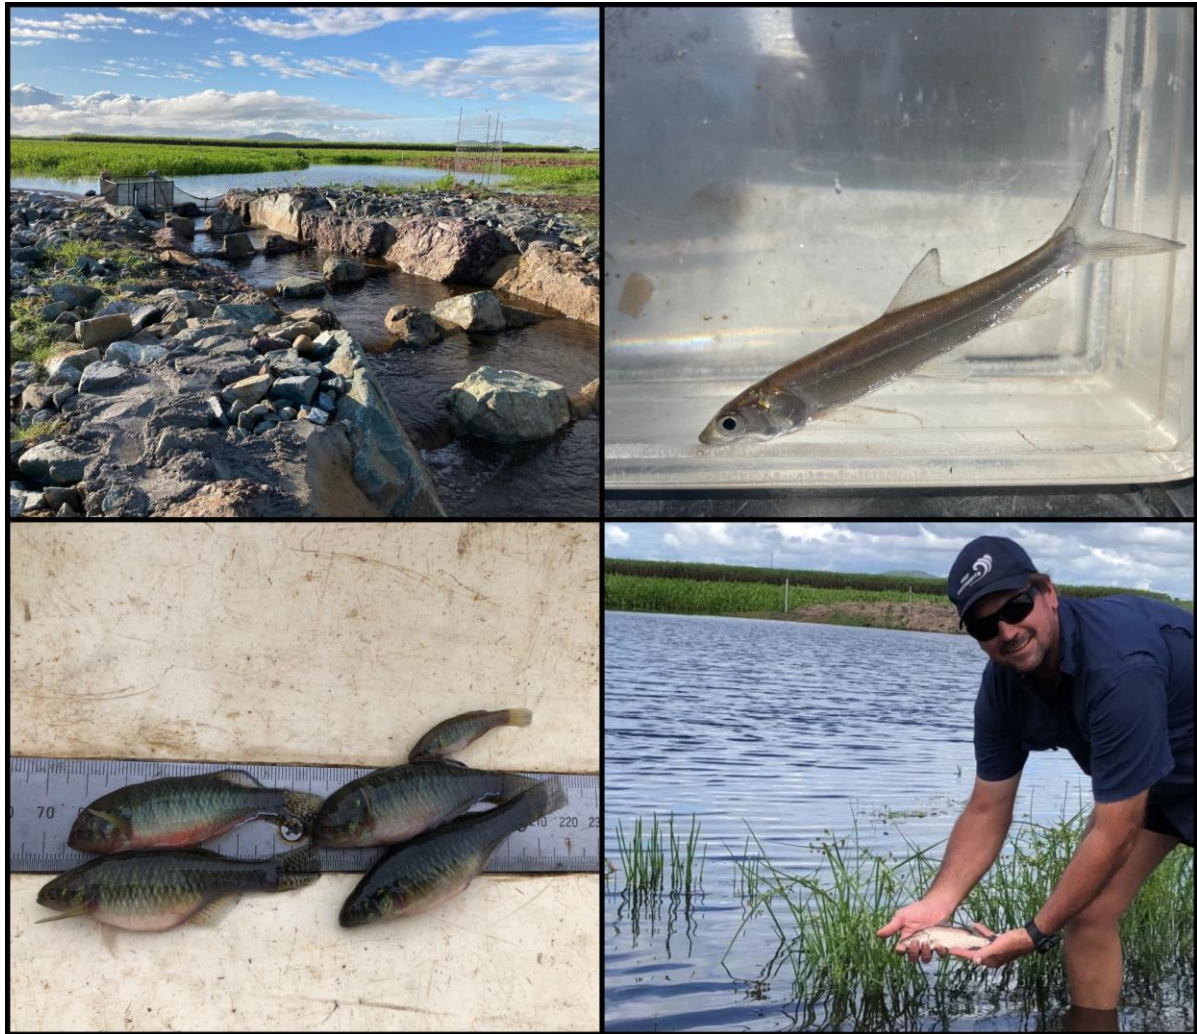
**Figure 4. Showing fishway conditions during monitoring (top left); Giant herring caught in an overnight trap operation (top right); Empire gudgeon captured during a trapping operation (bottom left); Landholder Jason Bradford releasing a barramundi in the wetland upstream of the fishway.**

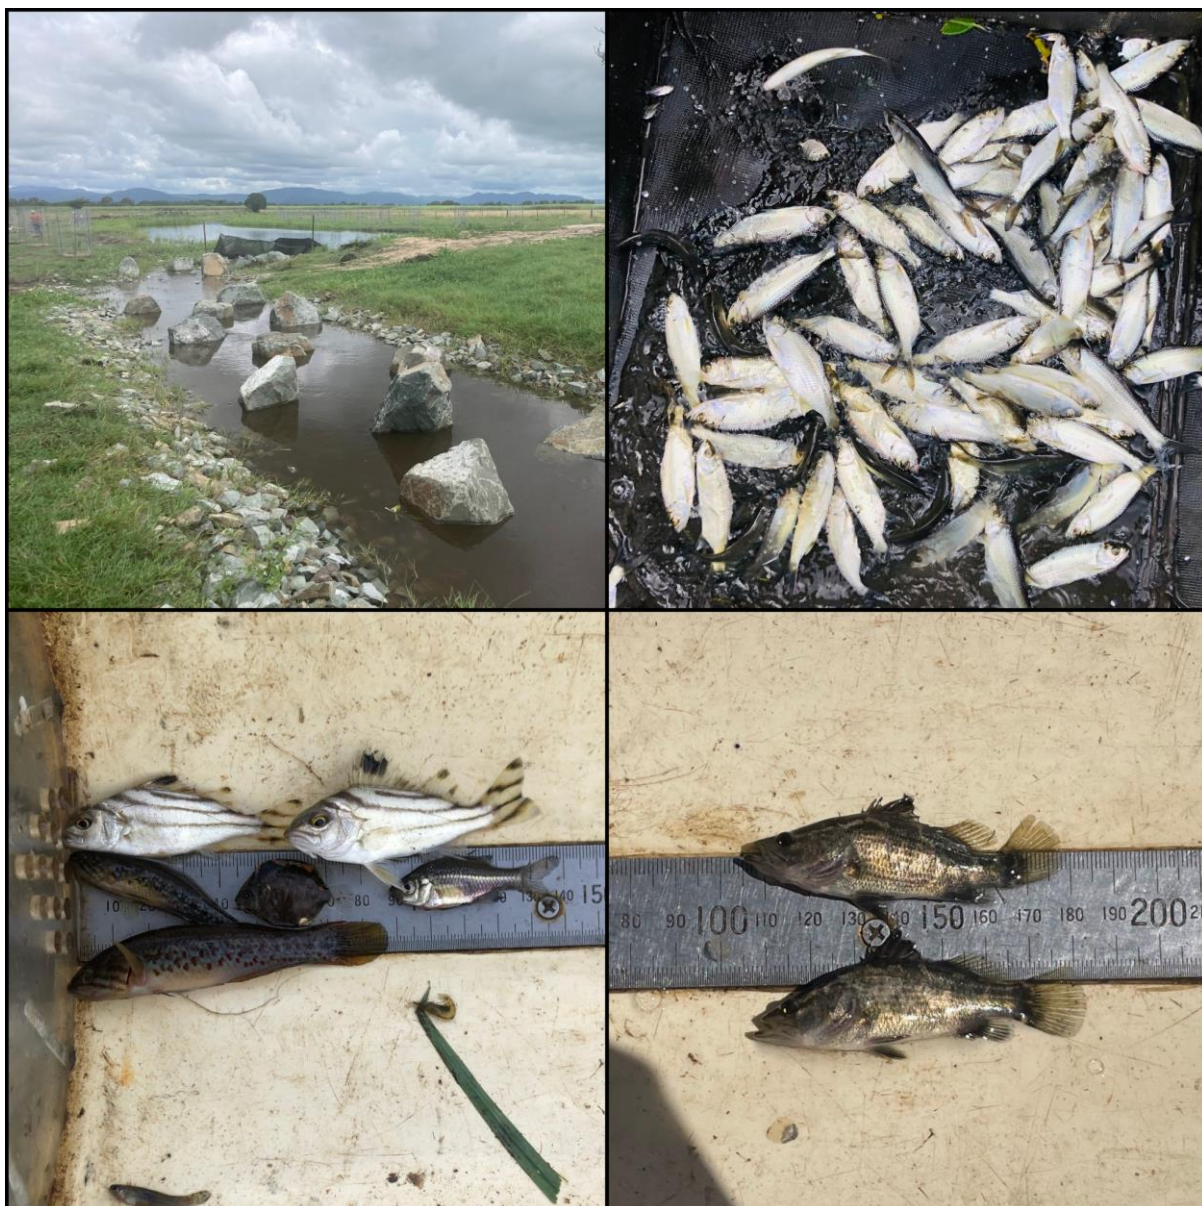
**Figure 7. Showing fishway conditions during monitoring (top left); Large haul of tarpon and other species (top right); Crescent perch, purple-spot gudgeon, banded scat, and Agassizi's glassfish captured during monitoring (bottom left); Two barramundi captured on the last day of monitoring.**

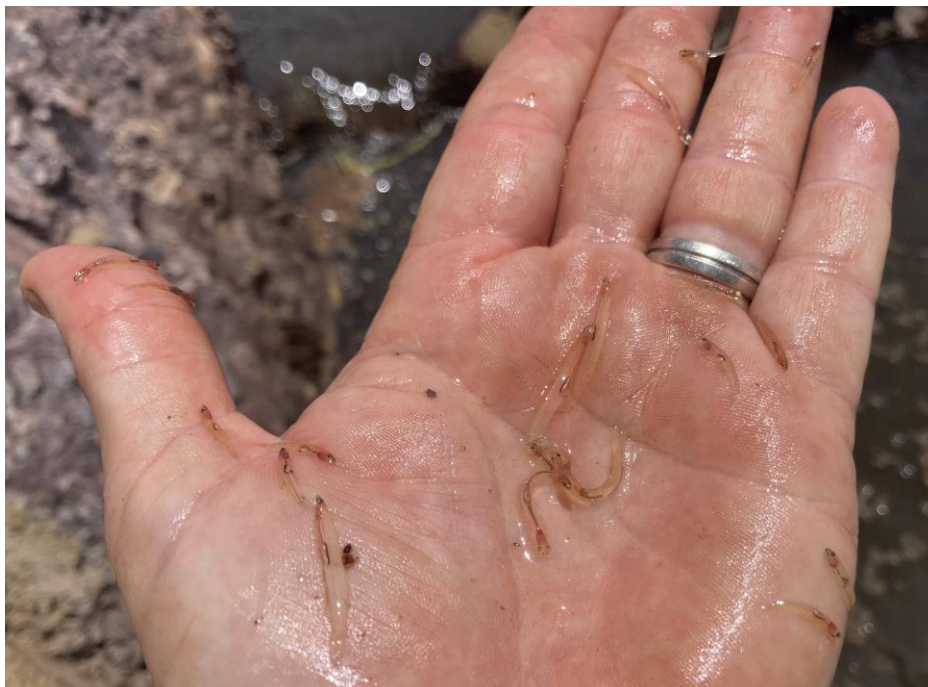
**Figure 11. Showing tarpon leptocephalus (longer translucent specimens) and post larvae empire gudgeon (shorter specimens), recorded via a dip net in the second last pool (exit) of the fishway in early January prior to fishway trap sampling. Leptocephalus and post larvae empire gudgeon have not been recorded in Australian fishway studies, so it's unlikely that they ascended the conventional rock ramp slot, and more likely that they used the novel nursery slot design.**

Larger bodied fish such as crescent perch were recorded using the opposite and deeper (>150 mm) side of the nursery slot. Unfortunately, no leptocephalus were captured during the monitoring period. However, this may be due to their migration from marine to freshwaters occurring prior to the monitoring period. Tarpon leptocephalus were observed in the fishway, including the 2<sup>nd</sup> last pool from the exit (top) in early January 2023 during the first flow event down the fishway. These specimens were recorded by the authors using a dip net. Very little information is known about the migration habitats of tarpon. Research from overseas suggests tarpon leptocephalus migrate from offshore marine waters towards the coast and eventually upstream through estuaries to freshwater around December-January period. Monitoring of the fishway occurred in April. It's possible that leptocephalus were not recorded in April because they had already metamorphosed into juvenile fish by this stage. Juvenile tarpon grow at between 30-40 mm per month. Tarpon around 120 mm were recorded successfully ascending the fishway in April. It's possible that these 120 mm tarpon belonged to the same cohort of tarpon leptocephalus observed at the fishway site 3 months earlier in January.
