# NEILLY GROUP ENGINEERING

**MACKAY WHITSUNDAY REGIONAL EROSION  
IDENTIFICATION, PRIORITISATION AND  
REMEDICATION STUDY**

**REEF CATCHMENTS**

**20 NOVEMBER 2023**

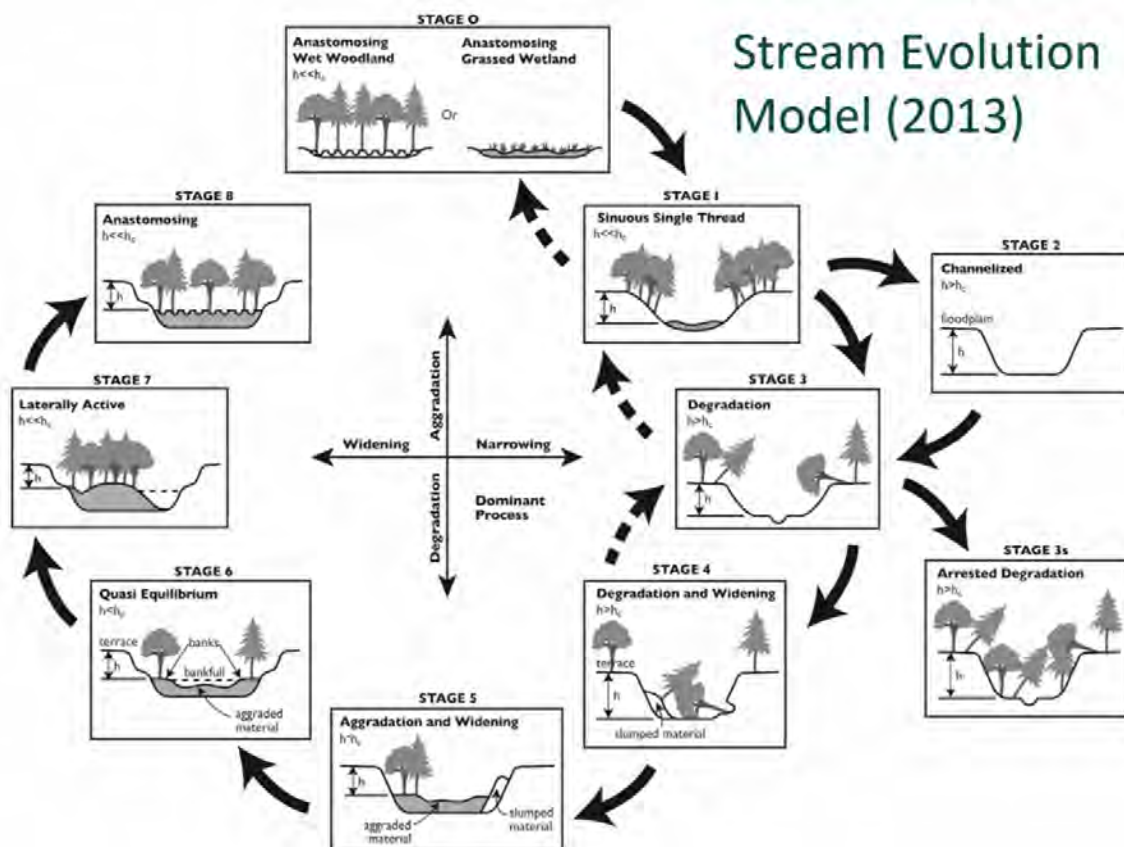
**Figure 6. Channel evolution model showing the potential for stream widening following deepening**

As river channels deepen, the banks become steeper. This can lead to over-steepening, resulting in large-scale bank failures and channel widening as outlined in the channel evolution model (Figure 6). The fallen material gets carried away during high water flow events, leaving the riverbank exposed to high-velocity flows and further intensifying erosion and decreasing the resistance of the channel's banks to further erosion.

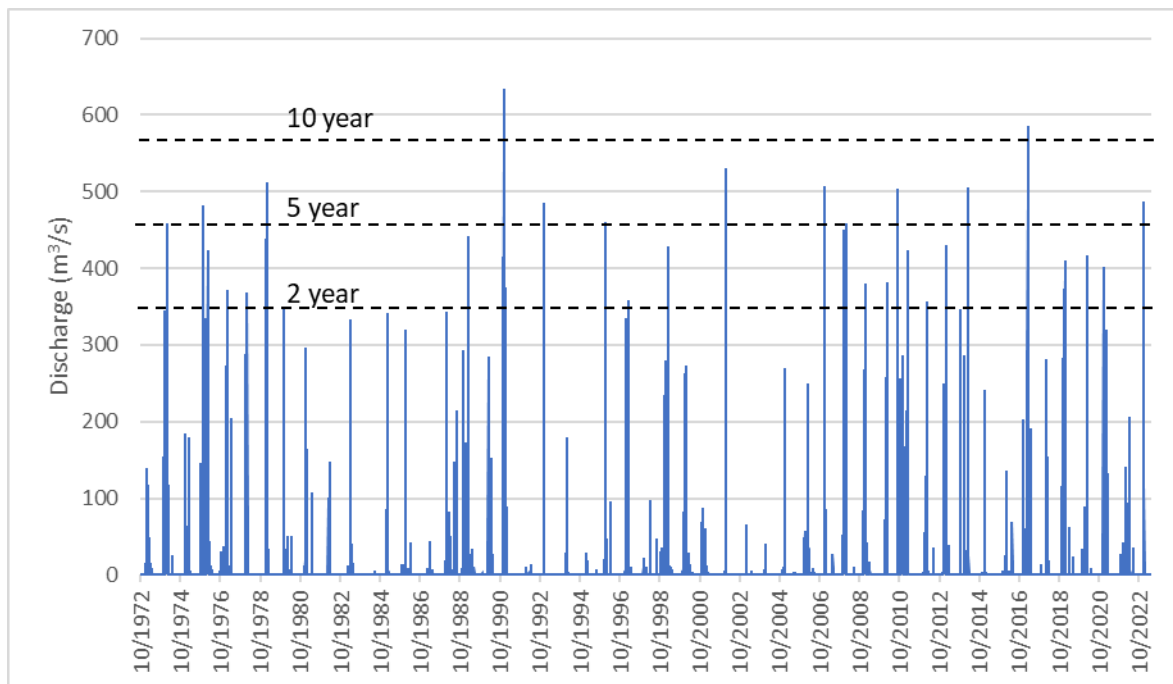
Figure 30. Discharge history for the Gregory River at Lower Gregory

The 2017 event was associated with Severe Tropical Cyclone Debbie and was the largest in recent history (using the Gregory River gauge as an indicator for the entire basin). With the exception of April 2014, which coincided with Cyclone Ita, the remaining flood events appear not to be associated with a tropical cyclone in the region. Even Cyclone Ului (2010) which caused relatively large amounts of destruction in the Proserpine and Whitsunday areas did not cause excessive flooding, with a peak discharge occurring between the 2-year and the 5-year ARI event in the Gregory River (Figure 30). The 2019 Tropical Monsoon event, which was associated with flooding across most of North Queensland, only resulted in a peak discharge between a 2-year and the 5-year ARI.

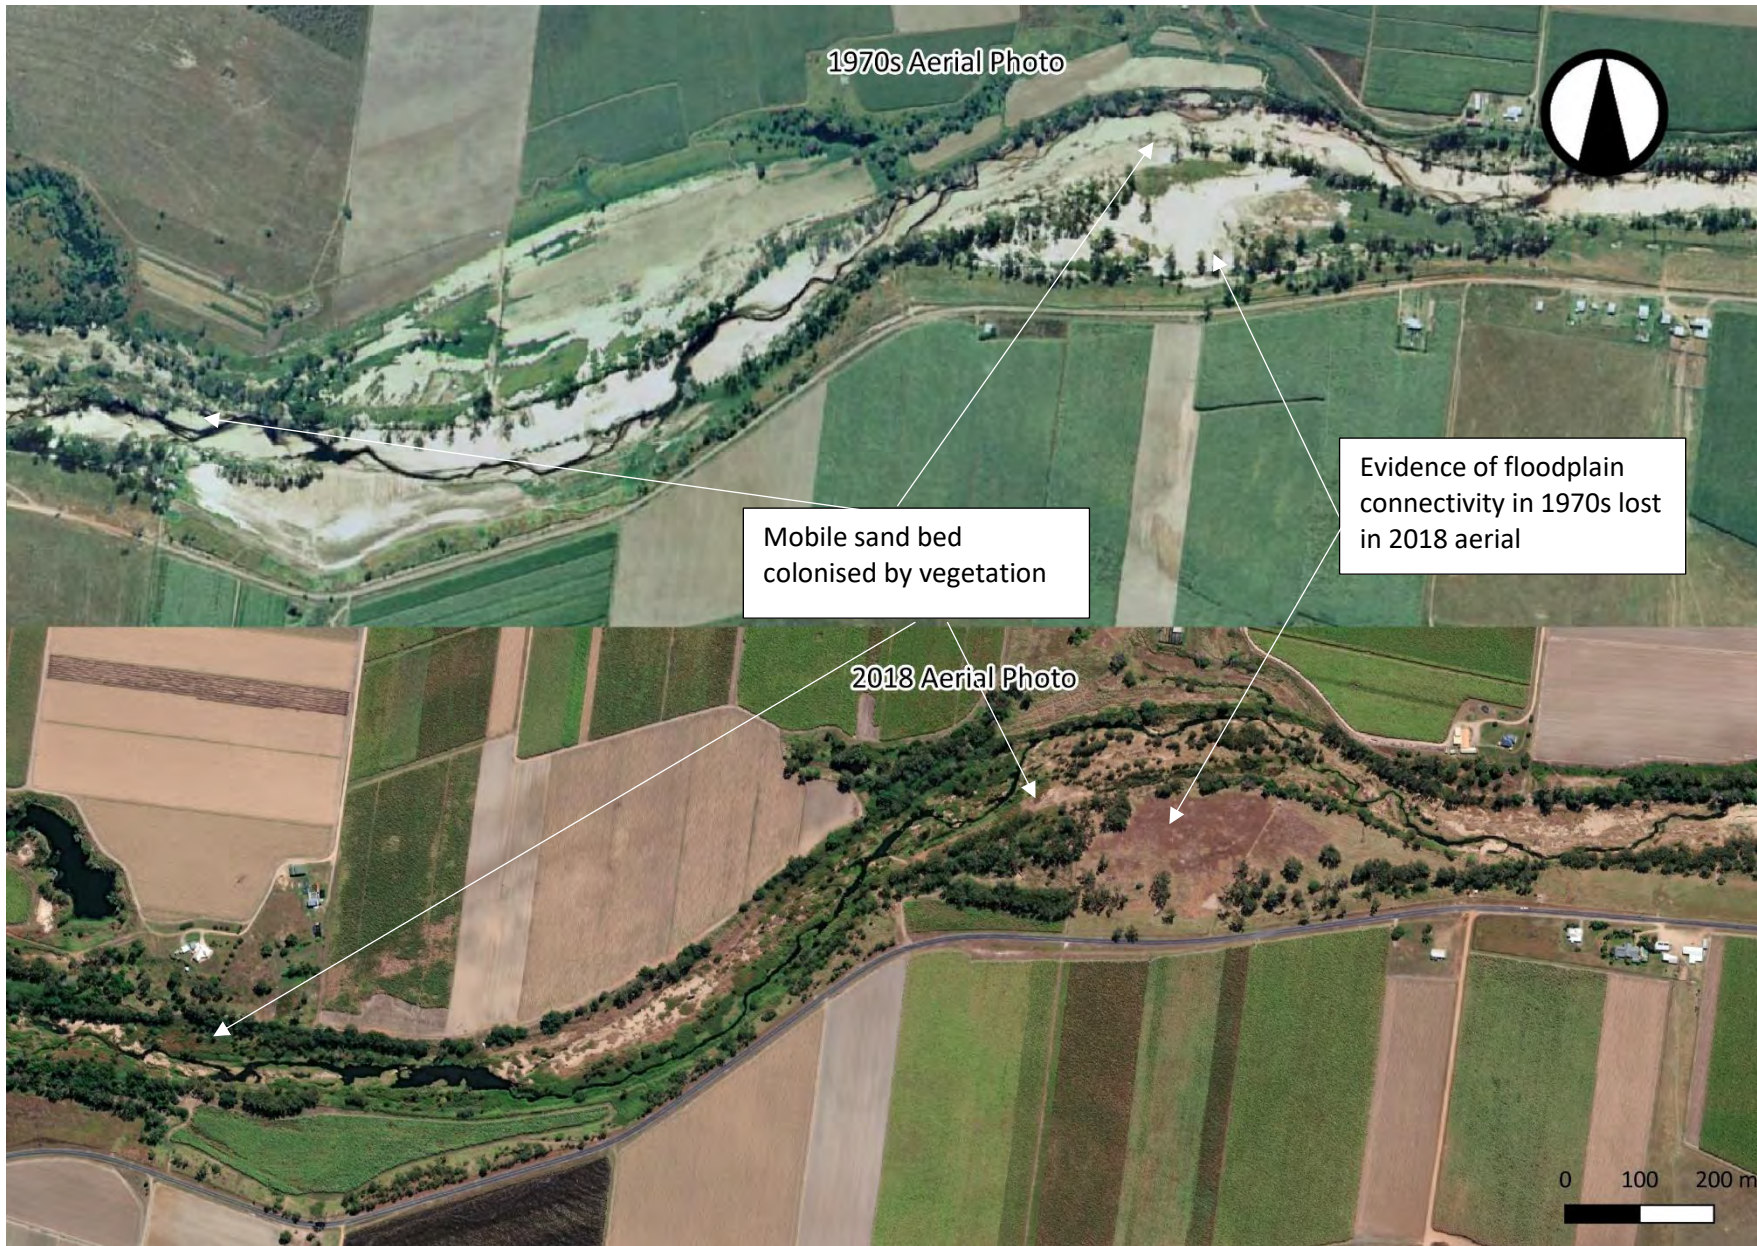
**Figure 46. Aerial photograph showing changes in the Proserpine River since 1970s**

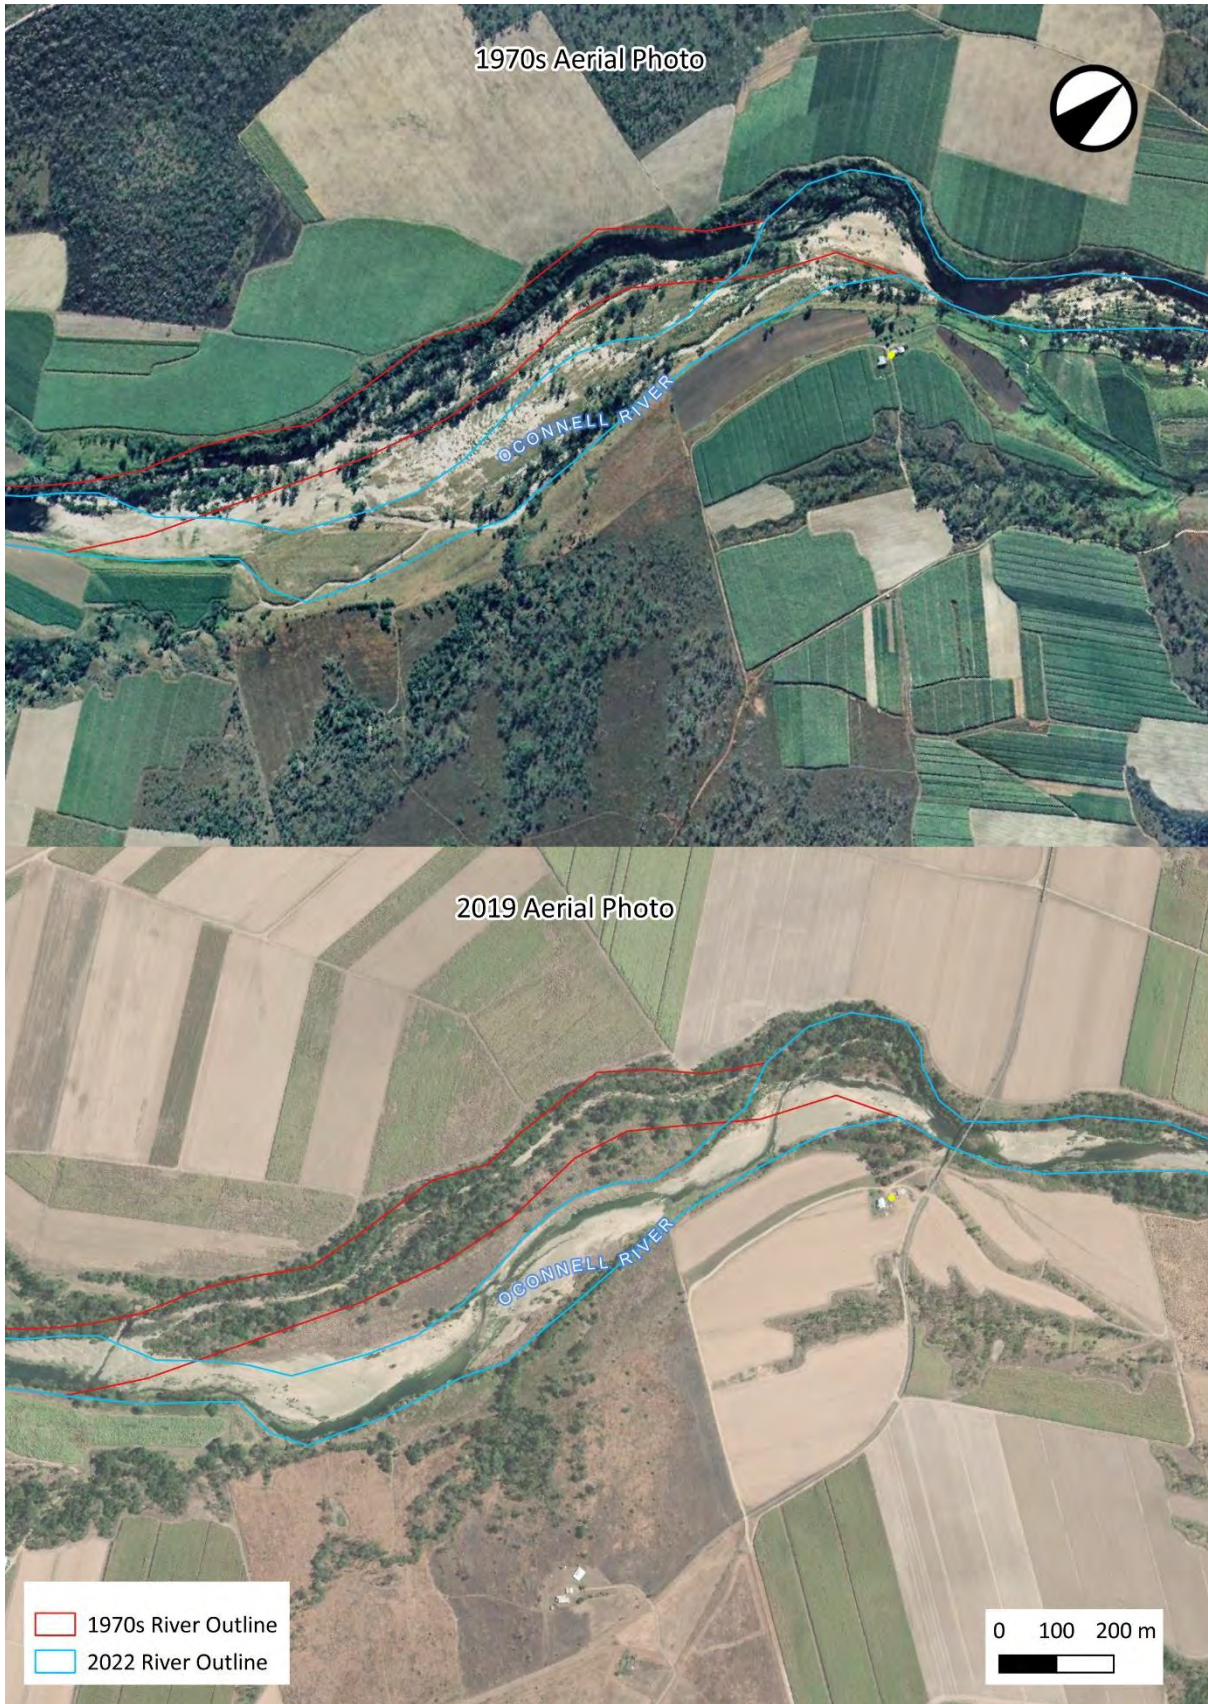
**Figure 65. Significant movement of the O'Connell River between 1970 and 2018**

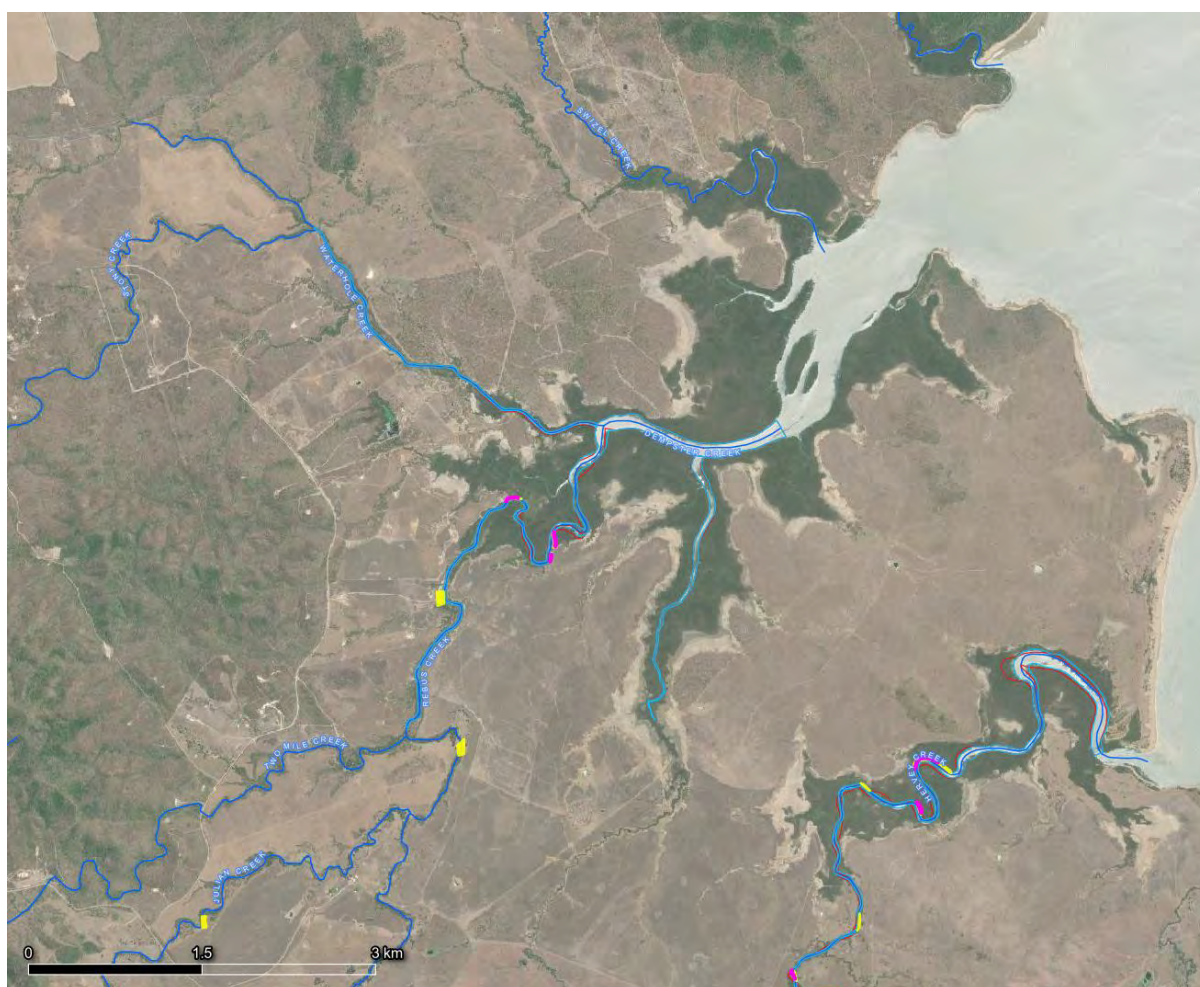
**Figure 66. Locations found within the Waterhole Creek catchment. Yellow polygons are all locations found; pink polygons represent locations of SECAT calculations; red outlined indicate 1970s channel delineations**

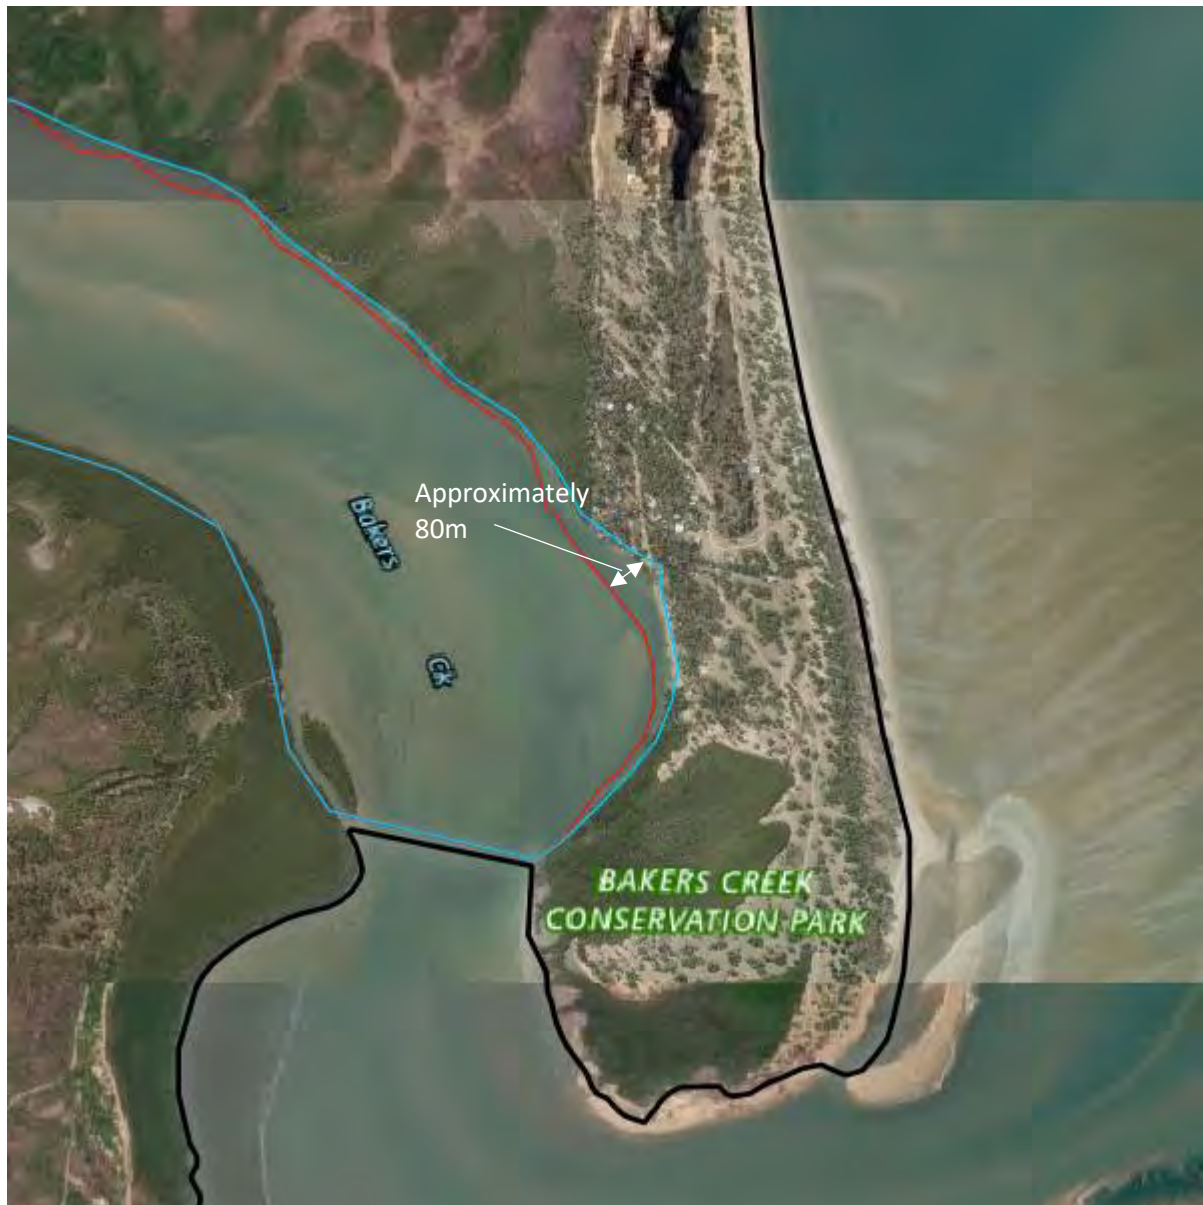
**Figure 91. Bakers Creek Conservation Park at risk of further erosion**
