## Reef Catchments Limited NRM

Carmila Creek Fish Barrier Remediation – Gauging Weir Fishway:

Monitoring Report for operational works permit 2501-44071 SDA

May 2026

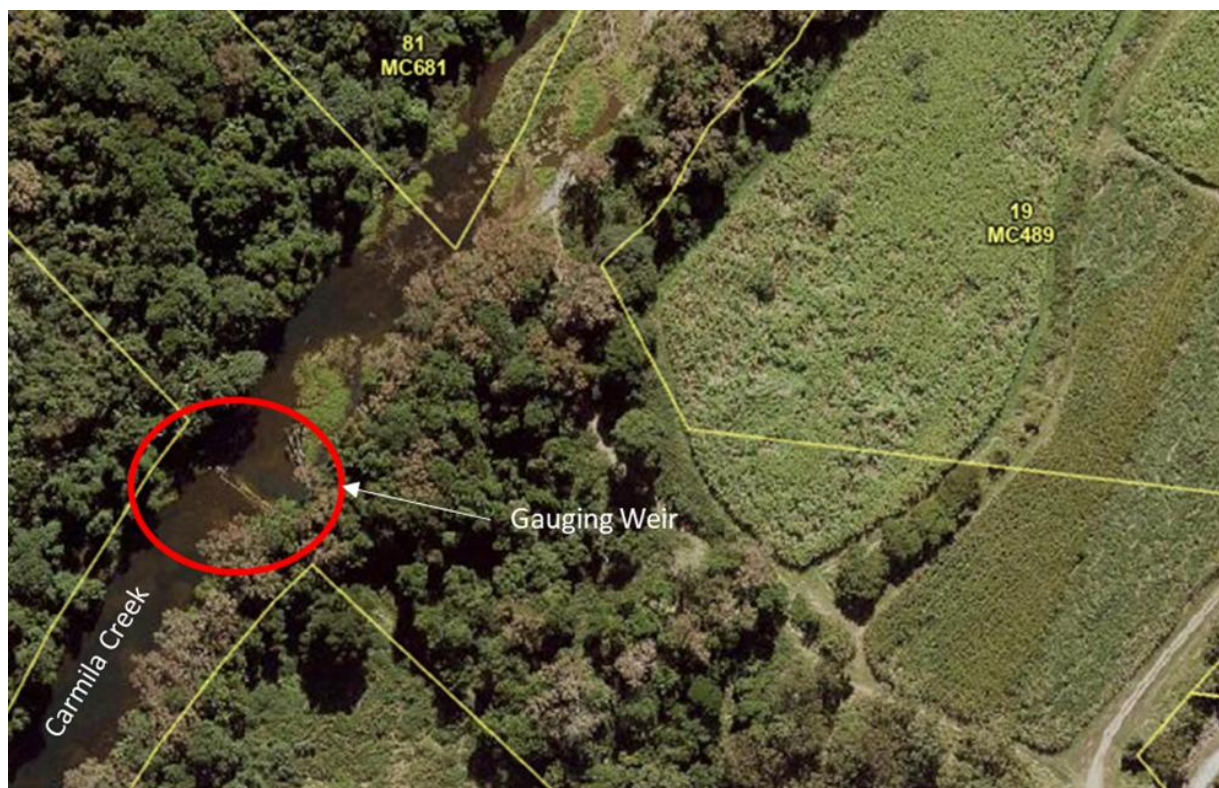
Figure 1. Location of Carmila Creek Gauging weir prior to the fishway construction.

Reef Catchments Limited (RCL) Natural Resource Management (NRM) are undertaking fish passage improvement work within the Mackay, Whitsunday and Isaac regions. This work includes multiple sites which require varying degrees of remediation to restore adequate connectivity. Carmila Creek Gauging weir (Figure 1) is used to capture stream flow data for water resource management. The gauging station is also used by the Bureau of Meteorology as a hydrological reference station. This station provides well-maintained river gauges of long, high quality streamflow records to estimate trends in long-term and seasonal water availability from climate variability and change.

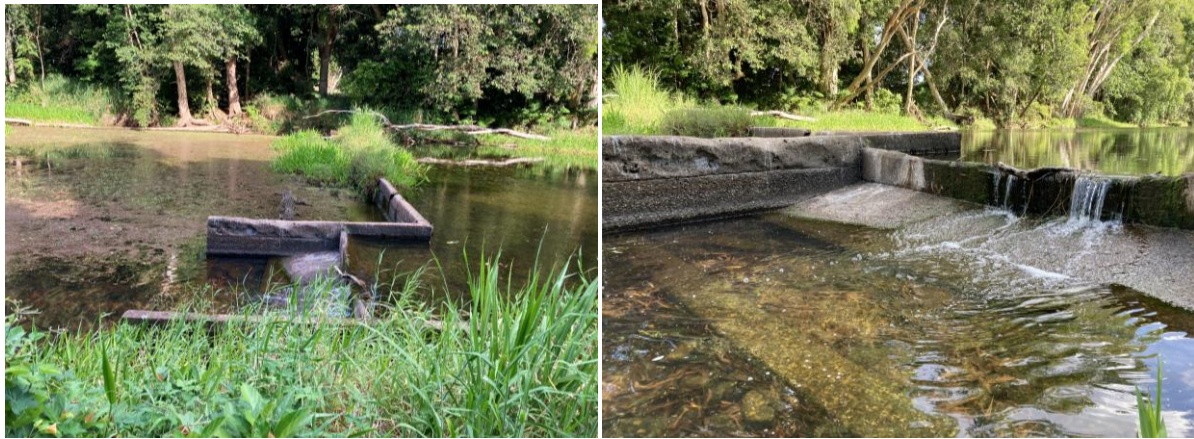
The arrangement of the weir (Figure 2) and its position within the catchment posed an impediment to fish movement within the catchment. Carmila Creek Gauging weir ranked 8<sup>th</sup> out of 9738 potential fish barriers within the region and was the highest ranked barrier within the catchment (Power et al 2021). RCL consulted with the Department of Local Government, Water and Volunteers (DLGWV) and gained support for undertaking fish passage remediation work on the weir. DLGWV advised the weir forms critical infrastructure and any remediation options must retain the function of the gauging weir.

Figure 2. Carmila Gauging Weir prior to the fishway construction.

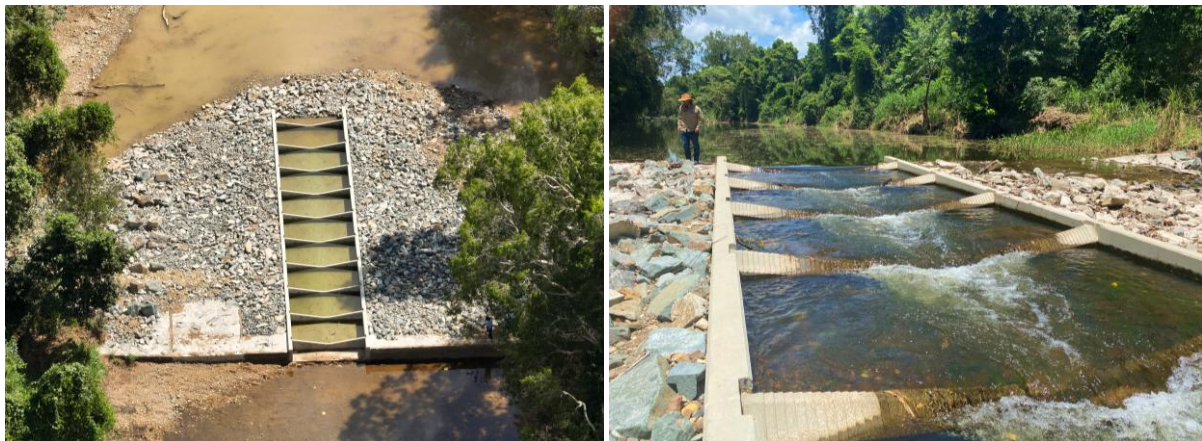
Figure 3. Overview of Carmila Gauging Weir fishway after completion prior to its first flow (left) and with the low flow trapezoidal ramp engage during a low flow (right).

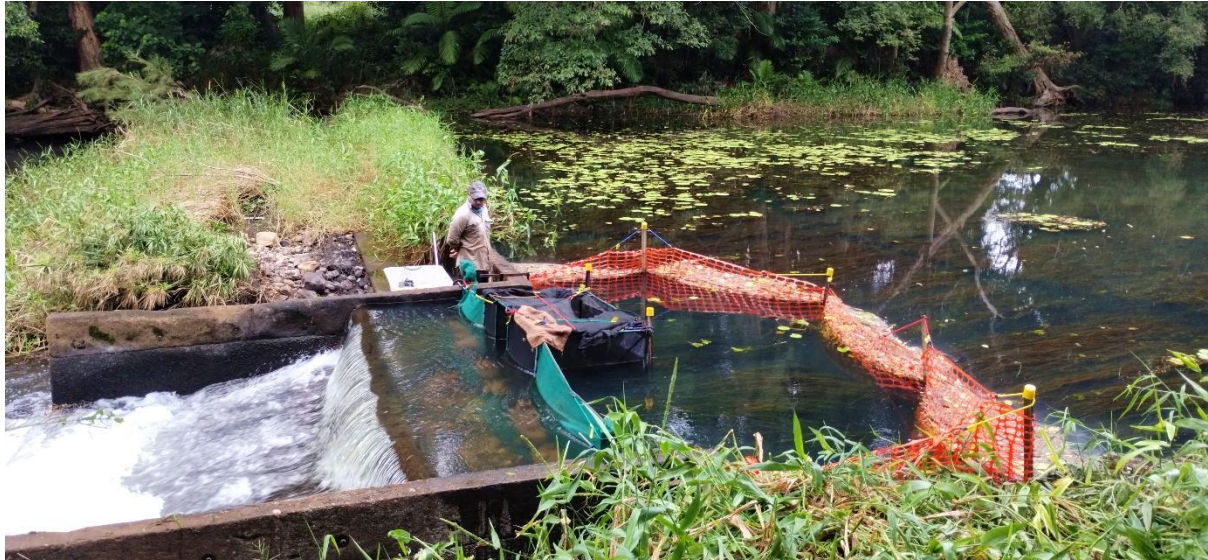
Barrier trapping was conducted pre- and post-construction. Pre-construction trapping was conducted in May 2025 (Figure 4) and post-construction trapping was conducted in March 2026 (Figure 5). Flow during pre-construction trapping was low with discharge at the weir confined to the existing V-notch spillway. Flow during the post construction trapping was moderate and some flow was passing over the graded scour protection on the northern bank. Trap setting was confined to the V-notch spillway during the pre-construction trapping. For the post-construction trapping, the trap was set in the low flow channel as well as the northern bank scour protection. On both occasions traps were only set at the top of the structure to capture fish which successfully ascended. Trapping focused on upstream movement of fish as small headloss barriers like Carmila Gauging Weir pose no impediment to downstream movement. Traps were set and checked multiple times per day to minimise stress and the potential of predation of fish within the traps.

Figure 4. Trapping Carmila Gauging Weir prior to construction of the fishway.

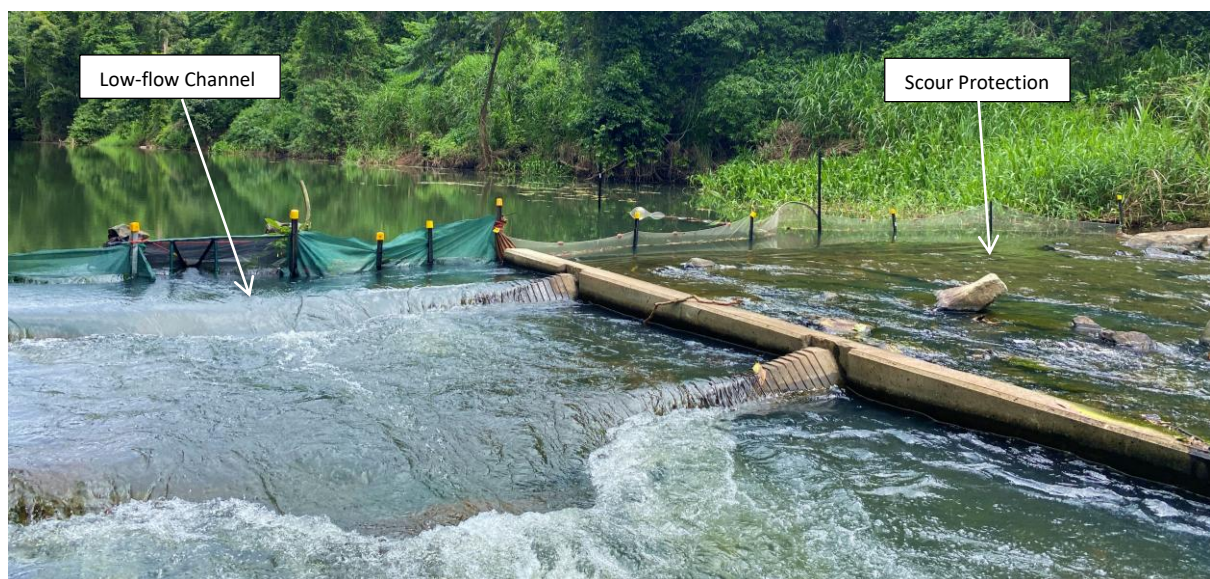
Trapping of the V-notch spillway and low-flow channel of the fishway utilised purpose-built traps. Traps were constructed from 10 mm round bar with shade cloth (4.0 mm mesh size) covering the frame. Shade cloth wing walls prevented fish from swimming around the traps on either side, whilst sandbags and star pickets were used to secure the traps and wing walls in place. The trap consisted of a single cone entrance, with dimensions of 1.4 m x 1.0 m x 1.1 m. Trapping of the graded scour protection utilised a double-winged fyke net. The Fyke net had a 1.2 m hoop entrance and a mesh size of 4.0 mm. Sandbags and star pickets were used to secure the fyke net in place.

Figure 5. Trapping of the low-flow channel and scour protection of the northern bank scour protection.

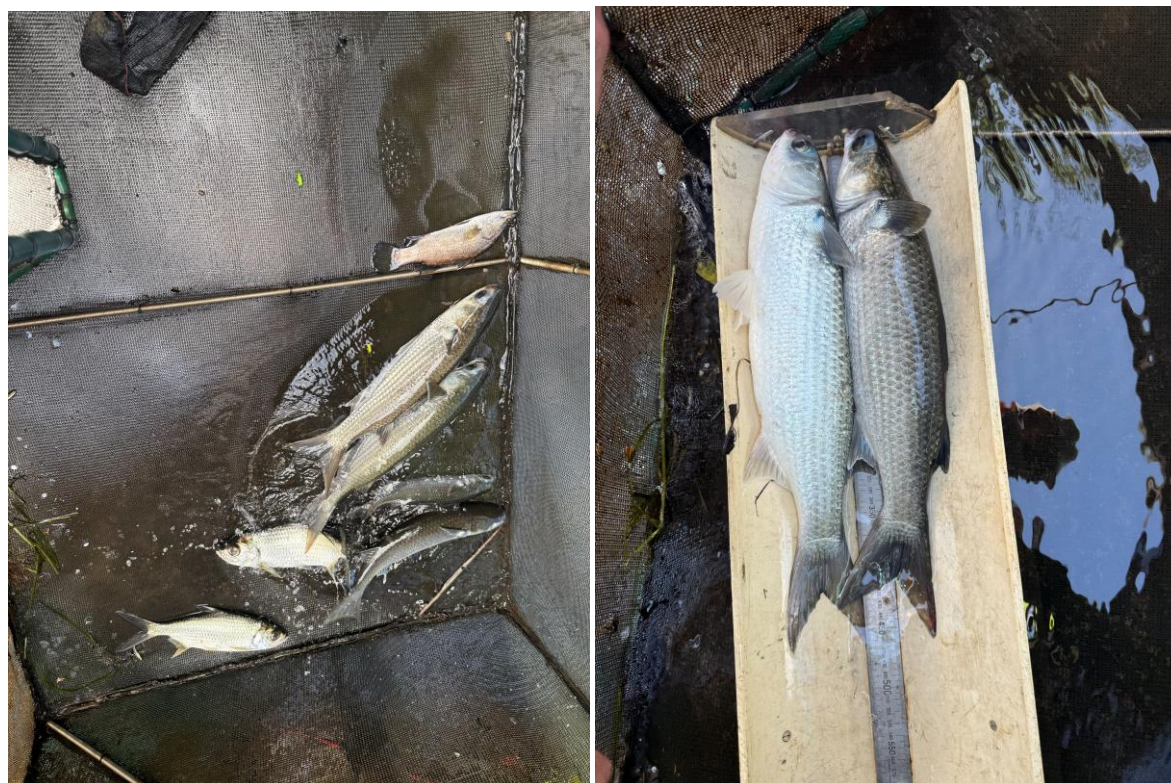
Figure 10. Examples of trap captures from the low-flow channel of the fishway.

Eleven species were captured during post-construction trapping operations, comprising all native species. Empire gudgeon were the most prevalent species representing 49.4% of the catch. Catch rates of empire gudgeon were notably higher through the scour protection (175.75 fish/day) compared to the low-flow channel (12.86 fish/day). Fly-specked hardyhead were the next most abundant species representing 39.2% of the catch. Catch rates of fly-specked hardyhead were also greater coming over the scour protection (124.92 fish/day) than through the low-flow channel (26.07 fish/day). The remaining species were captured in lower abundance (Table 2). Sea mullet were recorded moving through the low-flow channel and over the scour protection. Barramundi, tarpon, midgley's carp gudgeon and eastern rainbowfish were only recorded moving through the low-flow channel, while pacific blue-eye, spotted scat and mouth almighty were only recorded moving over the scour protection. Examples of trap set captures are provided in Figure 10.

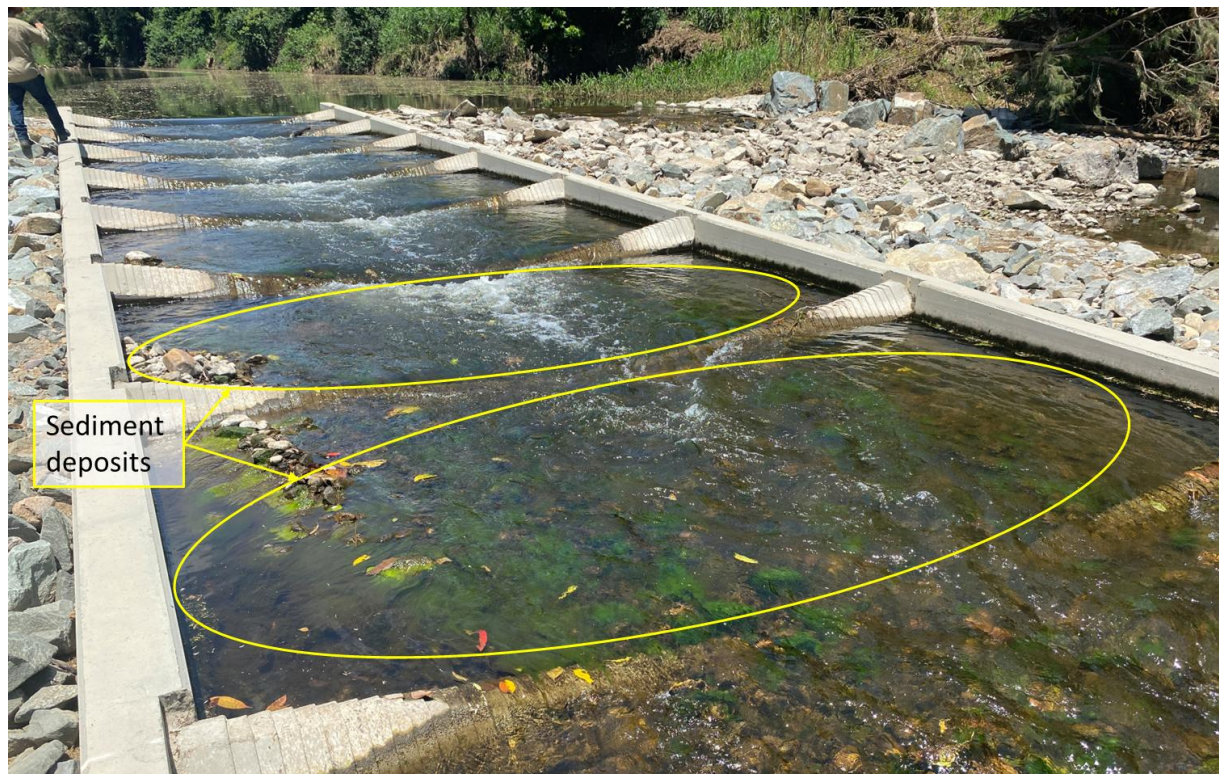
Of note, there was some deposition of gravel and cobble in the pools of the low-flow channel which resulted in some shallowing of the pools (Figure 14). The deposition of material in the bottom of the low-flow channel is to be expected in an alluvial system like Carmila Creek. This material is likely to vary in depth over time as it becomes resuspended. However, at the current level of deposition, it is not likely having a significant impact on the operation of the fishway.

**Figure 14. Sediment deposits within pools of the low flow channel at Carmila Gauging Weir fishway.**

Sediment deposition within the fishway should be monitored in accordance with the maintenance schedule. Where deposition levels are such that it prevents low flows from passing down the low-flow channel (i.e. it bypasses the fishway or spills out part the way down) it should be removed and reprofiled on the bank immediately downstream.
