## Wetland Walkabout Baseline Fish Community Assessment

**Reef Catchments Limited**

March 2025

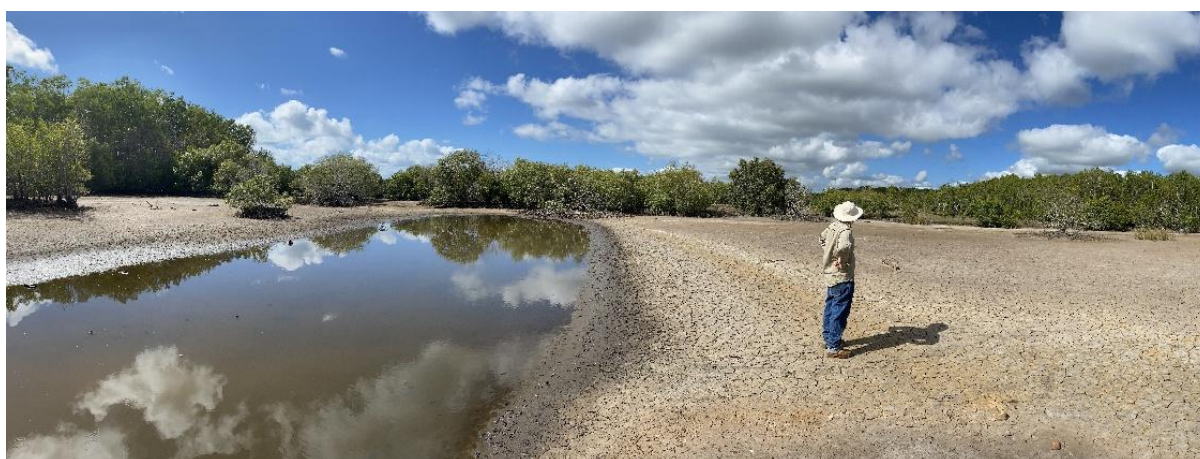
Figure 2. Showing Tidal Floodgate site.

The Tidal Floodgate site is located between a mangrove-dominated estuary (downstream) and a tidal salt pan (upstream) and is bounded by a constructed bund. When the floodgate is opened during high tidal periods, saltwater inundation recharges the salt pan, upper creek channels and constructed wetlands. During the sampling period only one shallow pool (0.2 – 0.3 m deep) remained (Figure 2). This pool was brackish and approximately 30 m (length) x 5 m (width). The pool was void of complex habitat and lacked shade. Turbidity was high.

Monitoring results at the Tidal Floodgate site showed fish community assemblages to be in poor condition, with low species diversity and abundance. Three of the four fish (Figure 6) recorded at this site, barramundi (*L. calcarifer*), milkfish (*C. chanos*), and spotted scat (*S. argus*) are diadromous species. Fish species belonging to the diadromous migration classification typically spawn in saltwater habitats before migrating upstream into lowland freshwater nursery areas such as Wetland Walkabout. They utilise brackish and lower freshwater wetlands as juveniles to feed, grow and evade predators before migrating downstream to saltwater habitats to spawn as adults. Facilitating unimpeded connectivity and maintaining good quality nursery habitats with complex in-stream logs, intact riparian corridors, shade and good water quality increases their chances of survival and completing their life-cycle.

It's recommended that wetland restoration works prioritise the construction of deep pool refugia and the addition of in-stream habitat such as logs with root balls. These restoration works will improve water quality and provide opportunities for fish to persist throughout the dry season. Adding in-stream habitats like logs with root balls helps improve food resources by providing areas for algae, small invertebrates, and fish. These structures also offer shelter for fish, helping them

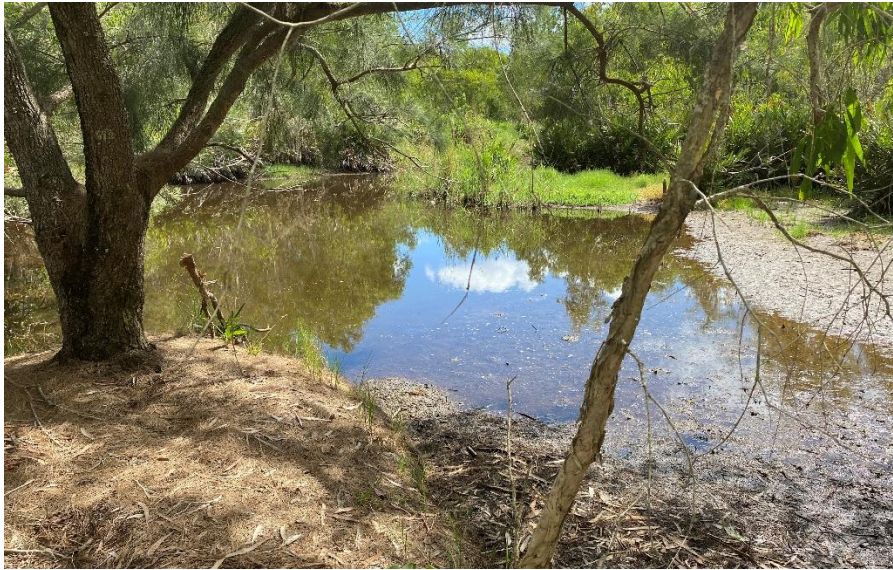
**Figure 3. Showing Timber Footbridge site**

The timber footbridge site is influenced by freshwater inflows emanating from upstream urban areas. The site is connected to the downstream Tidal Floodgate site during the wet season but only had a shallow (0.2 m deep) wetland pool remaining during the sampling period. This pool was approximately 20 m (length) x 10 m (width) (Figure 3). Riparian vegetation was in moderate condition, dominated by mangrove fern, melaleuca, casuarina species and invasive floating aquatic weed; *Salvinia molesta*. In-stream habitat was in poor condition with minimal native macrophytes and complex wood habitat. The substrate was comprised of dead and decomposing organic matter.

Monitoring results revealed the wetlands fish community assemblages to be in poor condition, with low species diversity and abundance. No fish were recorded at the Timber Footbridge site. pH readings at this site were extremely low (2.86), and water depth very shallow (0.3 m deep). The lack of fish at this site is likely due to insufficient water depth and lack of permanent refugia. It is possible that the pooled water at this site during the study was from localised rainfall and not from stream flows. These stream flows provide connectivity with downstream permanent wetlands, allowing fish the opportunity to migrate upstream into new habitats. Additionally, the shallow nature (0.3 m) of this site, combined with high evaporation rates experienced in the tropics, may have resulted in this wetland habitat completely drying out (prior to rainfall filling it up, but not enough to re-connect with permanent downstream habitats), and any fish that accessed this habitat during the previous wet season perishing. Priority wetland restoration works at this site include construction of deep pool refugia to increase survival rates.

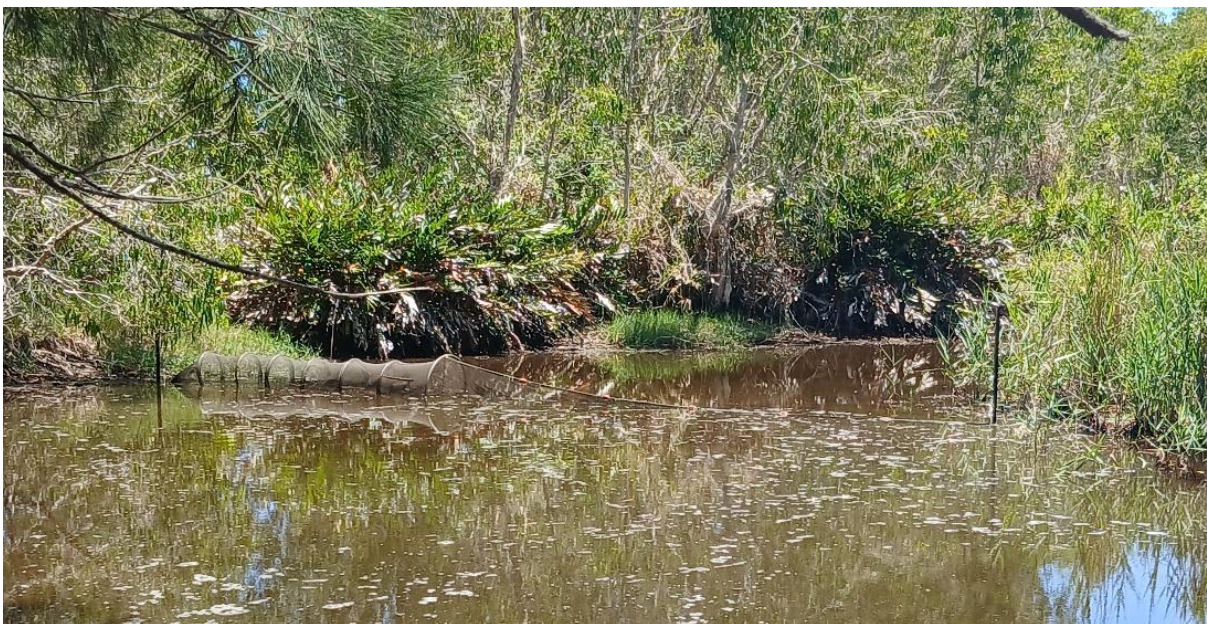
A single fyke net was employed at each site consisting of a single 5m wall configuration, with 600mm hoops and 4 mm mesh. The cod end of each fyke net was raised and held above the water surface by a star picket. A small surface float was placed inside the fyke net to ensure any air breathing animals did not drown if they were inadvertently trapped in the net. At both sites, a single fyke net was set perpendicular to the shore to direct and capture fish into the funnel-shaped opening. The net was anchored to the ground with a star picket. The fyke net was set in the day and left overnight, before being checked and emptied the following day.

**Figure 4. Showing fyke net sampling at the Timber Footbridge site**

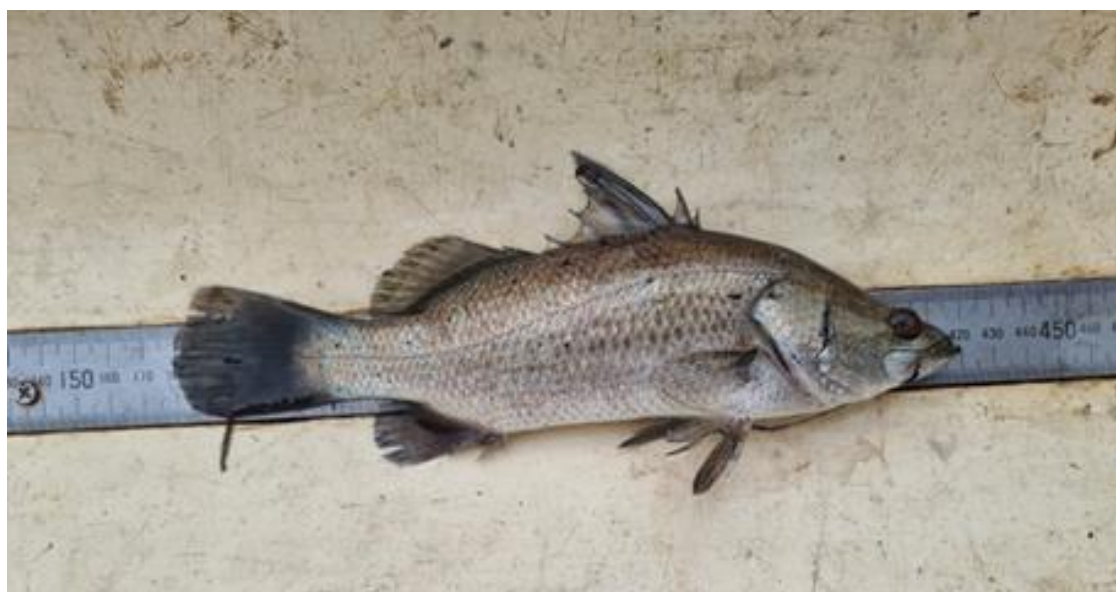
A total of 16 individual fish (Table 2), were recorded at the Tidal Floodgate site across the four fish species. Three of the captured species were classified as diadromous and in the juvenile stages of their lifecycle, while one species, Unknown goby species (*Gobiidae sp.*) is classified as marine and was a mature adult at 35 mm fork length (FL). A single juvenile barramundi (*Lates calcarifer*) was the largest fish species recorded, measuring 230 mm FL (Figure 5).

**Figure 5. Juvenile barramundi recorded at the Tidal Floodgate site during the pre-restoration works survey**

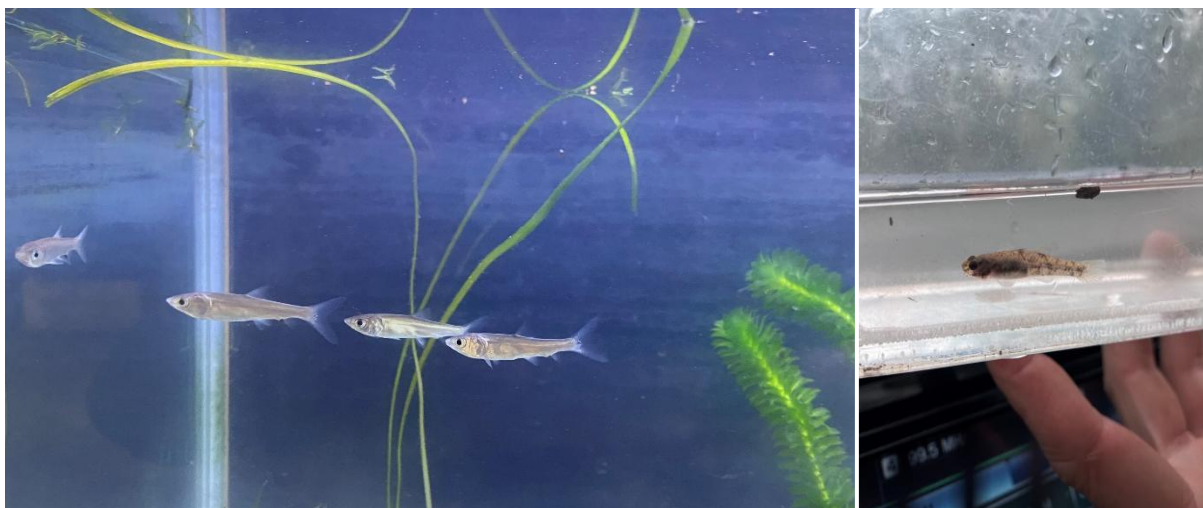
**Figure 6. Fish recorded during the survey; juvenile milkfish (left), unknown goby species (right).**
