FIND  
YOUR  
SOLUTION.

## Wetland Walkabout: Post-restoration Fish Community Monitoring Report

May 2026

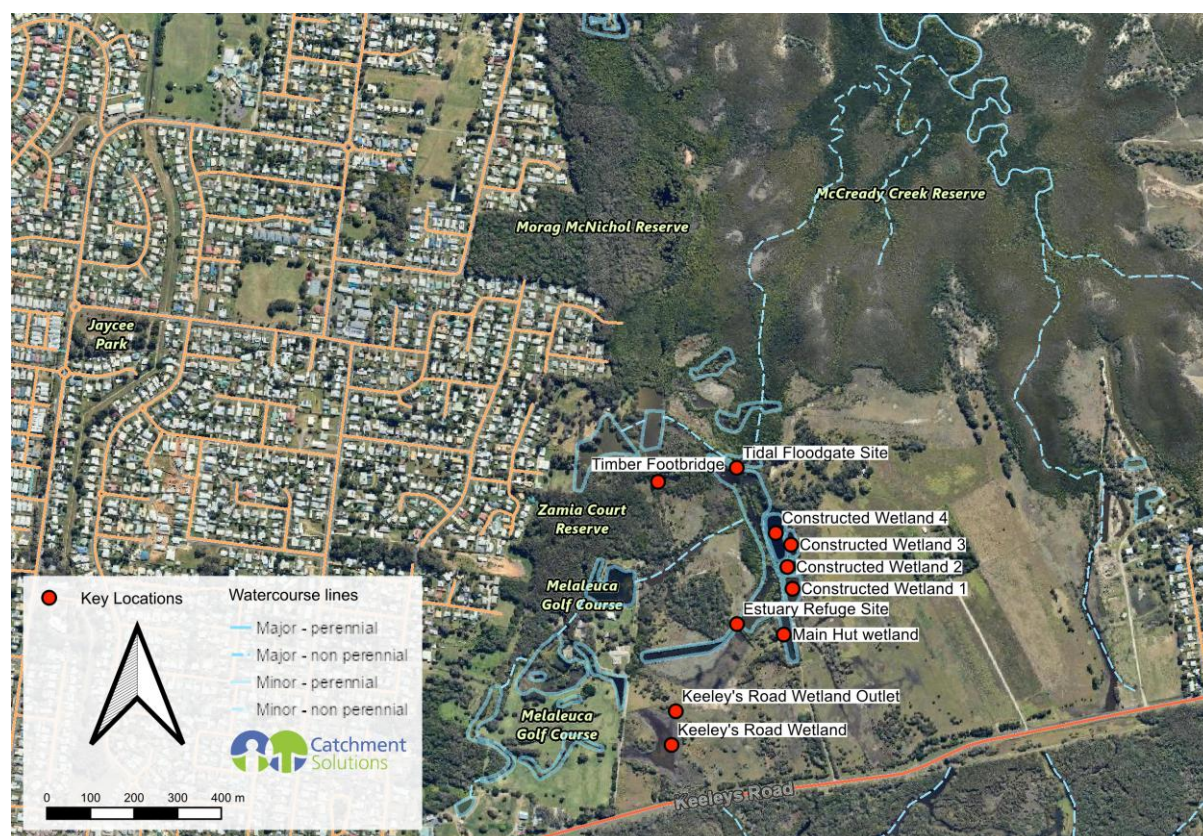
**Figure 1: Map of the Wetland Walkabout complex and surrounds. Key locations include the existing wetlands (constructed) and pre/post fish community assessment sites.**

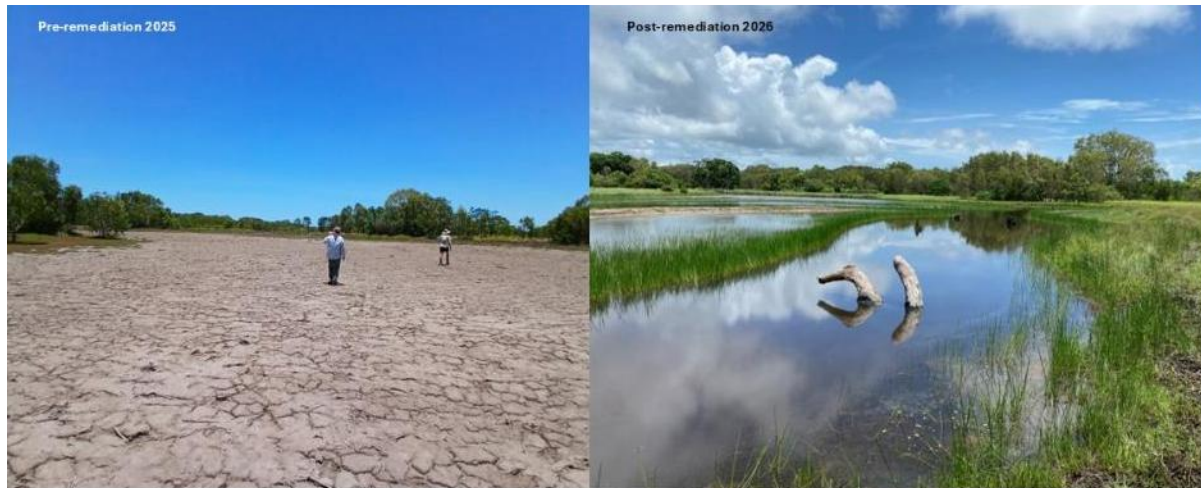
**Figure 2: Keeley's Road Wetland during preliminary monitoring 2024 (left); Keeley's Road Wetland post-restoration 2026 (right).**

Keeley's Road forms a hydraulic and physical boundary between the site and the upstream extent of the Vines Creek Melaleuca swamp, a freshwater forested wetland (Moore et al 2007). Restoration works to improve habitat quality and condition were undertaken in December 2025. Restoration works included the provision of refugia and the installation of hardwood habitat logs. Refuge habitats were provided to prevent aquatic fauna from perishing every year at the site due to its modified shallow nature, which caused the wetlands to evaporate (Figure 2).

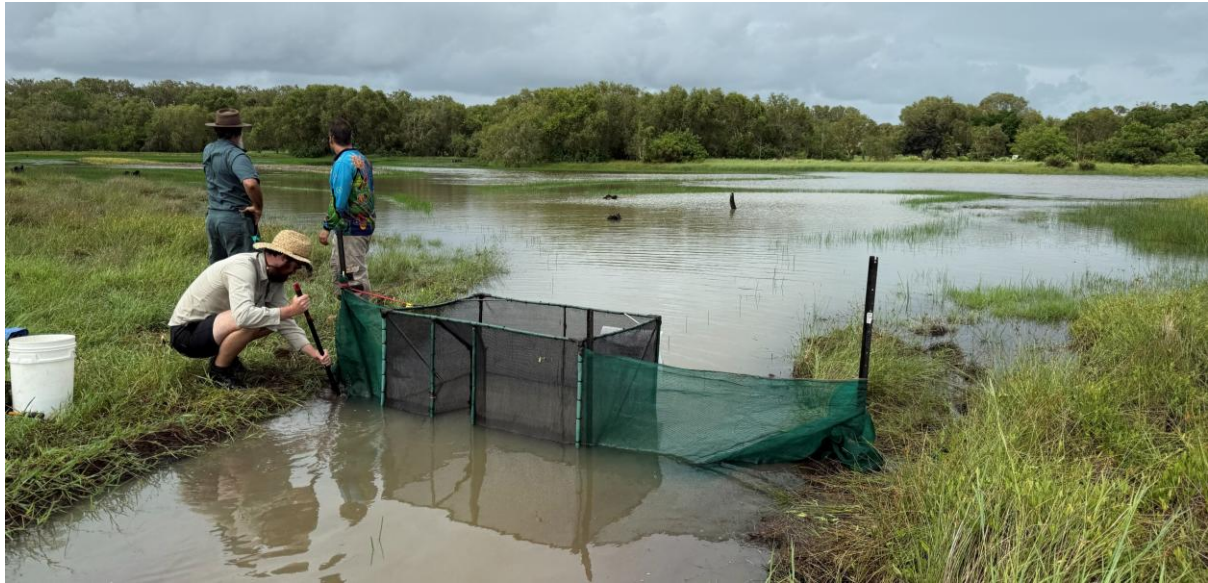
Box trapping utilised purpose-built traps (Figure 3). Traps were constructed from 10 mm round bar with shade cloth (4.0 mm mesh size) covering the frame. Shade cloth wing walls prevented fish from swimming around the trap on either side, whilst sandbags and star pickets were used to secure the trap and wing walls in place. The trap consisted of a single cone entrance, with dimensions of 1.2 m x 1.2 m x 0.8 m.

**Figure 3. Showing box trap set-up.**

The trap was set at the outlet channel of the 'Keeley's Road Wetland' and checked multiple times per day to minimise stress, potential predation, and escape of fish from within the trap.

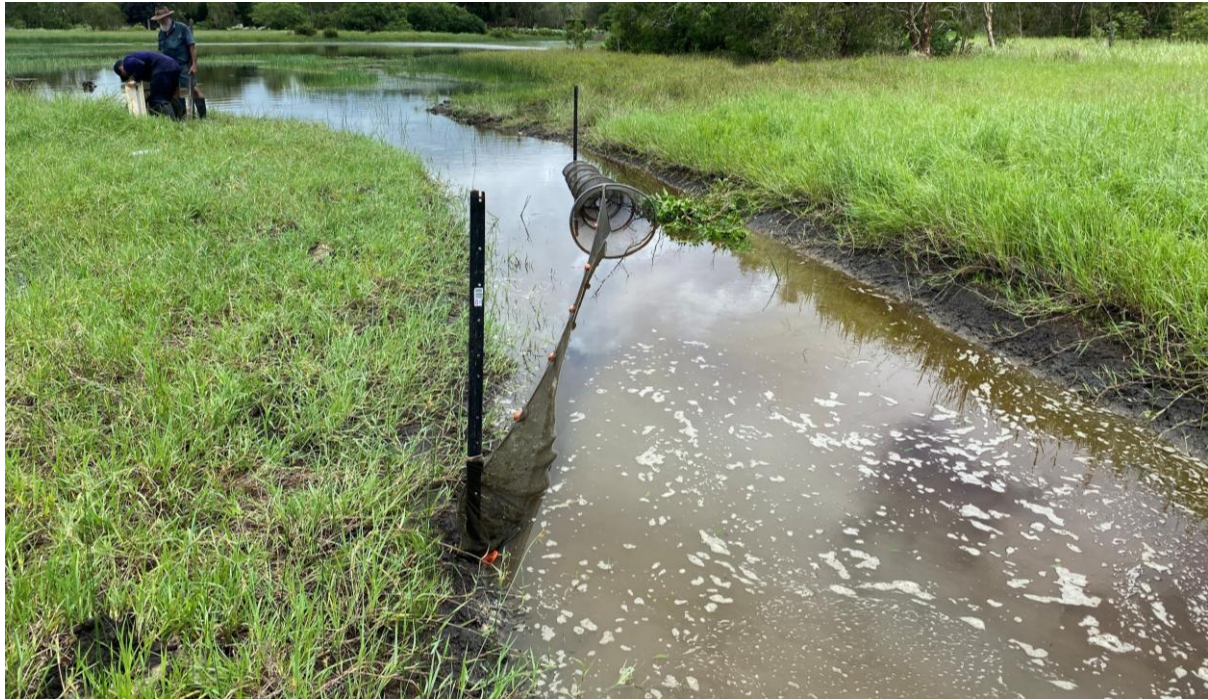
A single fyke net was employed at each site consisting of a single 5m wall configuration, with 600mm hoops and 4 mm mesh (Figure 4). The cod end of each fyke net was raised and held above the water surface by a star picket. A small surface float was placed inside the fyke net to ensure any air breathing animals did not drown if they were inadvertently trapped in the net. At both sites, a single fyke net was set perpendicular to the shore to direct fish into the funnel-shaped opening. The net was anchored to the ground with a star picket. The fyke net was set in the day and left overnight, before being checked and emptied the following day.

**Figure 4. Showing Fyke net set up to monitor wetland fish communities.**

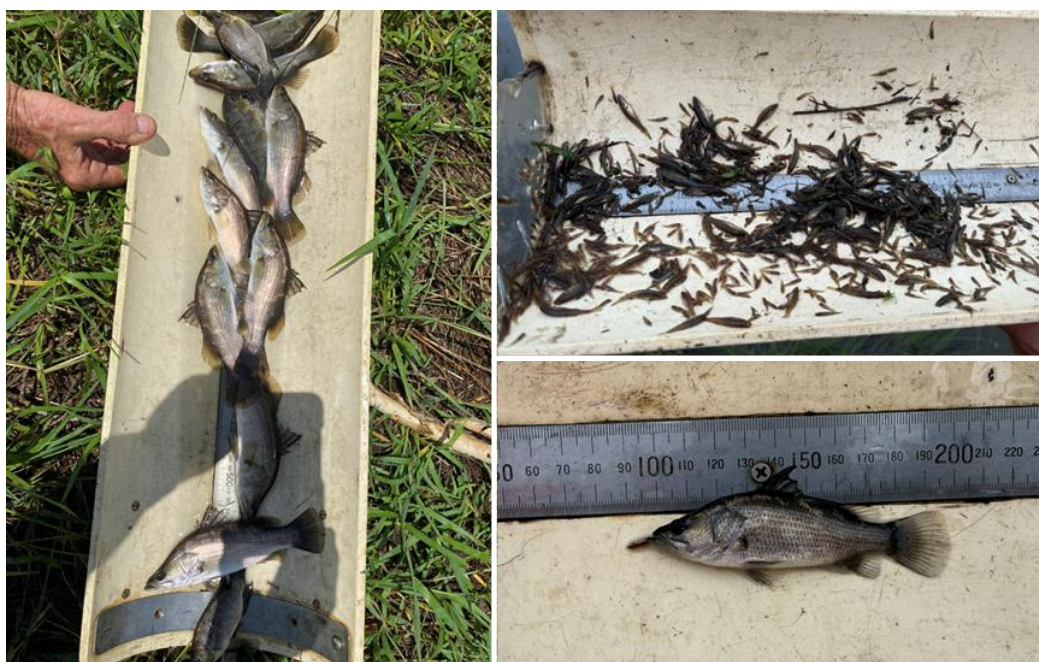
Barramundi were recorded entering Keeley's Road Wetland and residing in the wetland. Barramundi are a diadromous species that migrate between marine and freshwater environments during their life-cycle, with adults moving downstream between November and February to spawn in the lower reaches of river and creek systems. Young or juvenile barramundi typically migrate upstream to freshwater or low-salinity habitats, such as wetlands, during their first wet-season at around 3-6 months of age (Munpholsri et al 2025). Wet-season flows provide floodplain connectivity and act as environmental cues that facilitate the upstream movement during early life stages (Munpholsri et al 2025). Wetlands provide important nursery habitat for juvenile barramundi, supporting high productivity and offering refuge from predation. Not all individuals adopt this life-history strategy, but those that enter freshwater habitats often exhibit faster growth rates and earlier maturation than individuals remaining in marine environments (Munpholsri et al 2025). The size ranges of barramundi recorded during the assessment are consistent with young-of-the-year or early juvenile barramundi. This indicates that the restored wetland is being utilised by early life stages and suggests active recruitment and use of the wetland as nursery or growth habitat following restoration.

Figure 7. Showing juvenile barramundi recorded in restored wetlands (left & bottom right), and juvenile empire gudgeon recorded migrating into wetlands (top right)

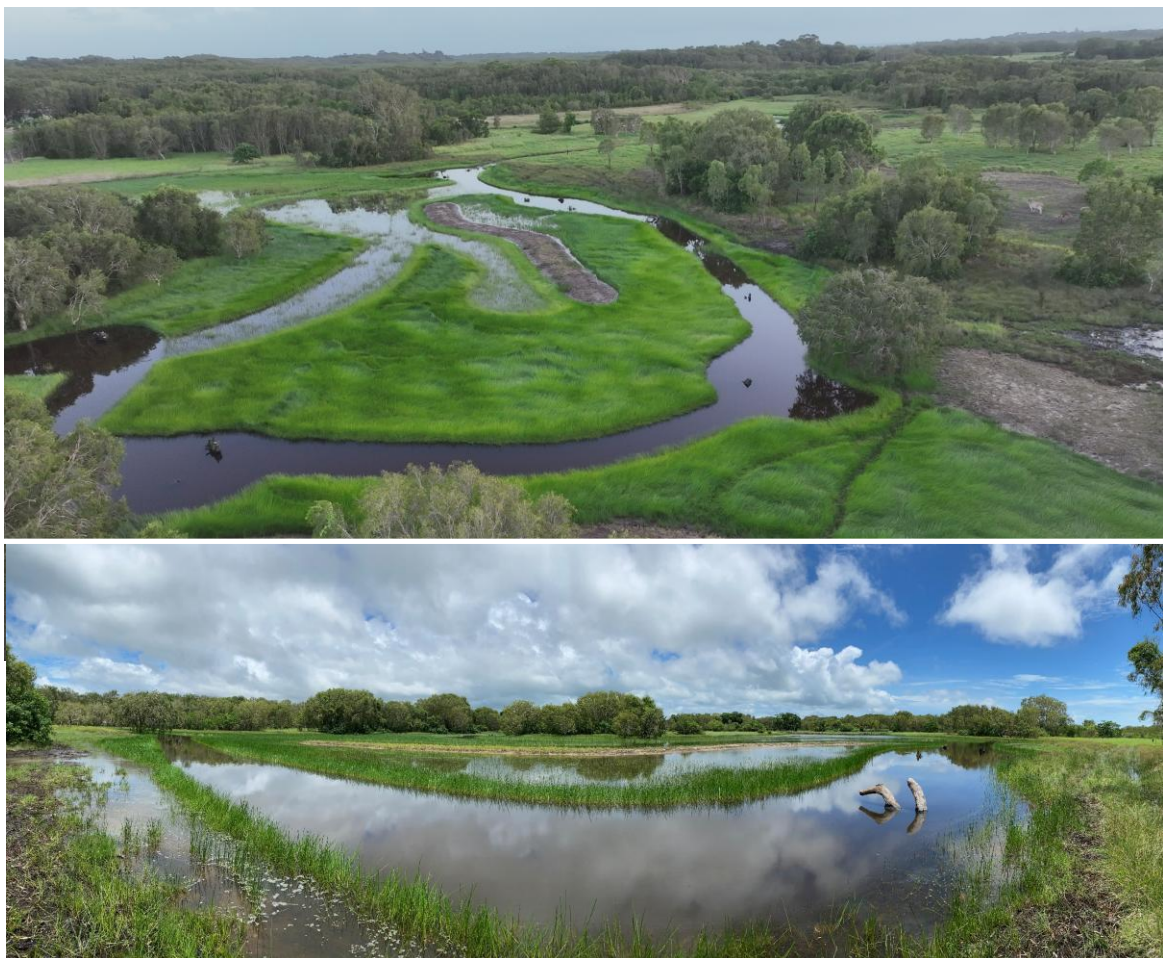
Aquatic flora at Keeley's Road Wetland is establishing following restoration. Macrophytes, including reeds and sedges, have densely colonised the shallow margins and edges of the wetland, while other native species were observed in deeper areas.

**Figure 8. Top and bottom; Showing restored wetland with hardwood habitat logs**
