## Reef Catchments – Rubble to Reef Monitoring Report

Post-Deployment - Round 2 and 3

August 2026

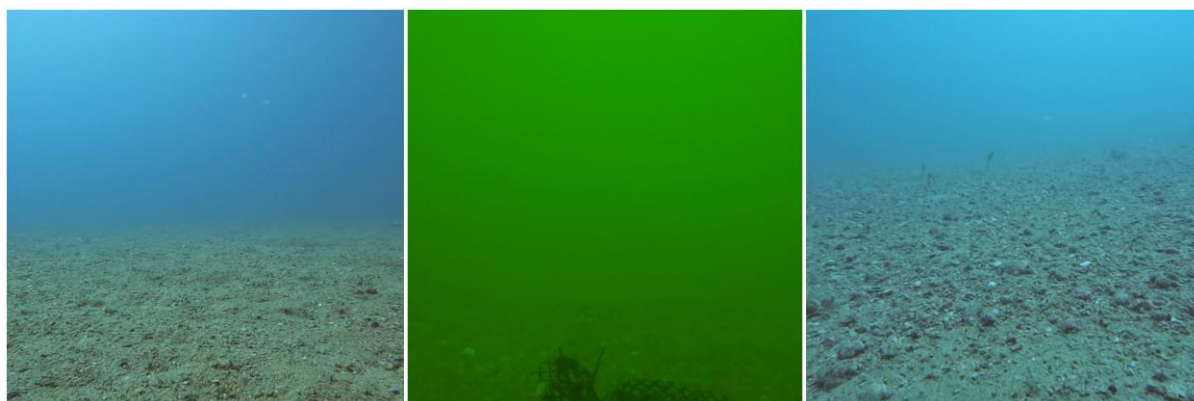
Underwater visibility varied considerably between each round and appeared to influence the observed fish assemblage metrics (Figure 12). Round 1 had the most favourable underwater visibility and recorded the highest fish abundance and fish species richness. In contrast, Round 2 experienced the poorest visibility and recorded substantially lower richness and abundance at both sites. Improved visibility during Round 3 coincided with a recovery in these metrics, but not to levels observed in Round 1. Therefore, it is likely that the poorer underwater visibility observed in the current monitoring period reduced the detectability and identification of fish during sampling, possibly resulting in lower recorded species richness and abundance.

**Figure 12: Typical footage recorded from BRUVs in post-deployment monitoring Round 1, 2, and 3 (left to right).**
