## Mackay Coasts and Communities

# **Bucasia Beach**

**Beach Plan**

2010

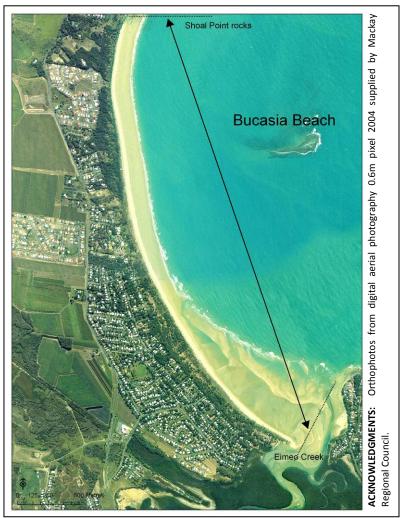
Figure 1: Extent of Bucasia Beach unit

Bucasia Beach stretches for approximately four kilometres from the Shoal Point rocks south to Eimeo Creek (Figure 1). The beach is backed by a wide foreshore along its length, and vegetated parabolic dunes in the north.

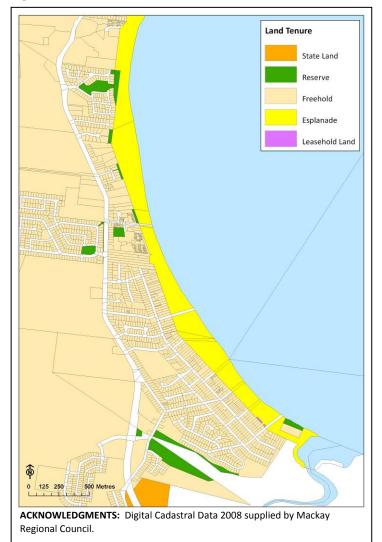
Figure 2: Land tenure Bucasia Beach

Bucasia is a growing population centre, with large areas of Freehold, Urban Residential development and additional areas zoned for Urban Expansion and High Density Residential (Figures 2, 3). With the exception of a privately owned caravan park at the southern extent of the beach, the foreshore is tenured as Esplanade under the management of the Mackay Regional Council and zoned Open Space. The second zoned tourism activity in the centre of the beach unit is the Kohuna Sands Resort. A small amount of State Land borders the mangrove communities at the mouth of Eimeo Creek.

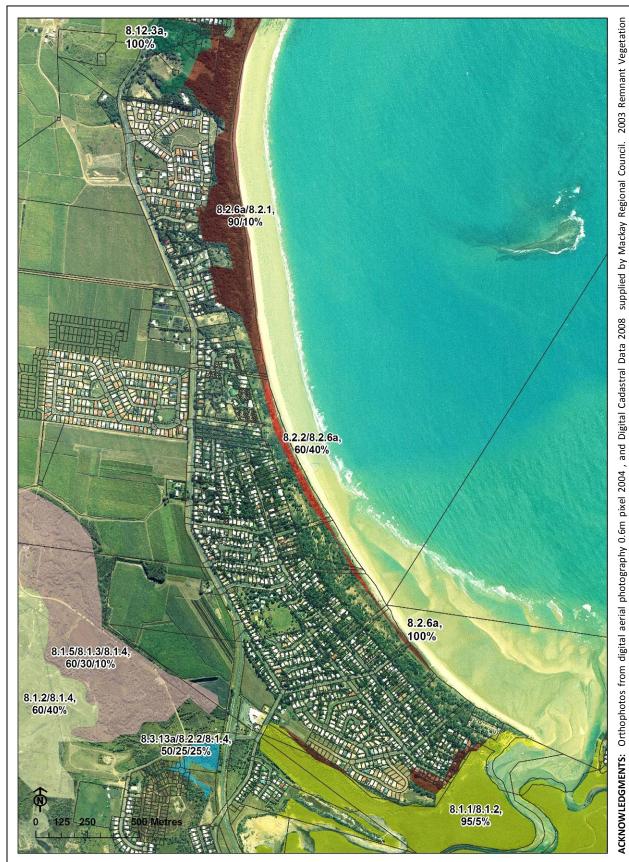
Figure 4: Remnant vegetation Bucasia Beach

The northern end of Bucasia Beach Esplanade (north of Homestead Bay Avenue access) retains the majority of its remnant vegetation and will be a key area to maintain. This community is a mix of eucalypt and acacia open forest with beach scrub understorey, and open casuarina forest with spinifex and other grasses on the foredunes (Table 1, Figure 4). Both of these Regional Ecosystems are listed as 'Of Concern' by state legislation (*Vegetation Management Act, 2005*). Weed invasion, extension of residential lawns and gardens across Esplanade tenure, and illegal removal of native vegetation in some areas is reducing the condition of this remnant vegetation.

South of the Homestead Bay Avenue access, only a very narrow band of remnant vegetation remains on the Esplanade. Approximately two hectares of this is recorded as microphyll vine forest on coastal dunes (RE 8.2.2, 'beach scrub'), which is listed as 'Critically Endangered' by federal legislation (*Environment Protection and Biodiversity Conservation Act, 1999*). Revegetating a buffer zone around this community would potentially allow this ecosystem to be maintained and expanded. Documented threats to beach scrub communities include inappropriate fire regimes, weed invasion, impacts of coastal development and recreational use (Ecosystem Conservation Branch, 2007).

At the southern extent of the beach unit, approximately 30 hectares of mangrove and samphire forbland communities border Eimeo Creek. The quantity and quality of storm water entering the system from the catchment as residential development increases will be important for mangrove health into the future.

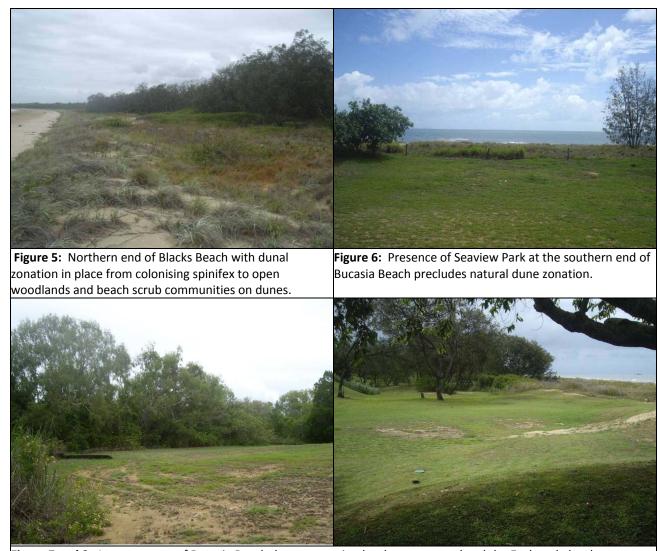
**Figure 7 and 8:** In some areas of Bucasia Beach dune vegetation has been removed and the Esplanade has become an extension of neighbouring properties, removing and preventing natural dune zonation.

In some areas of Bucasia Beach, residential lawns and gardens have been extended onto the Esplanade and native vegetation has been removed (Figures 7, 8). This process removes natural dune zonation and threatens the resilience of the dunes into the future.

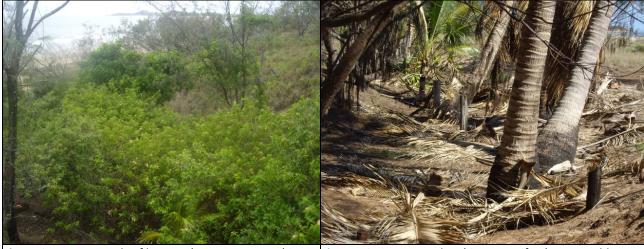
Figure 9: Dense stands of lantana (Lantana camara) in remnant vegetation at the northern end of Bucasia Beach threaten to out-compete native vegetation and increase the threat of fire.

Figure 10: Coconut palms (Cocos nucifera) pose problems with the risk of falling coconuts and fronds, and fronds which don't readily decay preventing regeneration by native species.

Throughout much of the Bucasia Beach Esplanade Guinea grass (Megathyrsus maximus) and lantana (Lantana camara) pose an environmental threat, outcompeting native vegetation and providing a fire risk to adjacent fire sensitive remnant vegetation communities (Figure 9). Additional declared weeds (Land Protection Pest and Stock Route Management Act, 2002) are also present along the length of the beach including prickly pear (Opuntia sp.) and singapore daisy (Sphagneticola trilobata). Garden escapees are concentrated along access ways and the western margin of the Esplanade, bordering residential communities. The accumulation of vegetative waste from dense stands of coconut palms (Cocos nucifera) on the Esplanade smother native vegetation and prevent regeneration (Figure 10).

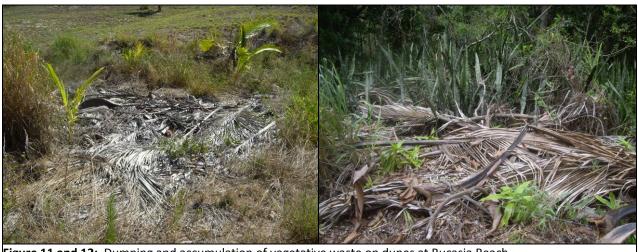
Figure 11 and 12: Dumping and accumulation of vegetative waste on dunes at Bucasia Beach.

Vegetative waste is present on dunes at Bucasia Beach, particularly where there are adjacent residential areas (Figures 11, 12). This leads to the smothering of native vegetation and spreading of non-native species.

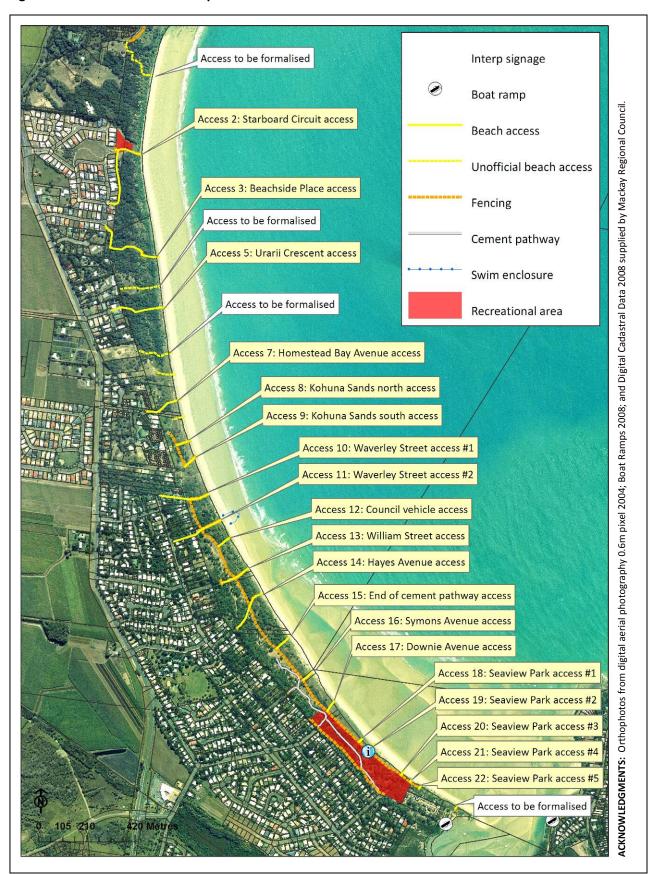
Figure 15: Bucasia Beach access points and recreational areas

There are currently 19 designated beach access points provided with fencing and associated infrastructure along Bucasia Beach (Figure 13, 15). These lead from Seaview Park and/ or connect with key residential areas along the length of the beach. Many unofficial access tracks have also been created from private housing along the length of the beach (Figure 14). The formalisation and fencing of access points associated with new residential developments in the north, and the boat ramp in the south, are required to protect dune systems.

- Formalise three pedestrian beach access paths. Three currently unofficial tracks (one from Belangason Way; one equidistant between Homestead Bay Ave and Urarii Crescent; and one in between current access tracks marked as 2 and 3) to be made official to join with Esplanade fencing proposed (Figure 15). Formalising these tracks includes associated activities such as fencing a defined track to direct pedestrians and exclude vehicles, and rehabilitation of coastal vegetation adjacent to the paths.

Rehabilitation/ revegetation of frontal dunes on Bucasia Spit adjacent to boat ramp.
- Fencing and beach access paths. Fencing from southern extent of Reserve tenure to continue to Spit and border car parking area. Fencing will delineate Reserve/ Esplanade boundary, prevent encroachment from Freehold tenure, restrict vehicle access, and direct pedestrians to official beach access paths. Unofficial beach access from car park to beach front to be formalised with fencing to direct pedestrians (Figure 15).

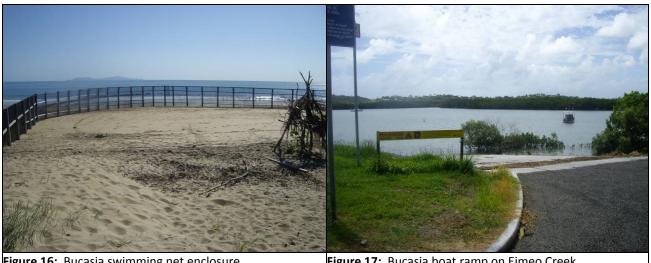
Figure 16: Bucasia swimming net enclosure.

Figure 17: Bucasia boat ramp on Eimeo Creek.

There is a swimming enclosure net associated with Waverley Street access (Figure 15, 16), and a Council managed boat ramp is provided at the southern end of the beach unit on Eimeo Creek (Figure 17).

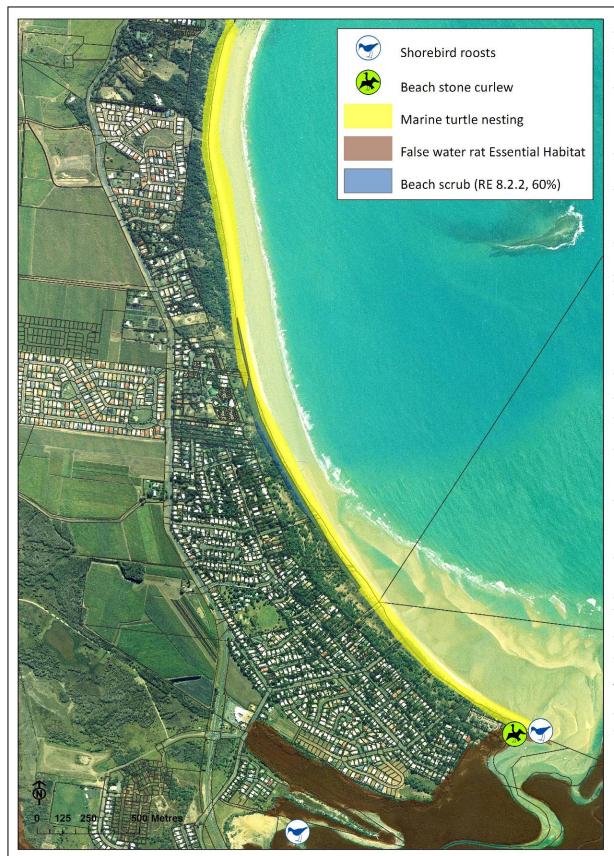
Figure 18: Wildlife values Bucasia Beach

The southern end of Bucasia Beach, including the complex of sandbanks and adjacent foreshore, is identified as an intertidal roost for shorebirds in the Mackay region and disturbance via boating and pedestrian traffic impact on shorebird roostings at this site (Milton, 2009). Waders are also recorded to use the Bucasia saltplan on the upper reaches of Eimeo Creek at high spring and king tides. No major threats have been recorded in this site and disturbance is negligible (Milton, 2009). Sightings of the vulnerable beach stone curlew (Esacus magnirostris) were recorded at Bucasia Eimeo Creek mouth in 2000 and 2004 (Andrews, M. 2009, pers. comm., 2 July).

Essential Habitat mapping for the false water rat (Xeromys myoides) covers the mangroves adjacent to Eimeo Creek at the southern end of Bucasia Beach. The quantity and quality of storm water entering the system at this point will be of relevance to the health of the false water rat population. Although no other Essential Habitat mapping is currently available, beach scrub ecosystems are considered to provide habitat for the listed northern quoll (Dasyurus hallucatus), rusty monitor (Varanus semiremex), and coastal sheathtail bat (Taphozous australis). Bucasia Esplanade has approximately 2 ha of beach scrub vegetation (Figure 18). The condition of these communities is threatened by inappropriate fire regimes, weed invasion, and the impacts of coastal development and recreational use.

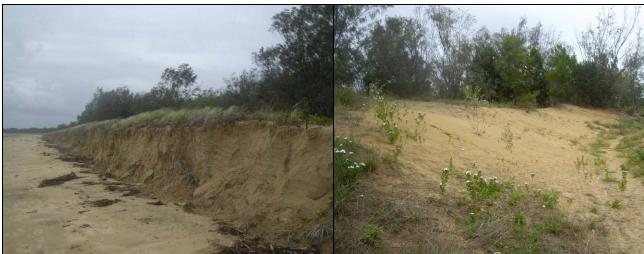
**Figure 19:** The existence of wide buffer zones at Bucasia Beach enables resilience against natural events such as king tides.

**Figure 20:** The removal of native vegetation has opened up bare patches of sand which are more susceptible to wind erosion and invasion by non-native species.

There are localised examples of erosion along Bucasia Beach owing to inappropriate access through the dunes. This opens up bare patches of sand, leaving them vulnerable to erosion processes and encourages the growth of non-native vegetation (Figures 20, 21, 22).

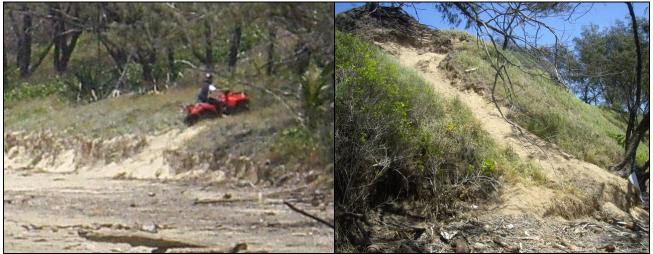
**Figure 21 and 22:** Localised erosion occurs from unofficial access, particularly in the steeper dunes at the northern end of Bucasia Beach.

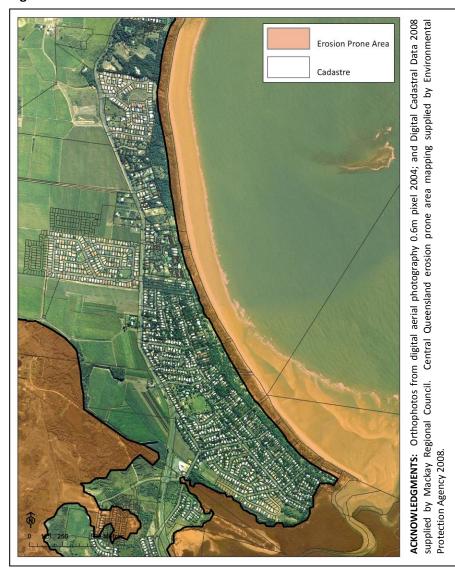
Figure 23: Erosion Prone Area Bucasia Beach

Development has been excluded from the erosion prone area along the Bucasia Beach unit with the exception of the caravan park at the southern end, now to become 'Bucasia Beach Resort and Spa' (Figure 23). The retention and maintenance of this wide buffer zone will ensure that there are minimal coastal management concerns into the future (Figure 19). In its assessment of future erosion issues at Bucasia beach, the Mackay Coast Study (Environmental Protection Agency, 2004) noted that "The caravan park is at risk of inundation from storm tide due to its proximity to the creek entrance. It is recommended that no increase in the density of development be permitted in this area".

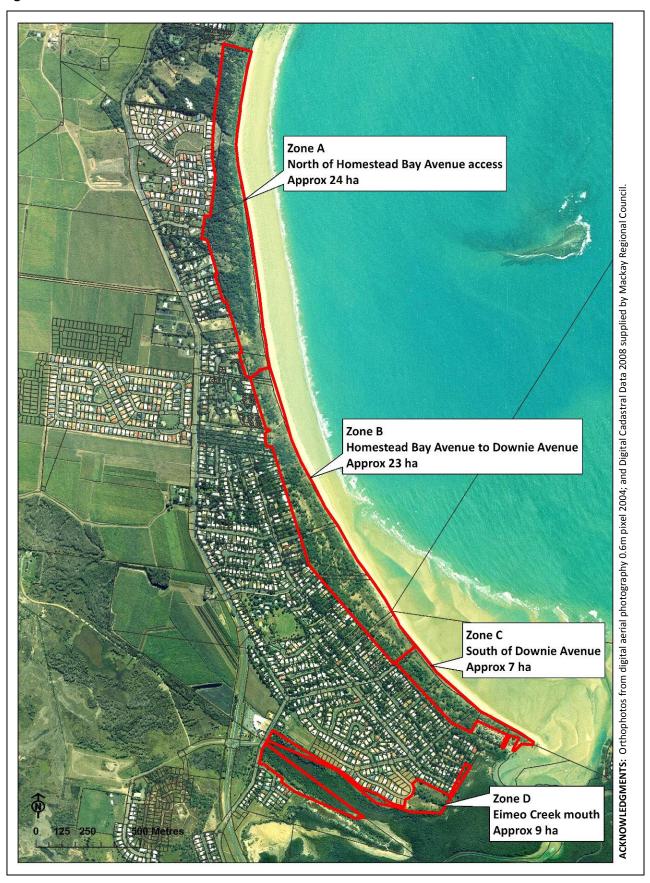
Figure 25: Zones for recommended activities Bucasia Beach

- Weed control, revegetation, remove waste dumping, remove private gardens and infrastructure. Major target weed species include lantana (*Lantana camara*), Guinea grass (*Megathyrsus maximus*), prickly pear (*Opuntia sp.*). Revegetation to replace removed weed species, and support frontal dune. Revegetation of bare patches currently being mown by residential areas. Remove vegetative waste dumped on dunes. Maintenance and expansion of mapped remnant vegetation. Limited revegetation and amenity plantings around margins of Nautilus Park.

- Weed control, revegetation, remove waste dumping, remove private gardens and infrastructure. Major target weed species include lantana, Guinea grass, prickly pear, garden escapees. Revegetation to replace removed weed species, and support frontal dune, particularly on foredunes to the east of current fenceline. Revegetation of bare patches currently being mown by residential areas. Remove vegetative waste dumped on dunes. To the west of current fenceline, restrict slashing and mowing activity to allow natural regeneration of shrub layer and support with revegetation if necessary. Slashing to continue to a minimal width along either side of the current cement pathway. Drainage line on western side of reserve to be kept clear.

Weed control, revegetation, remove waste dumping. Major target weed species include lantana and Guinea grass, particularly around the margins of the existing remnant vegetation. Revegetation to replace removed weed species and provide a buffer zone to the existing remnant vegetation. Remove garden waste and maintain storm water retention basin to ensure optimal operation.
