June 2020

# Fish ladder monitoring update

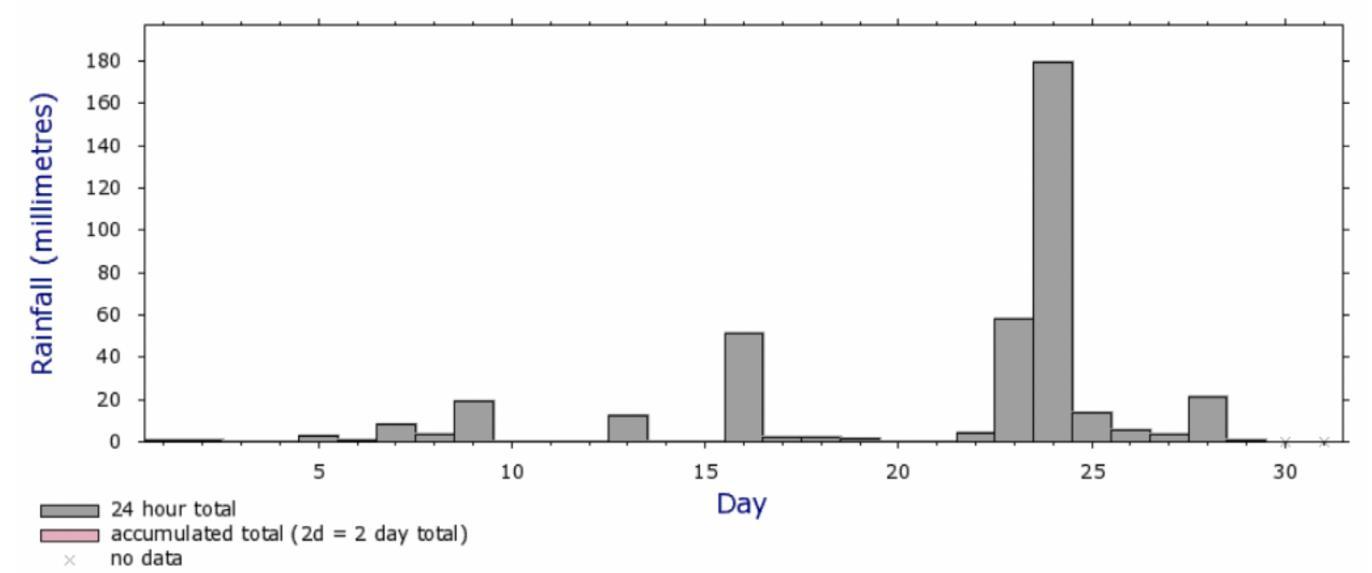
Figure 1- Daily rainfall graph for the monitored period (BOM)

#### Ooralea Racecourse (Mackay Turf Club) (033329) Feb 2020 rainfall

The monitoring that occurred from the 27th to the 28th followed a significant rain event with increased flows which provide ideal conditions for conducting fish passage assessments.
