COASTAL PRIORITIES CASE STUDY

Flaggy Rock Creek Fishway Remediation

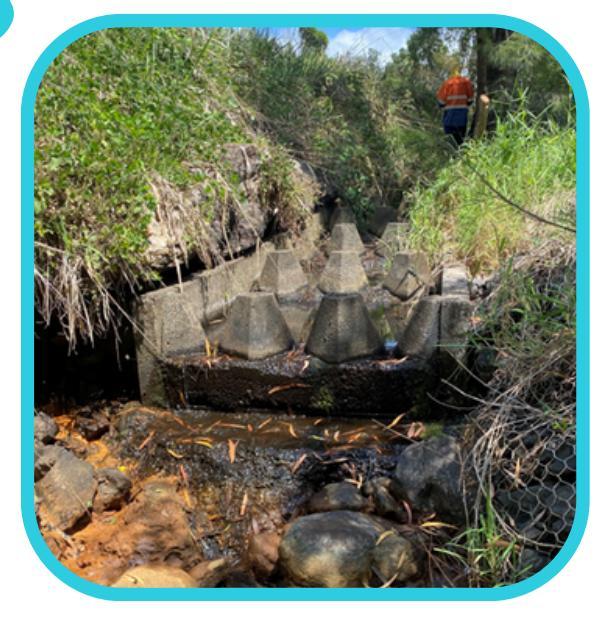
Flaggy Rock Creek, located south of Carmila, has a total of 161 recorded barriers in this waterway, in a catchment area of 190km2. The Flaggy Rock Creek fishway was ranked as a highpriority barrier in the region (Rank #2). The rock and concrete channel at the bottom of the fishway washed away in the 2010/2011 floods, which caused the bed to scour below the outlet and the tailwater level (waters immediately downstream of fishway) to drop, thus creating a physical fish barrier.

Image: Barrier at fishway entrance

This project sought to repair the Flaggy Rock Creek fishway by filling the scour erosion up to the natural bed and bank-level which reinstates the tailwater level, as well as reinstate the rock/ concrete channel at the fishway entrance acting to protect against future scour erosion.

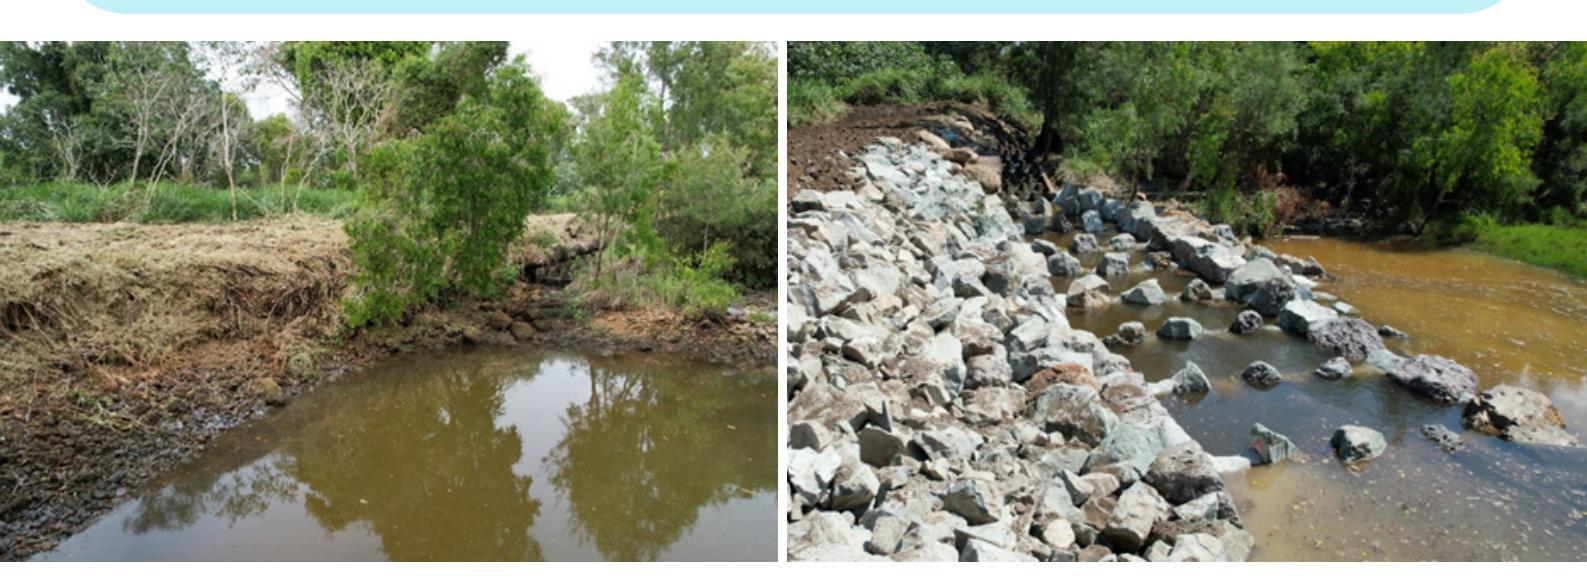
Images: Fishway entrance 'before' (left) and 'after' (right) remediation
