Sarina Coastal Sustainable Landscapes Project

Campwin Beach

Protection and Rehabilitation of Sarina Beaches Coastline

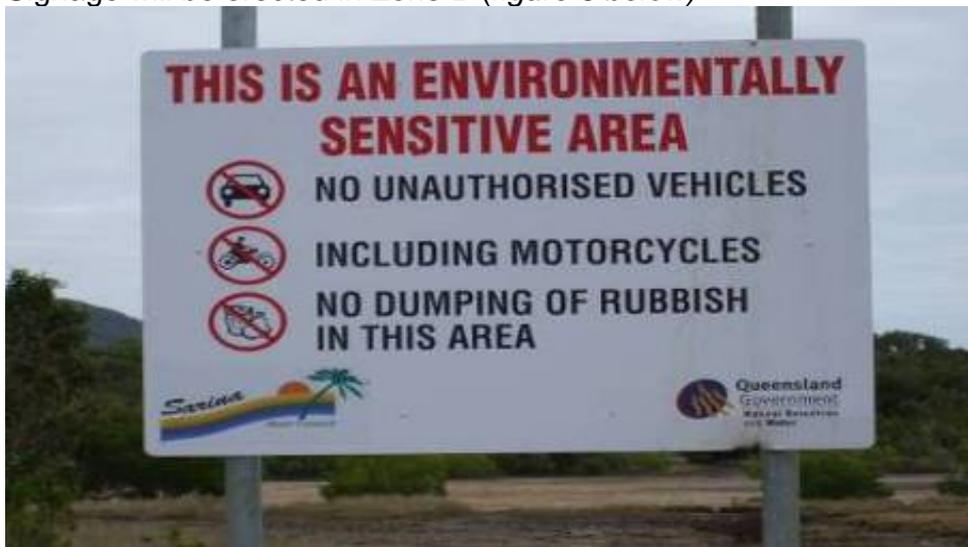
Figure 3 Environmentally Sensitive Area Sign

Signage will be erected in Zone B (*figure 3 below*)

Zone B - A post and rail fence will be erected in strategic areas along the saltpan area south west of Campwin Beach to prevent unauthorized motor vehicle and motor cycle access to this sensitive area. Signage stating motor vehicles prohibited will be erected at all entrances to the saltpan. (see figure 3)
