Laser Levels

2012

Reef Rescue Case Study: Laser Levels

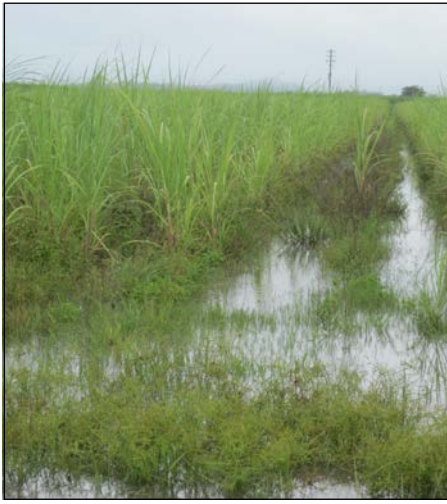
Example of flooding due to poor drainage

Water logging occurs when water is unable to drain effectively from a property and can lead to reduced yields. Poor drainage can also cost

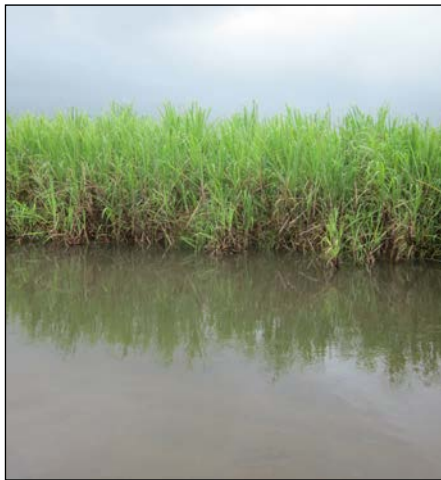
Poor drainage after 2011 wet season

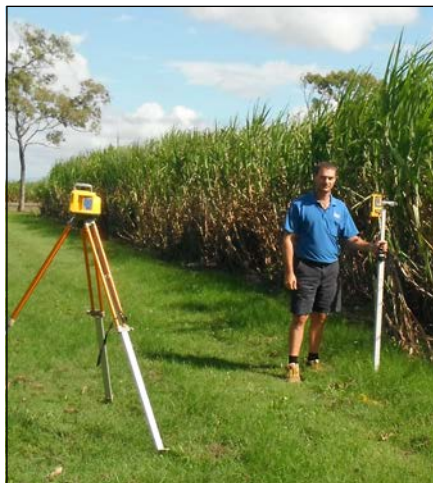
Brad Hussey with a BSES laser level

Brad Hussey from BSES Limited said that the levels selected for the project are Trimble LL400 Lasers Levels which have an operating range of 400m and are capable of grade matching. Grade matching means that the level can be setup at the top of the ridge and then the beam of the laser can be manually focused to a point down the slope to enable a drain of constant slope to be constructed with no additional calculations.

The lasers are equipped with a tripod, staff and a CR600 detector which can be used either on the staff or magnetically mounted on the earth moving equipment. With the detector mounted on the earth moving equipment the operator can maintain accurate drain depth with laser assistance. The laser beacon turns the process into a one man operation and solves the issue of having to find someone to hold the staff, or to get in and out of the machine to check levels.
