Mackay Whitsunday Fish Barrier Prioritisation

May 2015
Matt Moore

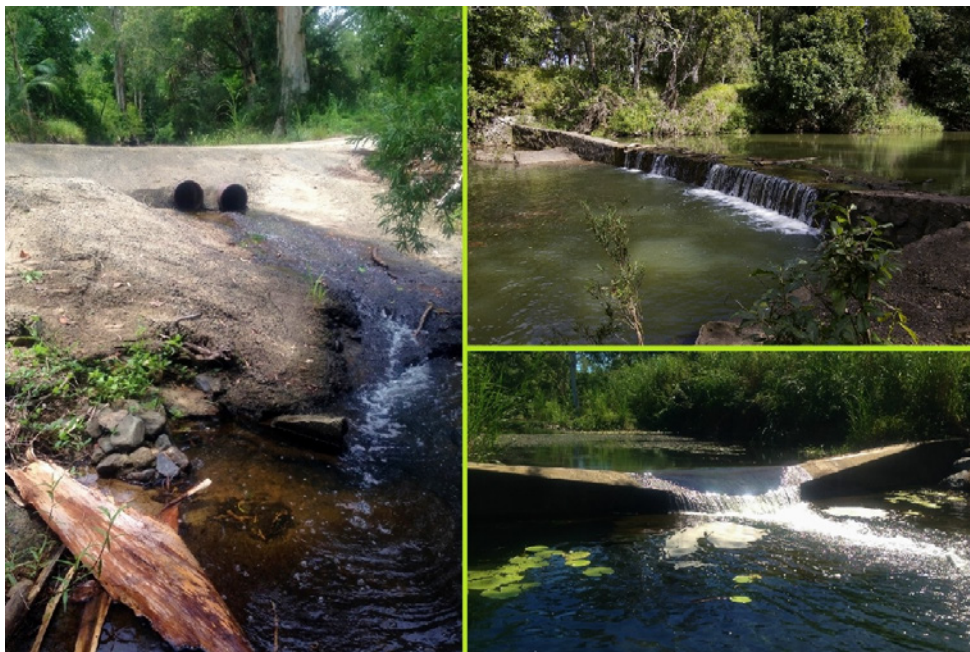
Figure 2. Different barrier types: pipe culverts and concrete apron (downstream) (left); weir (top right) and V-notch gauging weir, (bottom right).

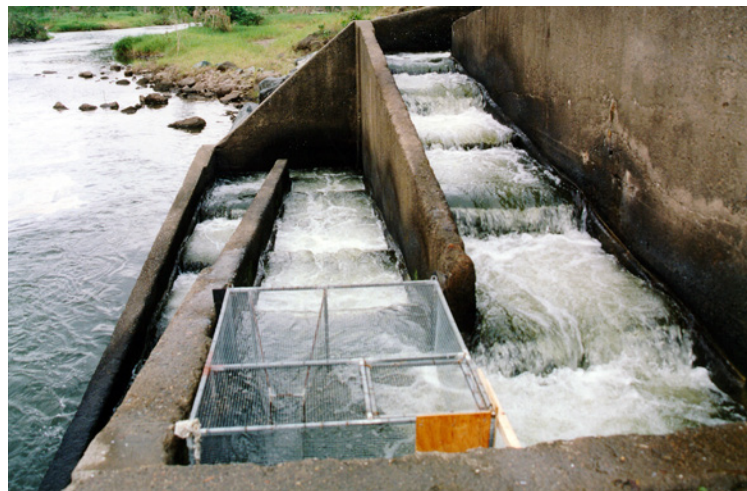
Figure 3. Northern Hemisphere designed pool and weir fishway on Marian Weir (Pioneer River, QLD). Excessive turbulence and velocity produced by this ‘fishway’ acts as a barrier to most Australian native fish.

The velocities these important fish species are able to negotiate pales in comparison with their Northern Hemisphere counterparts, adult Atlantic salmon, which are able to negotiate velocities of at least 2.4 m/sec (Mallen-Cooper, 1989). Unfortunately, many early Australian fishways were based on Northern Hemisphere designs and the swimming abilities of salmonids (Mallen-Cooper, 1996), which have the added capability of 'leaping' past small barriers (Thorncraft and Harris, 2000). These fishways have drops between pools, velocities and turbulence far in excess of what Australian fish communities are capable of ascending on a regular basis, and have themselves become fish barriers e.g. Marian Weir vertical slot fishway (Figure 3).

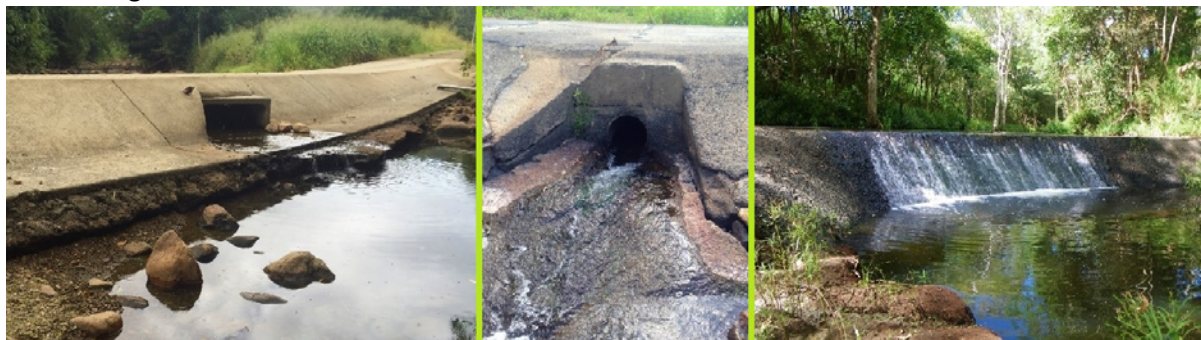
Figure 4. Left to right: Culvert causeway (Patullo Road, Gregory River) displaying a water surface drop, shallow water surface (through culvert and on apron) and velocity barrier (during medium-high flow conditions) exacerbated due to a culvert diameter <60% of stream width; Blackrock Creek pipe causeway displaying velocity and behavioural barriers (dark shadows/insufficient lighting in pipe) and water surface drop barrier (Sandy Creek Tributary).

- Velocity – When the speed of water is in excess of the swimming capabilities of fish attempting to pass the obstruction. High velocities often occur through pipes and culverts and downstream of weirs and regulators during medium and high flow events (Figure 4).
- Shallow Water – Shallow water depth of 5 mm - 100 mm depending on species, size and morphology. Larger bodied demersal species are affected more. Shallow water is often experienced during low flow condition across road crossings, through culverts and across culvert aprons (Figure 4).
- Behavioural – Dark shadows and reduced light conditions inside culverts/pipes, and under low bridges (Figure 4).

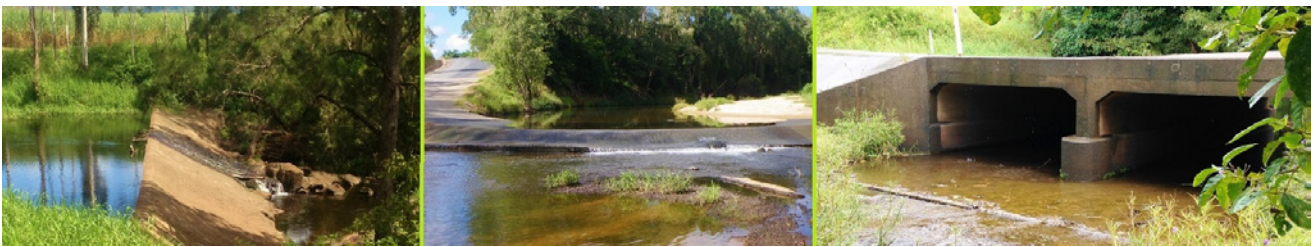
Figure 5. Left to right: Low transparency barrier (Macquarie Ck Weir), Medium transparency barrier (Palm Tree Rd causeway, Sandy Ck), High transparency barrier (Myrtle Ck).

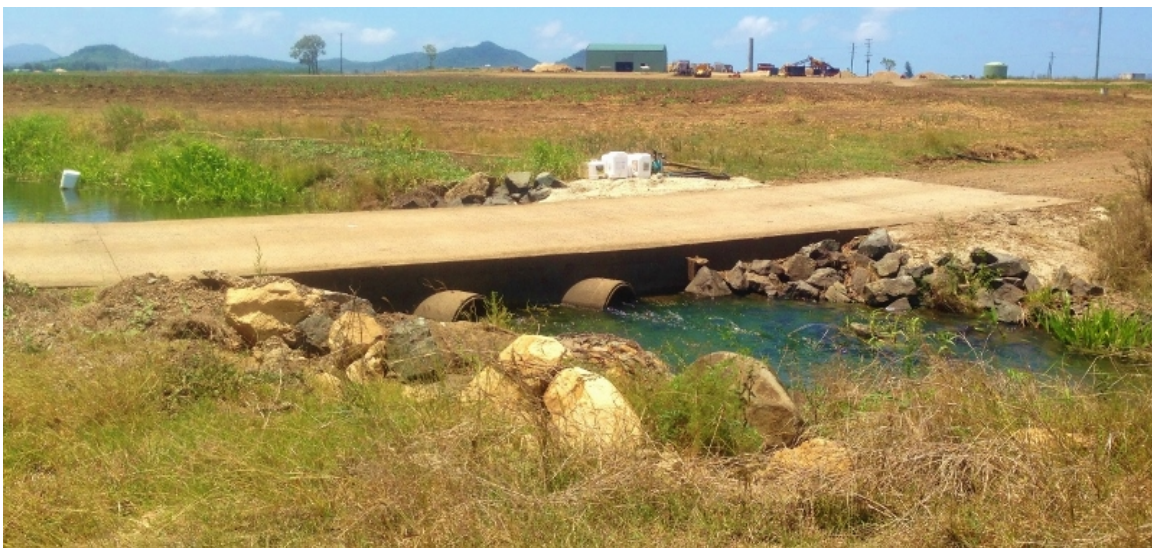
Figure 8. Upper Bakers Creek, a highly modified intensive cropping catchment. Showing a sugarcane farm (background), barrier (pipe causeway) to fish passage constructed to haul sugarcane, altered flow regime (irrigation flows for sugarcane), cleared riparian habitat, no shade, straightened channel and declared class 2 aquatic pest plant species; hymenachne.

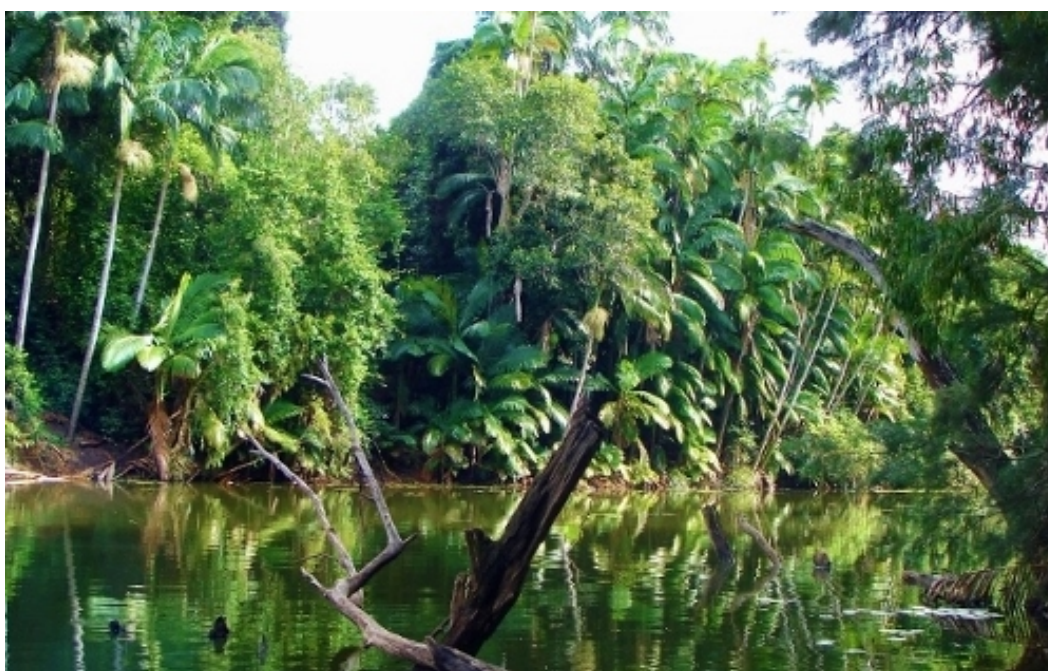
Figure 10. Good quality riparian and in-stream habitat; lower Rocky Dam Creek, Koumala.

It is estimated that within the Pioneer catchment about 20% of land is used for cane, 16% for grazing, 15% for other purposes and the remaining 49% is rainforest, steep open forest or steep woodland (Arthington *et al.*, 2001). Many of the districts plains have been cleared for agricultural purposes, with the majority of the forests occurring in the mountainous regions where cultivation is not undertaken. Waterways in these locations are still in good condition (Figure 10).

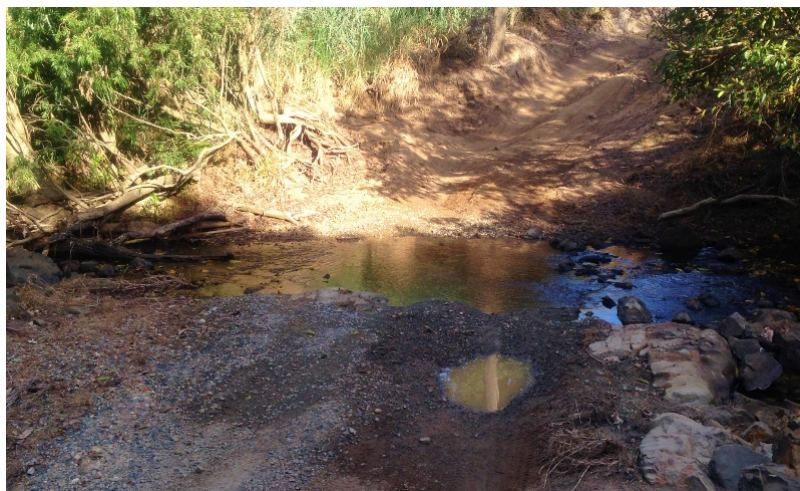
Figure 14. Natural bed level crossing on Macquarie Creek, Mt Ossa, QLD.

A total of 1737 potential barriers were assessed and ranked in accordance with the spatial and temporal habitat characteristic criteria set out in stage one. This was achieved using the analytical GIS stream network processing tool, RivEX. Due to time and funding constraints, 272 high ranking barriers were visited in the field. Of the 271 ground-truthed potential barriers, 171 were determined to be barriers that prevent, delay or obstruct fish migration. The remaining 101 potential barriers were assessed as not affecting fish passage. These consisted of bed level stream crossings (Figure 14) and structures such as bridges.

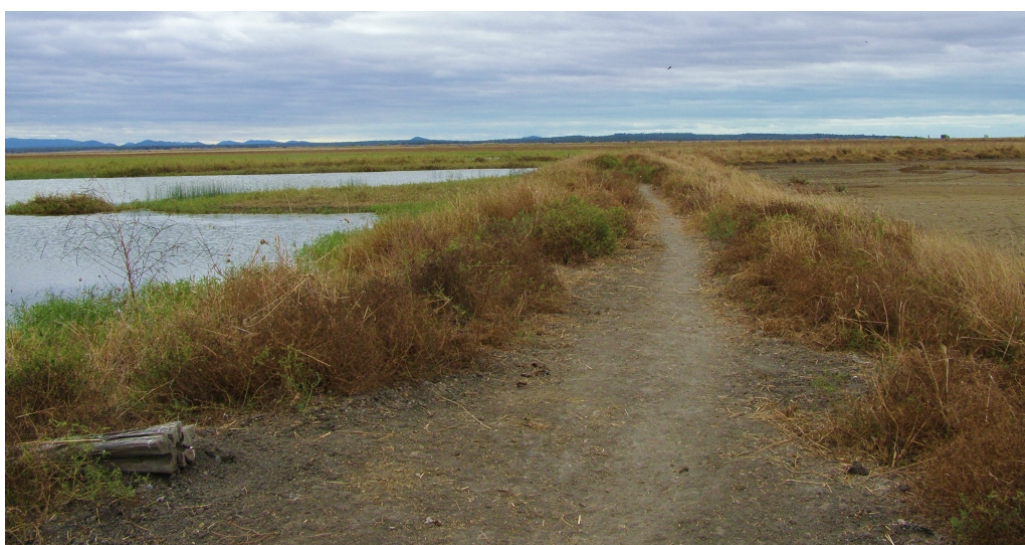
Figure 15. Ponded pasture tidal wetland bund, Amity Creek sub-catchment, St Lawrence. Freshwater wetland on the left hand side, estuarine salt pan on the right hand side.

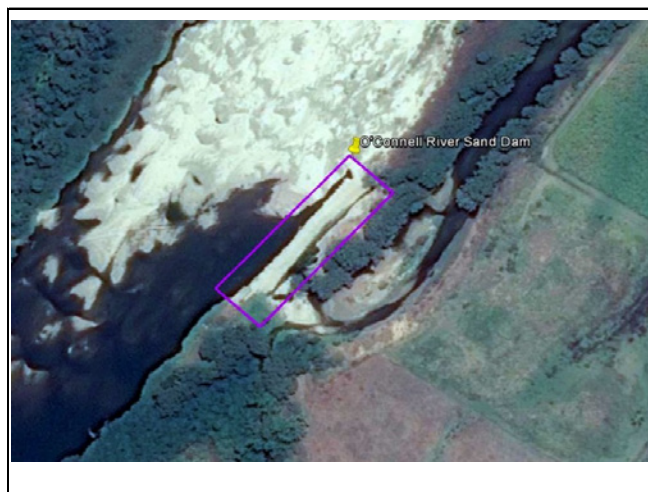
Overall Priority	1	
Stage 1 & 2 Priority	Stage 1	Stage 2
	1	1
Barrier ID	3931	
Stream Name	O'Connell R	
Location	20° 34.722'S	148° 36.249'E
Barrier Type	Sand Dam (Tidal Bund Weir)	
Barrier Name	Sand Dam	
Fishway Type Needed	Rock Ramp	
Approx. Cost of Fishway	\$100-200k

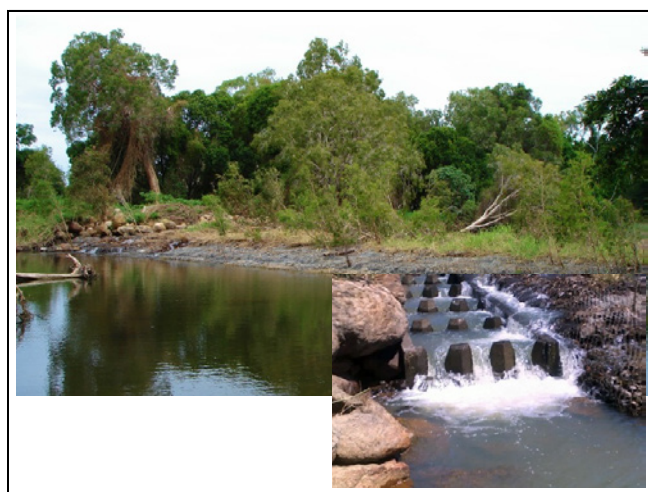
Overall Priority	2	
Stage 1 & 2 Priority	Stage 1	Stage 2
	12	2
Barrier ID	2769	
Stream Name	Flaggy Rock Creek	
Location	21° 57.365'S	149° 27.838'E
Barrier Type	F/Way tailwater control washed away	
Barrier Name	Gabion Tidal Weir	
Fishway Type Needed	Pre Cast Concrete Cone	
Approx. Cost of Fishway	\$20-30k

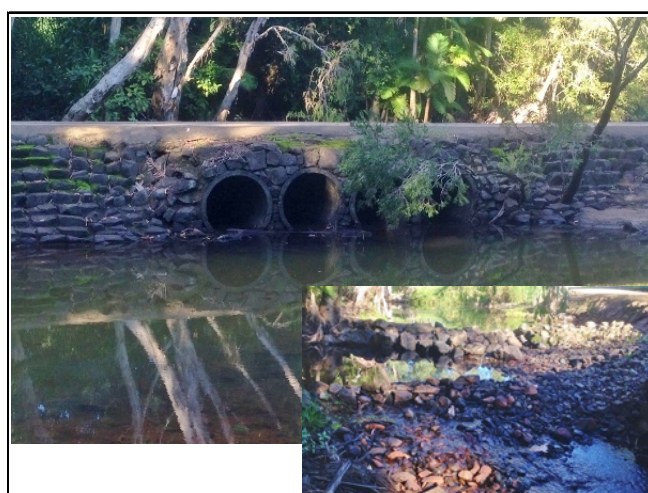
Overall Priority	3	
Stage 1 & 2 Priority	Stage 1	Stage 2
	12	3
Barrier ID	3792	
Stream Name	Cedar Creek	
Location	20° 24.599'S	148° 41.889'E
Barrier Type	4 Pipe C/way + U/S rock weir	
Barrier Name	Vitanza Rd	
Fishway Type Needed	Rock Ramp	
Approx. Cost of Fishway	\$20-30k

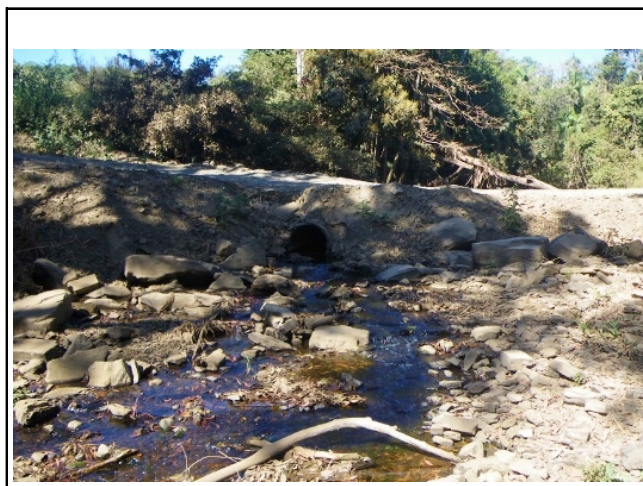
Overall Priority	4	
Stage 1 & 2 Priority	Stage 1	Stage 2
	12	3
Barrier ID	3573	
Stream Name	Marion Creek	
Location	21° 42.708'S	149° 24.109'E
Barrier Type	1 Pipe Causeway	
Barrier Name	Off Marion Settlement Rd	
Fishway Type Needed	Full Width Culverts + Baffles	
Approx. Cost of Fishway	\$60-120k

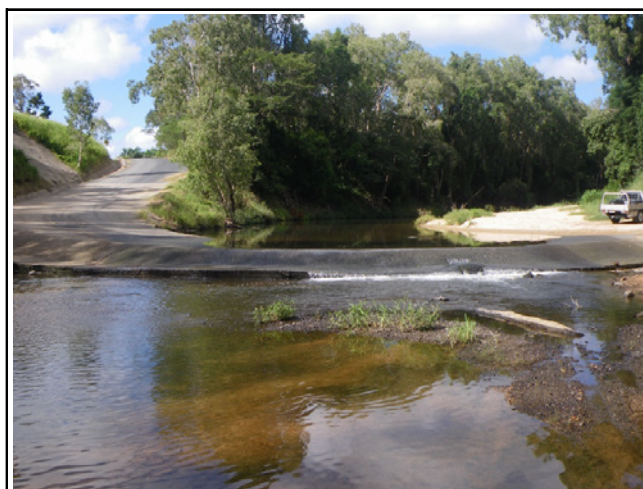
Overall Priority	4	
Stage 1 & 2 Priority	Stage 1	Stage 2
	12	9
Barrier ID	111	
Stream Name	Sandy Ck	
Location	21° 16.842'S	149° 4.945'E
Barrier Type	Causewy/Culvert	
Barrier Name	Palm Tree Rd Crossing	
Fishway Type Needed	Rock Ramp	
Approx. Cost of Fishway	\$75-80k

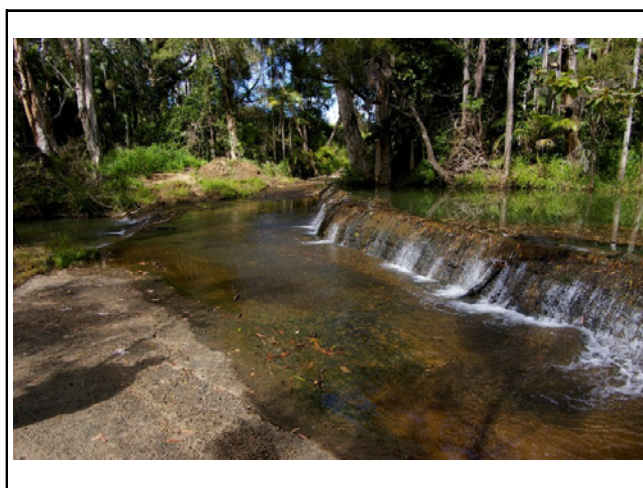
Overall Priority	4	
Stage 1 & 2 Priority	Stage 1	Stage 2
	23	9
Barrier ID	2630	
Stream Name	Constant Ck	
Location	21° 2.847'S	148° 59.299'E
Barrier Type	Weir/Road Crossing	
Barrier Name	Freds Weir	
Fishway Type Needed	Pre-cast/Rock Ramp	
Approx. Cost of Fishway	\$60-80k

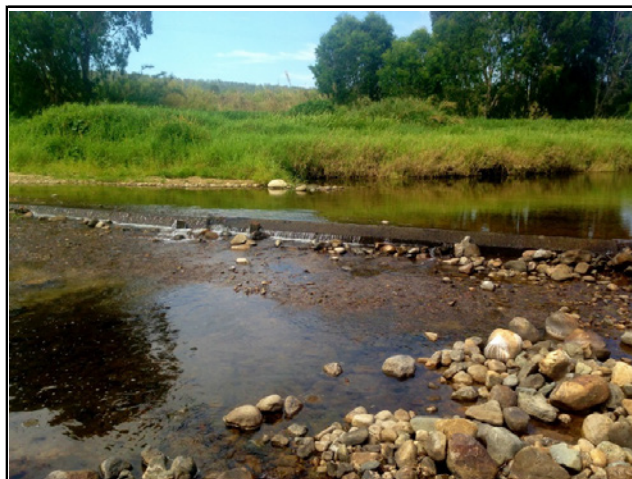
Overall Priority	7	
Stage 1 & 2 Priority	Stage 1	Stage 2
	2	3
Barrier ID	2593	
Stream Name	St Helens Ck	
Location	20° 54.714'S	148° 44.513'E
Barrier Type	Causeway	
Barrier Name	Russell Rd Crossing	
Fishway Type Needed	Rock Ramp	
Approx. Cost of Fishway	\$25-30k

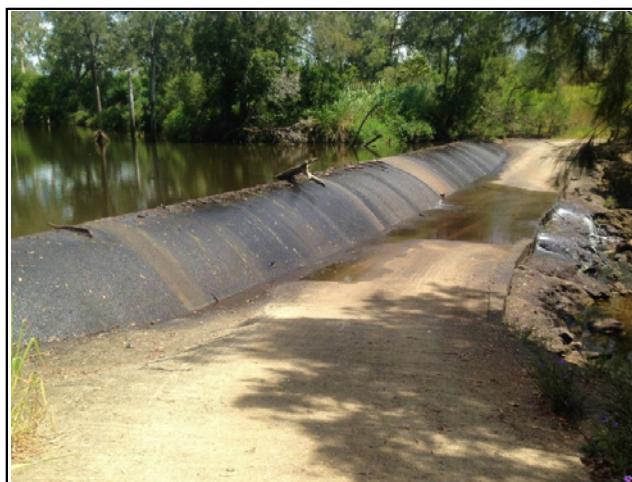
Overall Priority	7	
Stage 1 & 2 Priority	Stage 1	Stage 2
	31	3
Barrier ID	2614	
Stream Name	Jolimont Ck	
Location	20° 58.698'S	148° 52.734'E
Barrier Type	Weir	
Barrier Name	Mulherin Rd Crossing	
Fishway Type Needed	Pre-Cast/Rock Ramp	
Approx. Cost of Fishway	\$150-200k

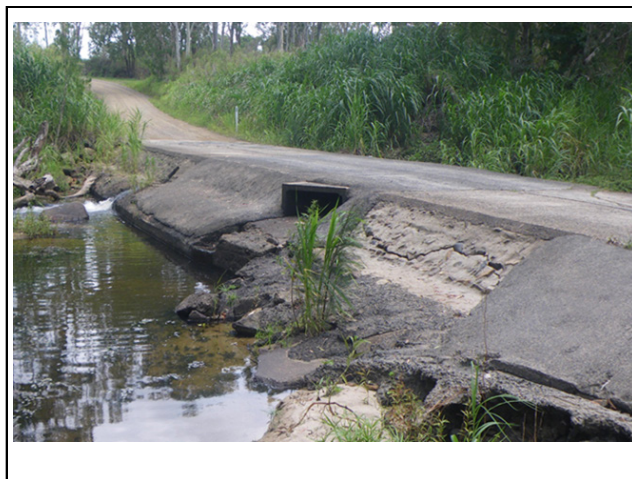
Overall Priority	7	
Stage 1 & 2 Priority	Stage 1	Stage 2
	5	12
Barrier ID	2588	
Stream Name	Blackrock Ck	
Location	20° 51.307'S	148° 45.426'E
Barrier Type	Causeway/Culvert	
Barrier Name	Old Bowen Rd Crossing	
Fishway Type Needed	Rock Ramp	
Approx. Cost of Fishway	\$60-70k

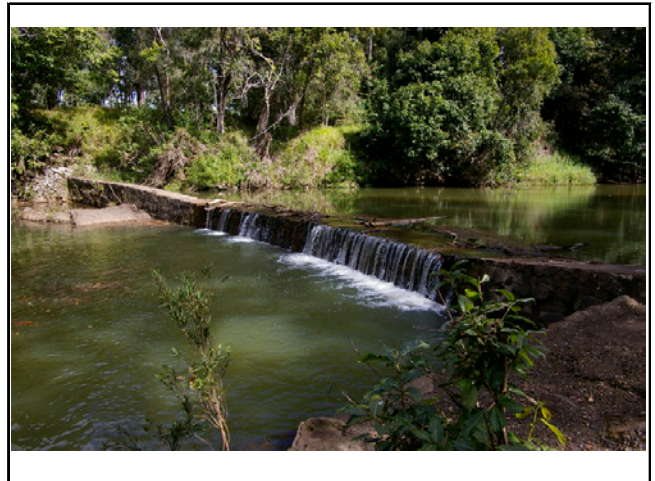
Overall Priority	7	
Stage 1 & 2 Priority	Stage 1	Stage 2
	31	12
Barrier ID	2631	
Stream Name	Constant Ck	
Location	21° 2.836'S	148° 58.997'E
Barrier Type	Weir	
Barrier Name	1938 Weir	
Fishway Type Needed	Pre-cast/Rock Ramp	
Approx. Cost of Fishway	\$70-90k

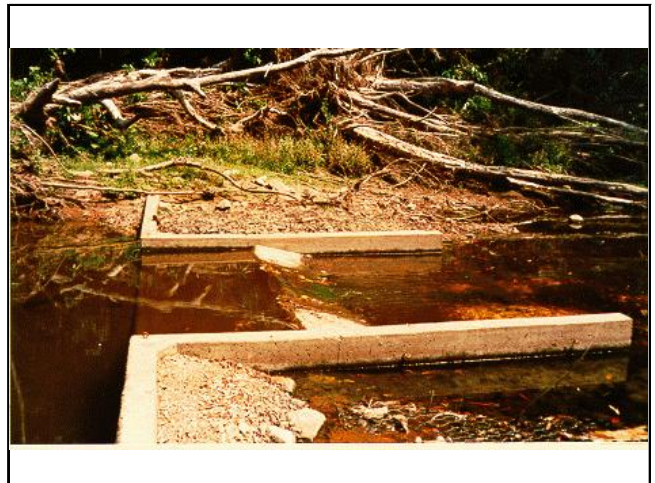
Overall Priority	11	
Stage 1 & 2 Priority	Stage 1	Stage 2
	4	3
Barrier ID	3965	
Stream Name	Carmila Creek	
Location	21° 54.723'S	149° 24.010'E
Barrier Type	Gauging Weir	
Barrier Name	DNRM Gauging Weir	
Fishway Type Needed	Rock Ramp	
Approx. Cost of Fishway	\$20-30k

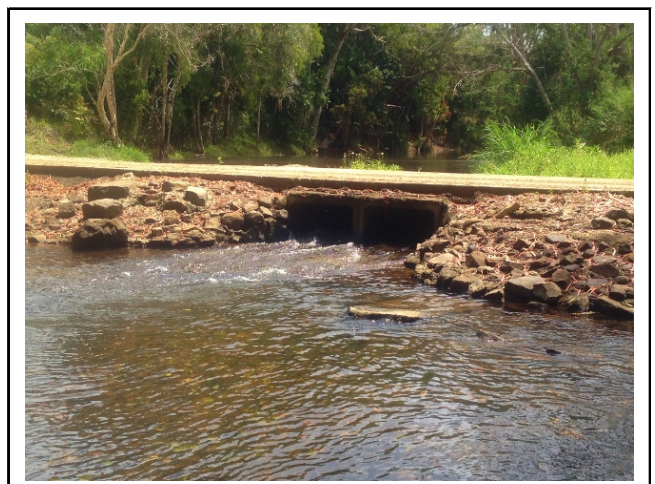
Overall Priority	11	
Stage 1 & 2 Priority	Stage 1	Stage 2
	23	17
Barrier ID	3574	
Stream Name	Marion Creek	
Location	21° 42.179'S	149° 23.753'E
Barrier Type	Culvert Causeway	
Barrier Name	Marion Settlement/Notch Pt Rd	
Fishway Type Needed	Rock Ramp + Baffles	
Approx. Cost of Fishway	\$20-30k

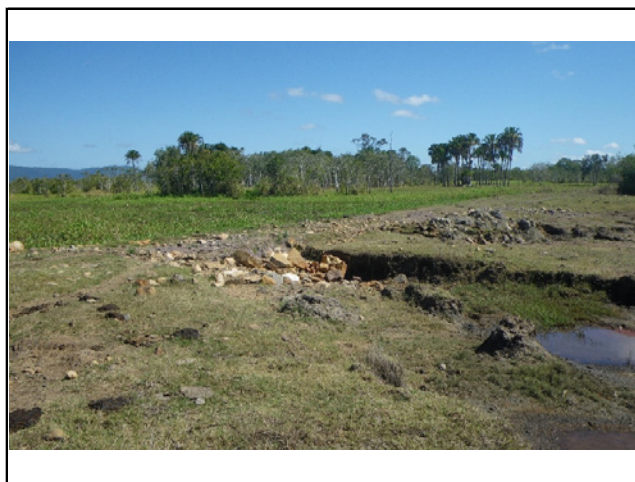
Overall Priority	13	
Stage 1 & 2 Priority	Stage 1	Stage 2
	12	9
Barrier ID	3120	
Stream Name	Tedlands Wetland	
Location	21° 33.470'S	149° 17.914'E
Barrier Type	Tidal Earth Bund	
Barrier Name	Tedlands Eastern Bund	
Fishway Type Needed	Rock Ramp/Precast Cone	
Approx. Cost of Fishway	\$75-85k

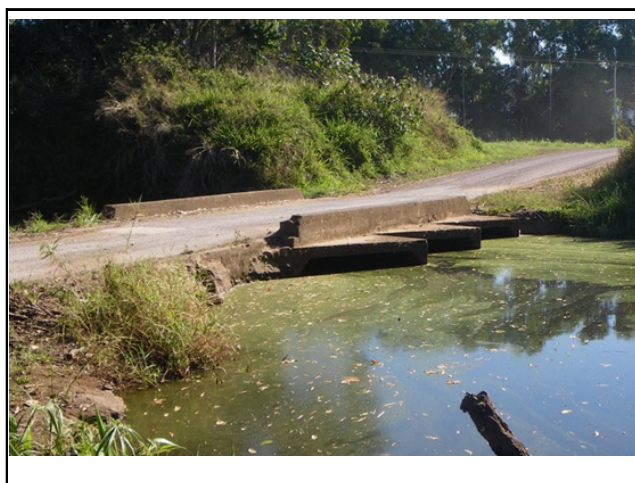
Overall Priority	13	
Stage 1 & 2 Priority	Stage 1	Stage 2
	4	12
Barrier ID	3174	
Stream Name	Cherry Tree Ck	
Location	21° 33.311'S	149° 15.379'E
Barrier Type	Culverts	
Barrier Name	East Inneston Rd	
Fishway Type Needed	Baffles	
Approx. Cost of Fishway	\$10-20k

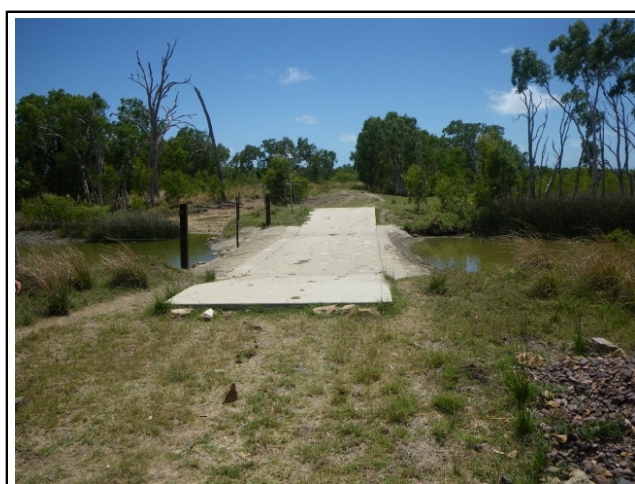
Overall Priority	13	
Stage 1 & 2 Priority	Stage 1	Stage 2
	53	17
Barrier ID	3981	
Stream Name	Boundary Creek/Wetlands	
Location	21° 31.499'S	149° 15.879'E
Barrier Type	Earth Bund/Causeway	
Barrier Name	Tidal Bund	
Fishway Type Needed	Rock Ramp/Precast Cone	
Approx. Cost of Fishway	\$75-85k

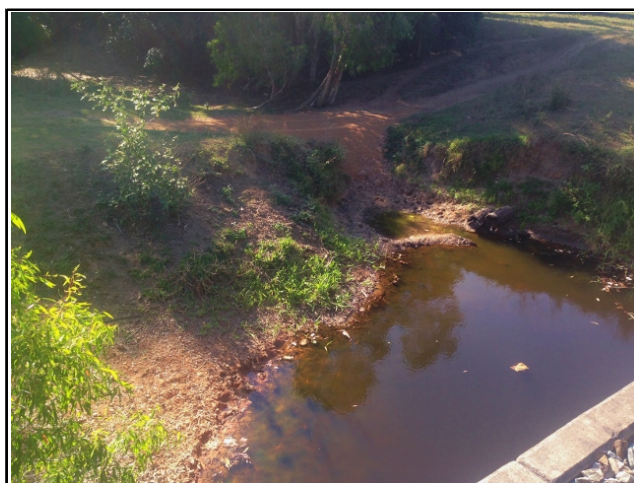
Overall Priority	13	
Stage 1 & 2 Priority	Stage 1	Stage 2
	12	22
Barrier ID	327	
Stream Name	Goorgana Creek	
Location	20° 28.410'S	148° 34.268'E
Barrier Type	Creek Crossing	
Barrier Name	Under Railway Crossing	
Fishway Type Needed	Removal/Rock Ramp	
Approx. Cost of Fishway	\$20-40k

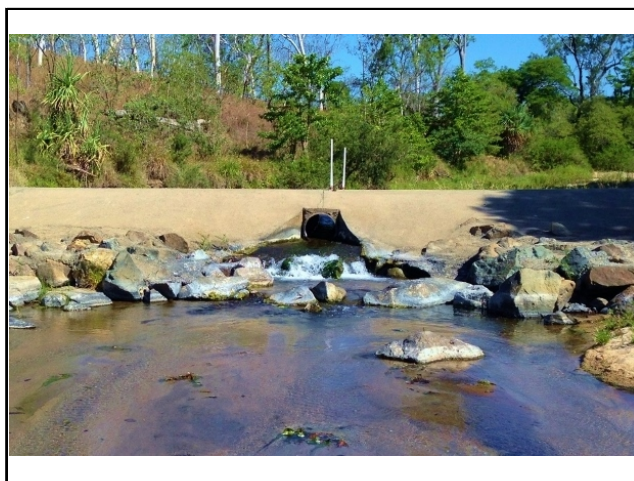
Overall Priority	13	
Stage 1 & 2 Priority	Stage 1	Stage 2
	31	22
Barrier ID	3933	
Stream Name	Mares Nest Creek	
Location	20° 34.932'S	148° 26.414'E
Barrier Type	Pipe Causeway	
Barrier Name	Station Rd	
Fishway Type Needed	Rock Ramp	
Approx. Cost of Fishway	\$40-50

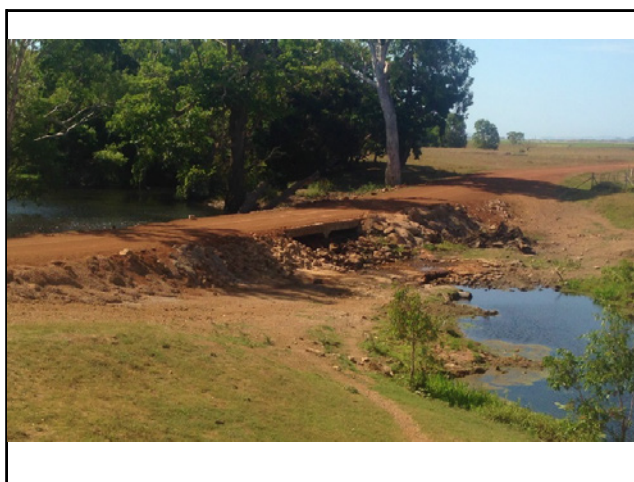
Overall Priority	18	
Stage 1 & 2 Priority	Stage 1	Stage 2
	53	34
Barrier ID	3881	
Stream Name	Lethe Brook	
Location	20° 26.286'S	148° 34.183'E
Barrier Type	Culvert + Rock Causeway	
Barrier Name	Upstream Railway Crossing	
Fishway Type Needed	Removal/Rock Ramp	
Approx. Cost of Fishway	\$40-60k

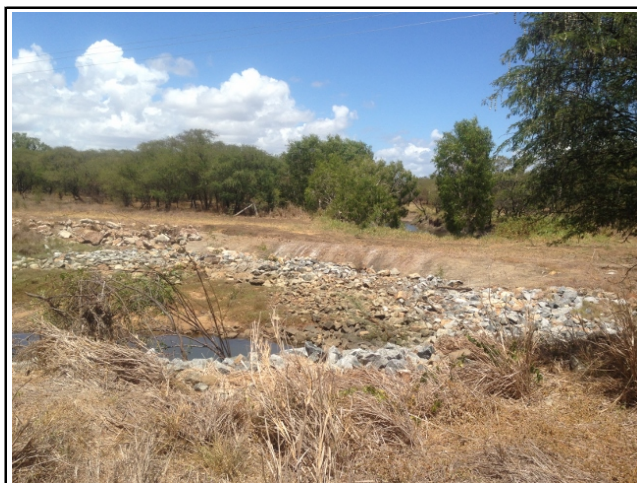
Overall Priority	18	
Stage 1 & 2 Priority	Stage 1	Stage 2
	23	17
Barrier ID	3331	
Stream Name	Hay Gully	
Location	20° 5.609'S	148° 14.867'E
Barrier Type	Concrete + Rock Weir	
Barrier Name	Immediately U/S Hwy	
Fishway Type Needed	Rock Ramp	
Approx. Cost of Fishway	\$40-60k

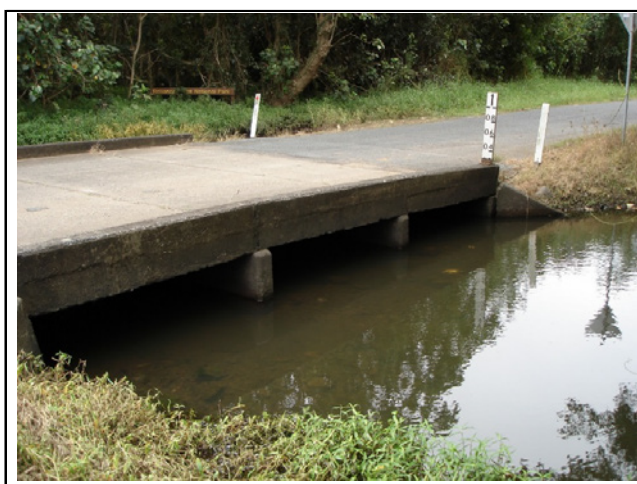
Overall Priority	18	
Stage 1 & 2 Priority	Stage 1	Stage 2
	12	3
Barrier ID	2636	
Stream Name	Reliance Ck	
Location	21° 2.797'S	149° 6.217'E
Barrier Type	Road Crossing	
Barrier Name	Neills Rd Crossing	
Fishway Type Needed	Baffles	
Approx. Cost of Fishway	\$15-25k

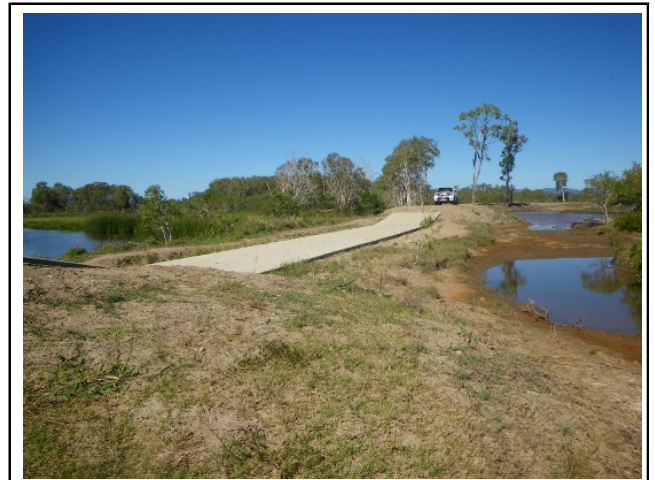
Overall Priority	18	
Stage 1 & 2 Priority	Stage 1	Stage 2
	53	17
Barrier ID	3988	
Stream Name	Boundary Creek (R.Dam)	
Location	21° 31.372'S	149° 16.103'E
Barrier Type	Concrete Bund/Causeway	
Barrier Name	Tidal Bund - Boundary wetlands	
Fishway Type Needed	Rock Ramp/Pre-cast Cone	
Approx. Cost of Fishway	\$70-80k

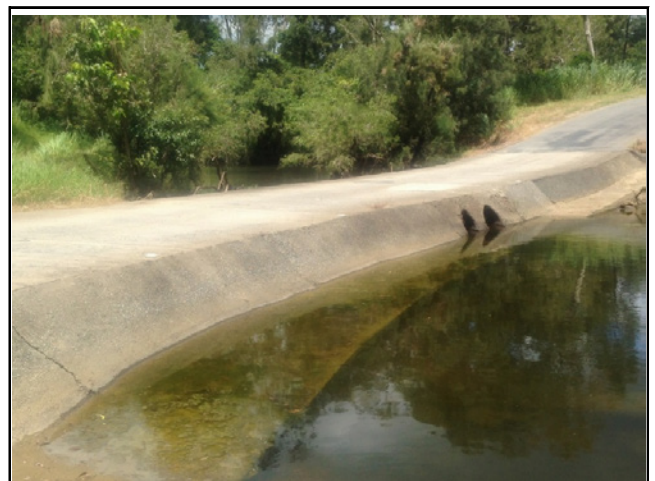
Overall Priority	18	
Stage 1 & 2 Priority	Stage 1	Stage 2
	31	22
Barrier ID	2616	
Stream Name	Jolimont Ck	
Location	20° 59.429'S	148° 53.303'E
Barrier Type	Culvert Road Crossing	
Barrier Name	Narpi Rd Crossing	
Fishway Type Needed	Baffled Culverts/ R.Ramp	
Approx. Cost of Fishway	\$60-80k/\$20-30k

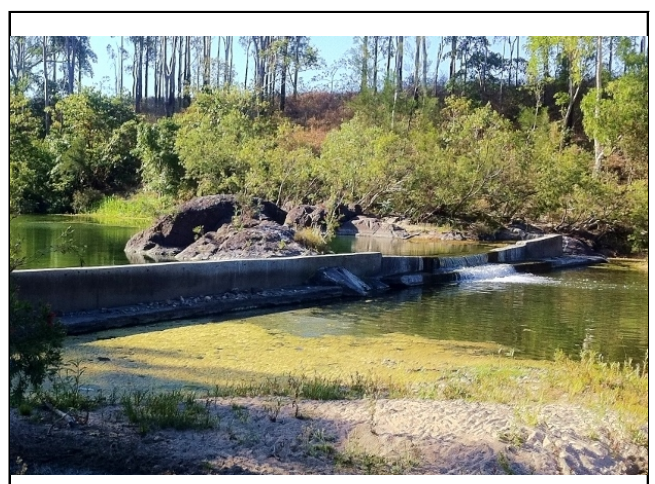
Overall Priority	24	
Stage 1 & 2 Priority	Stage 1	Stage 2
	5	12
Barrier ID	3999	
Stream Name	Andromache River	
Location	20° 34.391'S	148° 28.216'E
Barrier Type	Gauging Weir	
Barrier Name	DNRM Weir	
Fishway Type Needed	Rock Ramp/Pre-cast Cone	
Approx. Cost of Fishway	\$60-80k

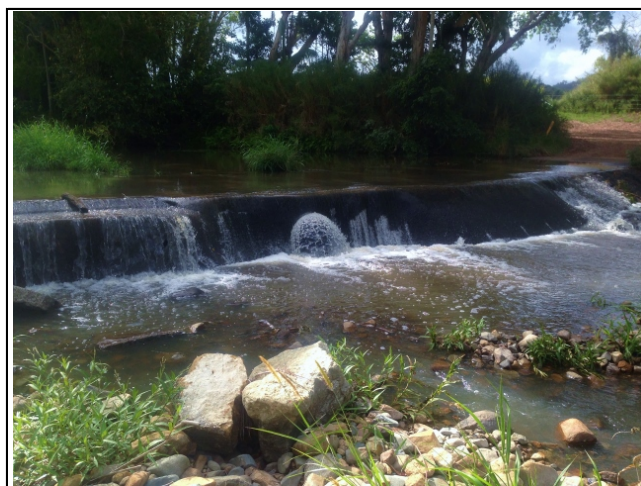
Overall Priority	24	
Stage 1 & 2 Priority	Stage 1	Stage 2
	12	22
Barrier ID	2750	
Stream Name	Carmila Creek	
Location	21° 55.538'S	149° 22.235'E
Barrier Type	Causeway/Weir	
Barrier Name	Jacksons Crossing Rd	
Fishway Type Needed	Rock Ramp	
Approx. Cost of Fishway	\$60-70k

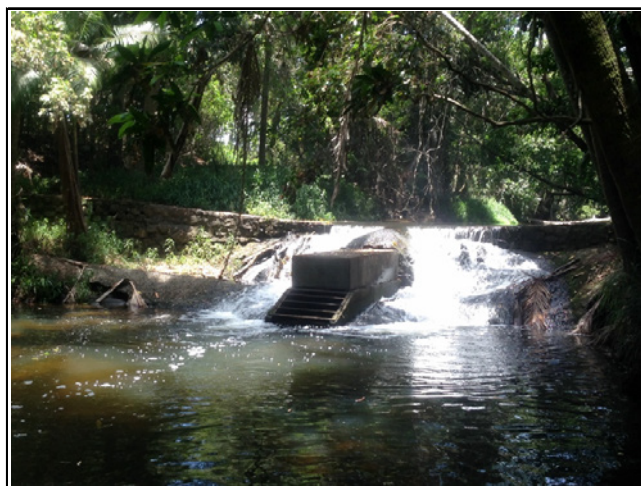
Overall Priority	26	
Stage 1 & 2 Priority	Stage 1	Stage 2
	41	22
Barrier ID	83	
Stream Name	Bakers Ck	
Location	21° 11.181'S	149° 5.899'E
Barrier Type	Weir	
Barrier Name	Bakers Ck Weir	
Fishway Type Needed	Rock Ramp/Precast Cone	
Approx. Cost of Fishway	\$100-130k

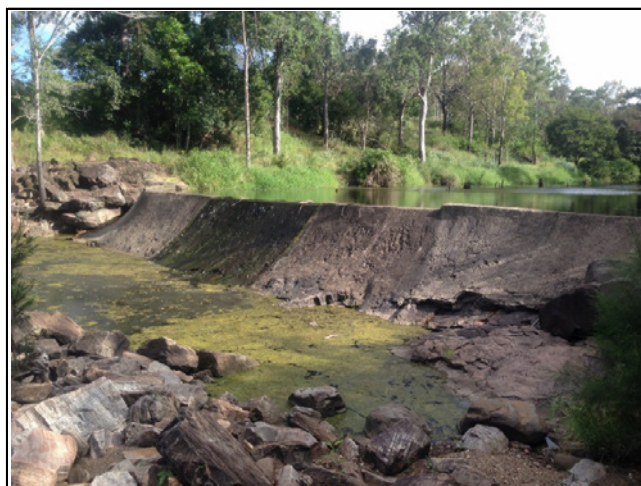
Overall Priority	26	
Stage 1 & 2 Priority	Stage 1	Stage 2
	31	29
Barrier ID	2610	
Stream Name	Macquarie Ck	
Location	21° 0.221'S	148° 51.181'E
Barrier Type	Weir	
Barrier Name	Private	
Fishway Type Needed	Pre-Cast/Rock Ramp	
Approx. Cost of Fishway	\$150-200k

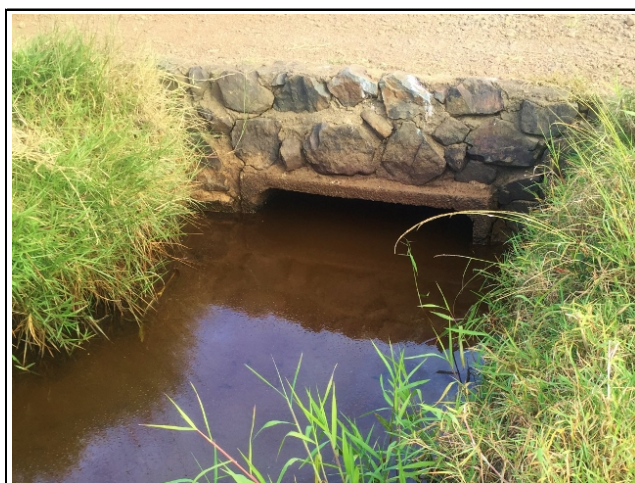
Overall Priority	26	
Stage 1 & 2 Priority	Stage 1	Stage 2
	41	29
Barrier ID	3127	
Stream Name	Tedlands Ck	
Location	21°35'20.34"S	149°18'24.51"E
Barrier Type	Culvert Causeway	
Barrier Name	Tedlands	
Fishway Type Needed	R.Ramp + Baffles/Culverts	
Approx. Cost of Fishway	\$15-20k/\$30-40k

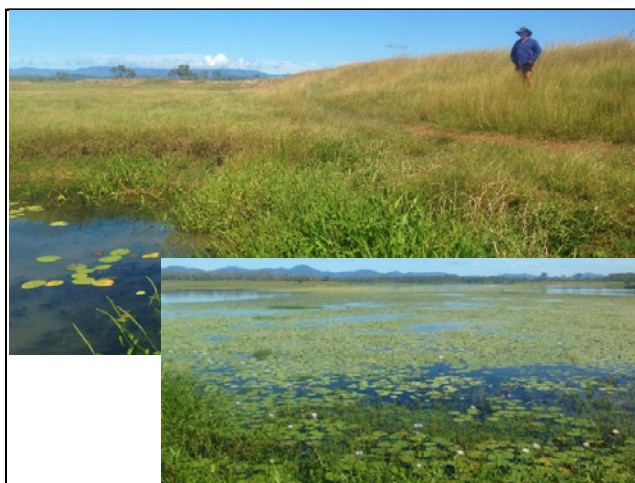
Overall Priority	26	
Stage 1 & 2 Priority	Stage 1	Stage 2
	67	34
Barrier ID	3928	
Stream Name	Thompson Creek	
Location	20° 31.006'S	148° 36.359'E
Barrier Type	Wetland Riser Pipe Bund	
Barrier Name	Thompson Ck Wetlands	
Fishway Type Needed	Rock Ramp	
Approx. Cost of Fishway	\$70-90k

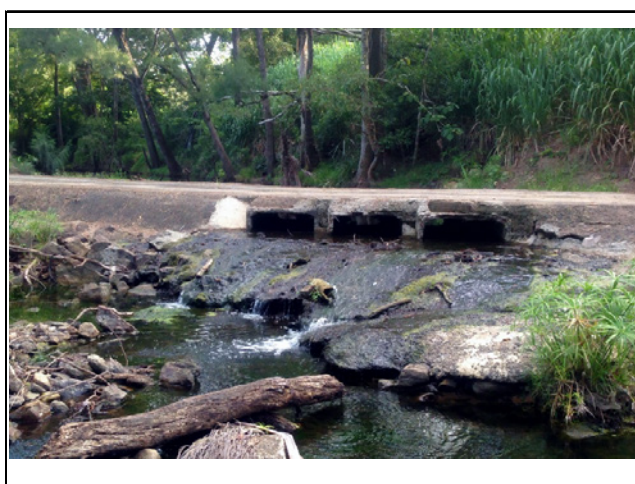
Overall Priority	26	
Stage 1 & 2 Priority	Stage 1	Stage 2
	41	37
Barrier ID	2575	
Stream Name	Macquarie Ck	
Location	21° 1.117'S	148° 50.197'E
Barrier Type	Culvert/Apron drop	
Barrier Name	McKays Rd Crossing	
Fishway Type Needed	Rock Ramp	
Approx. Cost of Fishway	\$40-50k

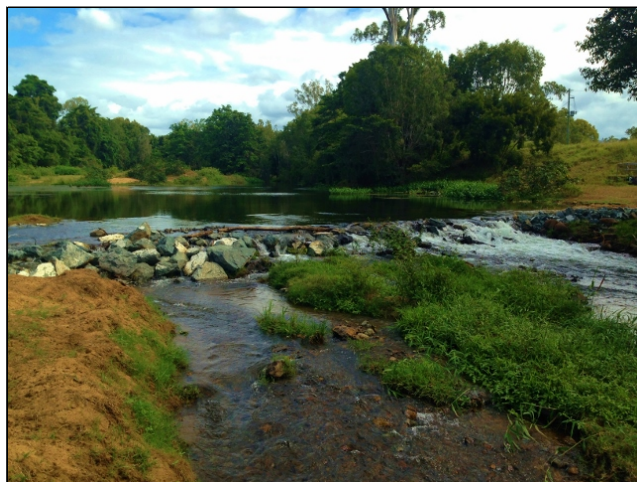
Overall Priority	26	
Stage 1 & 2 Priority	Stage 1	Stage 2
	31	37
Barrier ID	3673	
Stream Name	Proserpine River	
Location	20° 21.208'S	148° 26.889'E
Barrier Type	Rock Weir	
Barrier Name	New WRC Barrier	
Fishway Type Needed	Rock Ramp	
Approx. Cost of Fishway	\$40-50

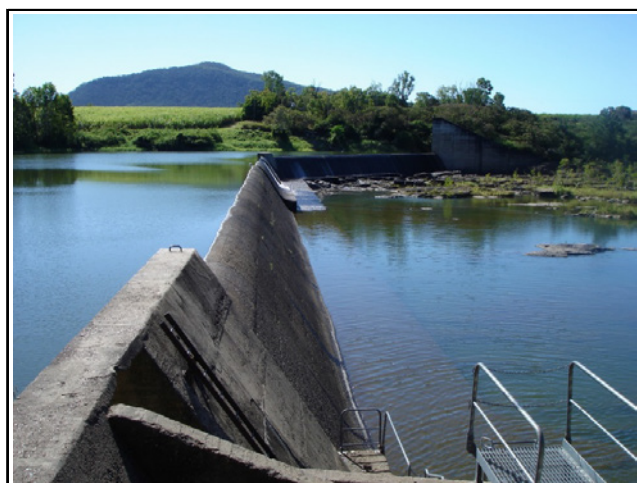
Overall Priority	32	
Stage 1 & 2 Priority	Stage 1	Stage 2
	5	12
Barrier ID	10	
Stream Name	Pioneer R	
Location	21° 8.430'S	148° 56.168'E
Barrier Type	Weir	
Barrier Name	Marian Weir	
Fishway Type Needed	Vertical Slot	
Approx. Cost of Fishway	~\$2 m

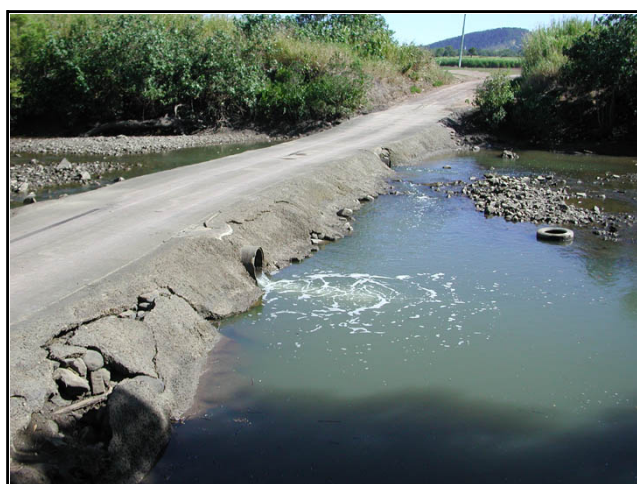
Overall Priority	33	
Stage 1 & 2 Priority	Stage 1	Stage 2
	31	22
Barrier ID	2544	
Stream Name	Plane Ck	
Location	21° 25.110'S	149° 14.707'E
Barrier Type	Tidal Bund/Pipe Crossing	
Barrier Name	Brooks Rd Crossing	
Fishway Type Needed	Baffled Culvert/Rock Ramp	
Approx. Cost of Fishway	\$50-70k/\$40-50k

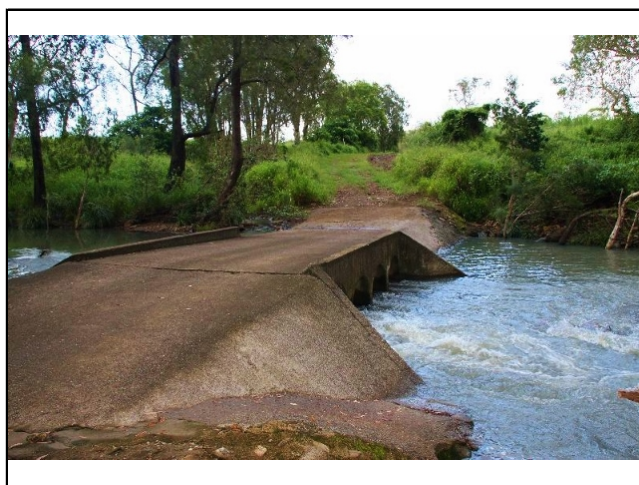
Overall Priority	33	
Stage 1 & 2 Priority	Stage 1	Stage 2
	41	29
Barrier ID	2734	
Stream Name	West Hill Creek	
Location	21° 49.206'S	149° 21.167'E
Barrier Type	Pipe Causeway	
Barrier Name	Off Browns Rd	
Fishway Type Needed	Rock Ramp	
Approx. Cost of Fishway	\$30-40k

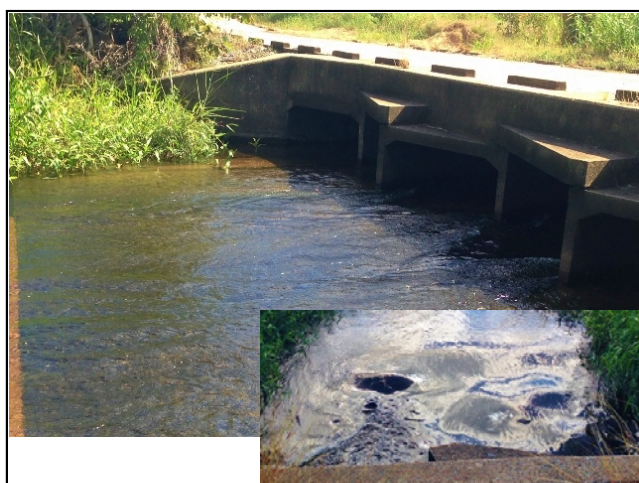
Overall Priority	33	
Stage 1 & 2 Priority	Stage 1	Stage 2
	41	37
Barrier ID	3980	
Stream Name	Proserpine River	
Location	20° 20.523'S	148° 29.624'E
Barrier Type	Culvert Causeway	
Barrier Name	Spruces Road	
Fishway Type Needed	Rock Ramp + Baffles	
Approx. Cost of Fishway	\$40-50K

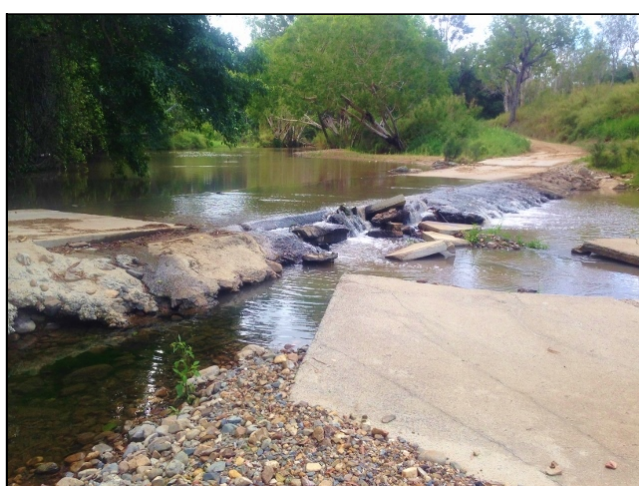
Overall Priority	33	
Stage 1 & 2 Priority	Stage 1	Stage 2
	53	43
Barrier ID	2744	
Stream Name	Carmila Creek	
Location	21° 55.368'S	149° 21.468'E
Barrier Type	Weir/Causeway	
Barrier Name	Streeters Rd Causeway	
Fishway Type Needed	Rock Ramp	
Approx. Cost of Fishway	\$40-50k

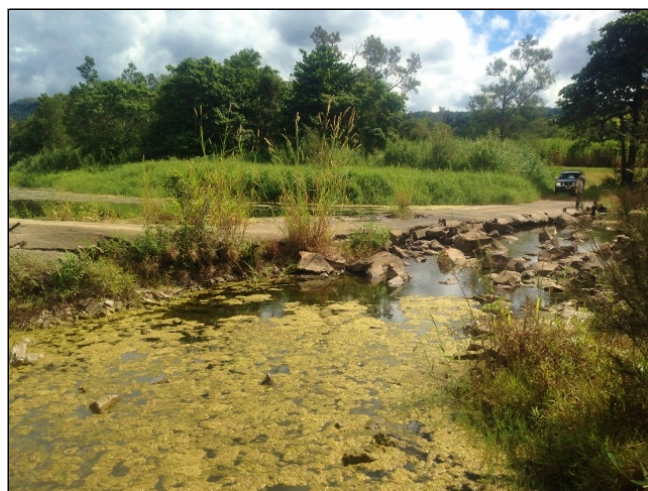
Overall Priority	37	
Stage 1 & 2 Priority	Stage 1	Stage 2
	41	34
Barrier ID	2601	
Stream Name	Murray Creek	
Location	20° 59.124'S	148° 45.248'E
Barrier Type	Causeway	
Barrier Name	Clewss Road	
Fishway Type Needed	Rock Ramp/Culvert Baffles	
Approx. Cost of Fishway	\$40-60k

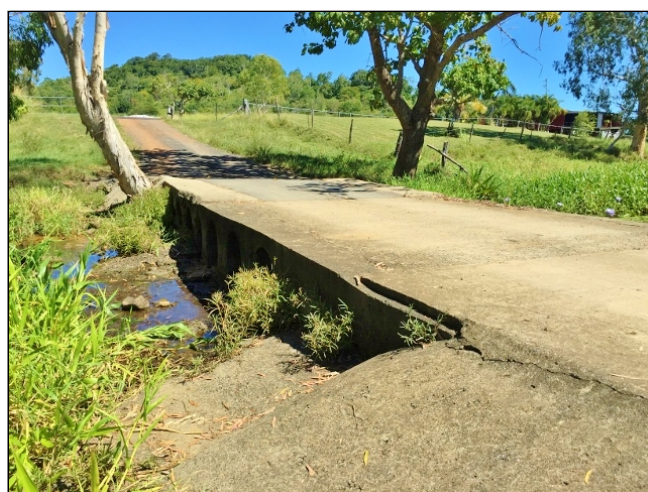
Overall Priority	37	
Stage 1 & 2 Priority	Stage 1	Stage 2
	146	45
Barrier ID	2601	
Stream Name	Leila Creek	
Location	21° 1.740'S	149° 6.233'E
Barrier Type	Pipe Causeway	
Barrier Name	Sants Rd	
Fishway Type Needed	Rock Ramp	
Approx. Cost of Fishway	\$15-25k

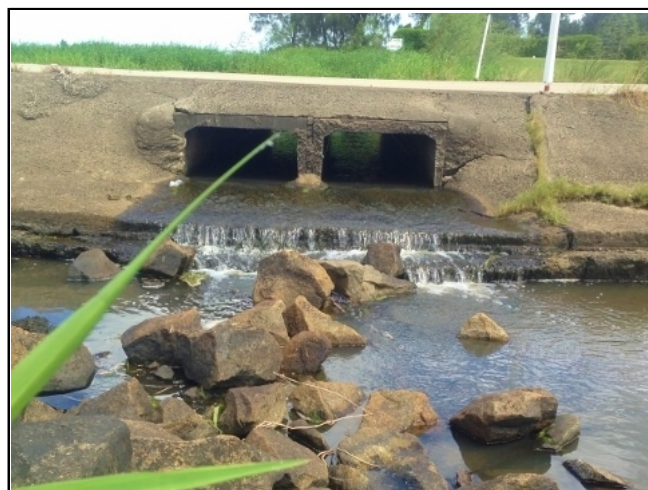
Overall Priority	37	
Stage 1 & 2 Priority	Stage 1	Stage 2
	257	61
Barrier ID	1316	
Stream Name	McCreadys Creek	
Location	21° 5.327'S	149° 9.922'E
Barrier Type	Culvert Causeway	
Barrier Name	Golf Links Rd (MRC)	
Fishway Type Needed	Rock Ramp + Baffles	
Approx. Cost of Fishway	\$20-30

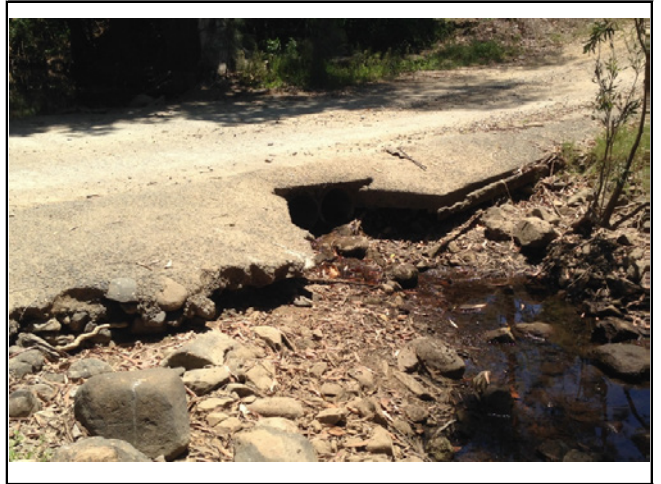
Overall Priority	40	
Stage 1 & 2 Priority	Stage 1	Stage 2
	53	45
Barrier ID	2586	
Stream Name	Alligator Ck	
Location	-20.828466°	148.667042°
Barrier Type	Pipe Culvert Road Crossing	
Barrier Name	Tolchers Rd Crossing	
Fishway Type Needed	Culvert + Baffle/R.Ramp	
Approx. Cost of Fishway	\$30-40k/\$20-30k
