# GULLY REPAIR | Ecosystem Repair Project

**PROJECT:** GULLY REPAIR: DARYL WATSON, ROCKY DAM CREEK ROAD, KOUMALA

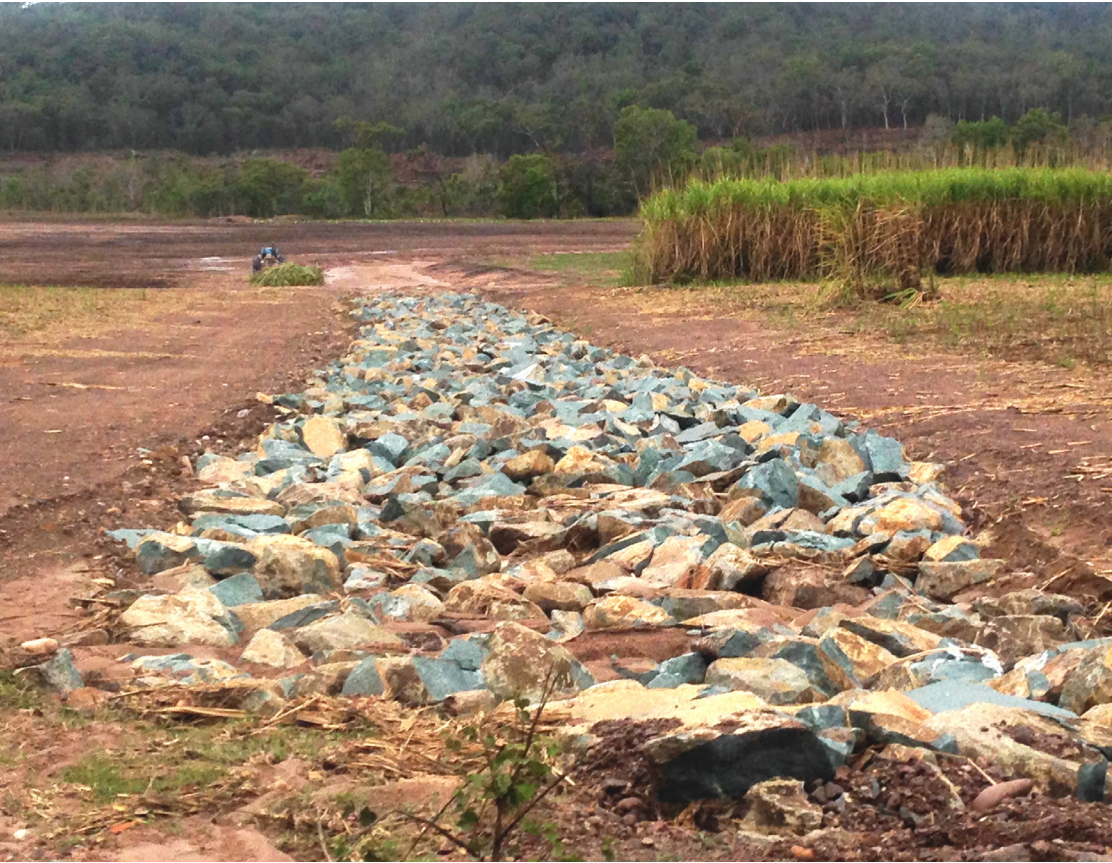
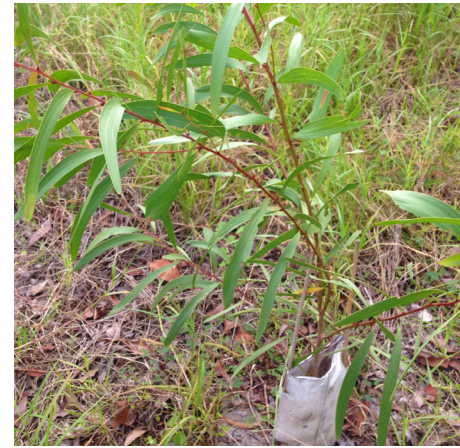
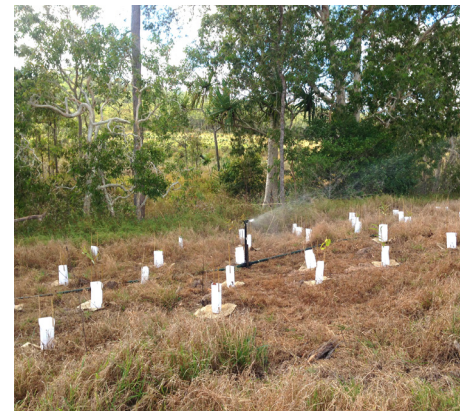
**CURRENT ACTIVITY:** The gully was lined with geofabric and rockered with various sizes of rocks to allow subsurface water flow, but to slow it down. At the end of the rock chute, water flows into one of three sediment detention basins currently being constructed, and then into a wetland feature before reaching a tributary of Rocky Dam Creek. Nearby on the creek, revegetation of the pre-clearing riparian vegetation has been implemented.

**STATUS:** In 2014 the gully repair was completed, which has halted the erosion of the adjacent cane paddocks during big flows. The revegetation of one section of the creek was also finished. One of the sediment detention basins has been completed, with two more to be finished over the next two months.
