Mackay Whitsunday Fish Barrier Prioritisation

May 2015
Matt Moore

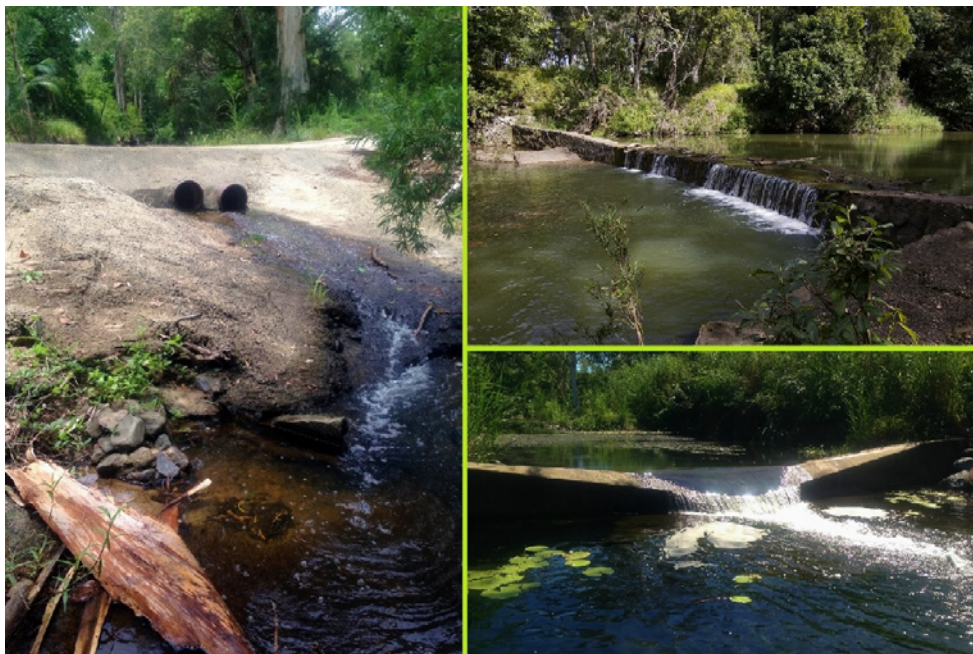
Figure 2. Different barrier types: pipe culverts and concrete apron (downstream) (left); weir (top right) and V-notch gauging weir, (bottom right).

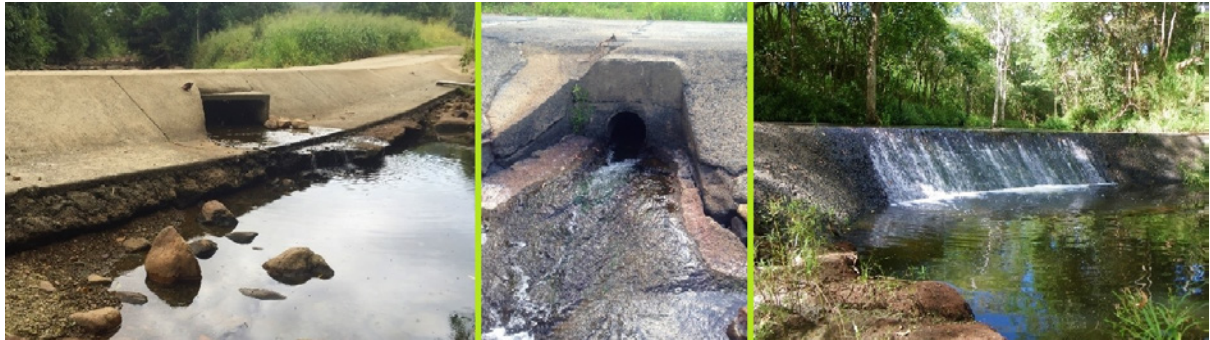
Figure 4. Left to right: Culvert causeway (Patullo Road, Gregory River) displaying a water surface drop, shallow water surface (through culvert and on apron) and velocity barrier (during medium-high flow conditions) exacerbated due to a culvert diameter <60% of stream width; Blackrock Creek pipe causeway displaying velocity and behavioural barriers (dark shadows/insufficient lighting in pipe) and water surface drop barrier (Sandy Creek Tributary).

- Velocity – When the speed of water is in excess of the swimming capabilities of fish attempting to pass the obstruction. High velocities often occur through pipes and culverts and downstream of weirs and regulators during medium and high flow events (Figure 4).
- Shallow Water – Shallow water depth of 5 mm - 100 mm depending on species, size and morphology. Larger bodied demersal species are affected more. Shallow water is often experienced during low flow condition across road crossings, through culverts and across culvert aprons (Figure 4).
- Behavioural – Dark shadows and reduced light conditions inside culverts/pipes, and under low bridges (Figure 4).

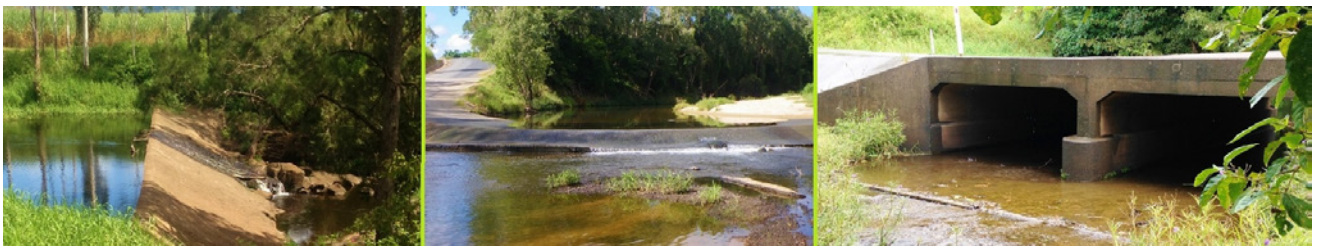
Figure 5. Left to right: Low transparency barrier (Macquarie Ck Weir), Medium transparency barrier (Palm Tree Rd causeway, Sandy Ck), High transparency barrier (Myrtle Ck).

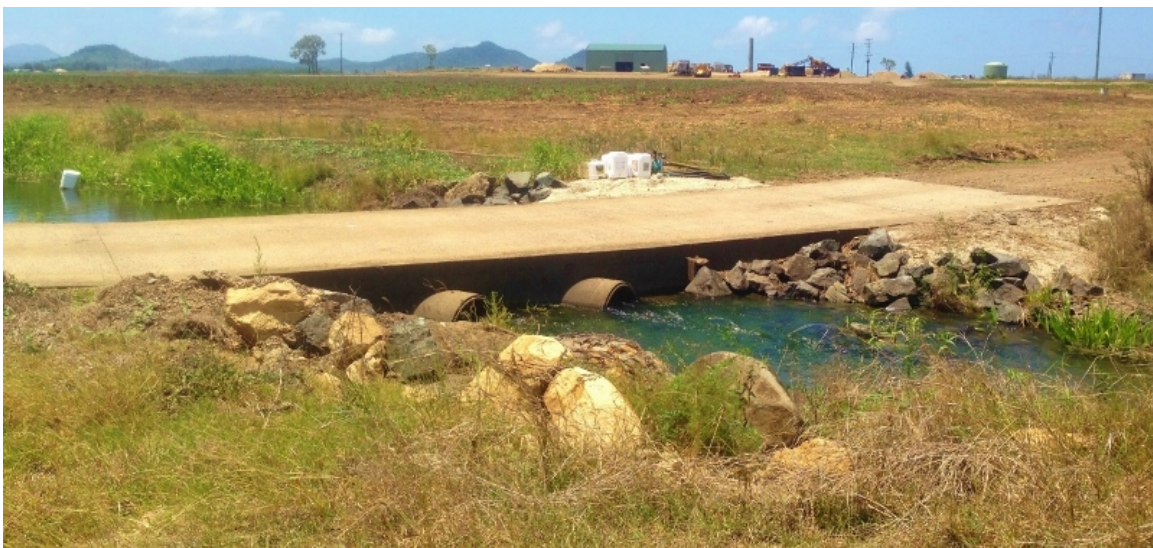
Figure 8. Upper Bakers Creek, a highly modified intensive cropping catchment. Showing a sugarcane farm (background), barrier (pipe causeway) to fish passage constructed to haul sugarcane, altered flow regime (irrigation flows for sugarcane), cleared riparian habitat, no shade, straightened channel and declared class 2 aquatic pest plant species; hymenachne.

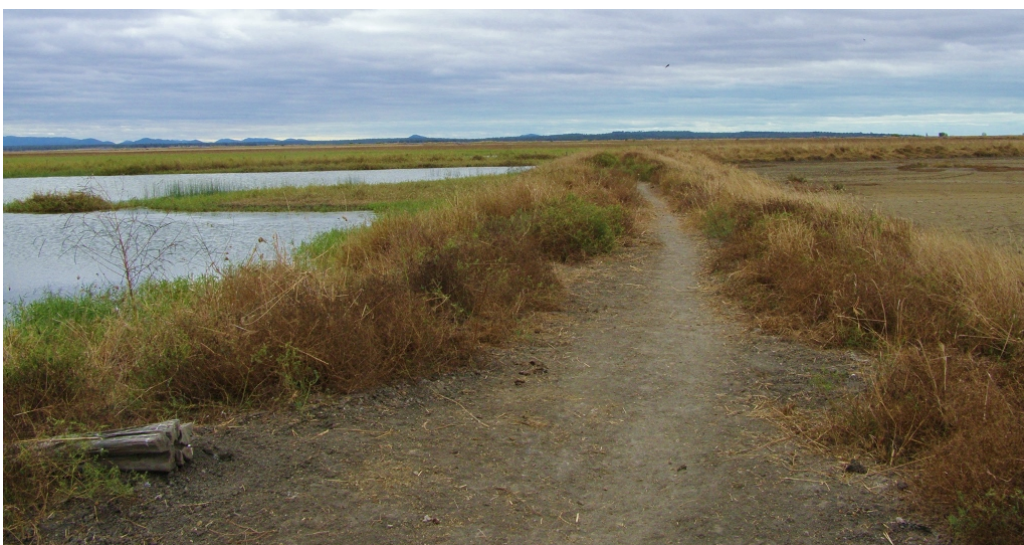
Figure 15. Ponded pasture tidal wetland bund, Amity Creek sub-catchment, St Lawrence. Freshwater wetland on the left hand side, estuarine salt pan on the right hand side.

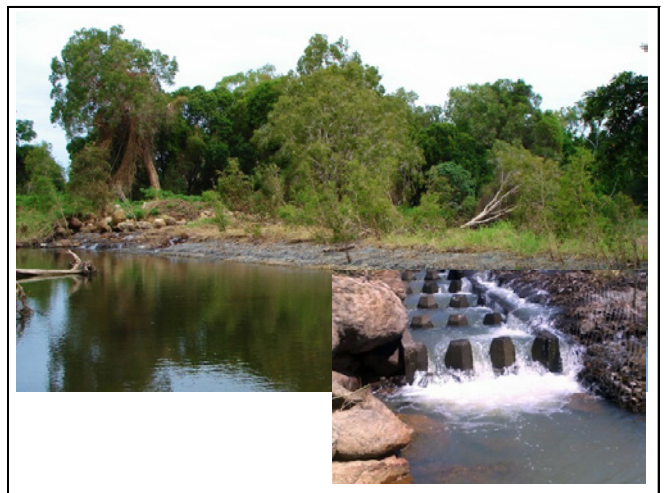
Overall Priority	3	
Stage 1 & 2 Priority	Stage 1	Stage 2
	12	3
Barrier ID	3792	
Stream Name	Cedar Creek	
Location	20° 24.599'S	148° 41.889'E
Barrier Type	4 Pipe C/way + U/S rock weir	
Barrier Name	Vitanza Rd	
Fishway Type Needed	Rock Ramp	
Approx. Cost of Fishway	\$20-30k

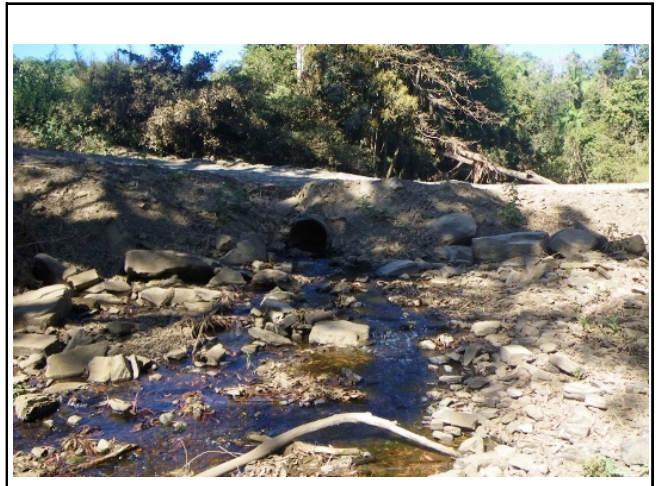
Overall Priority	4	
Stage 1 & 2 Priority	Stage 1	Stage 2
	12	9
Barrier ID	111	
Stream Name	Sandy Ck	
Location	21° 16.842'S	149° 4.945'E
Barrier Type	Causeway/Culvert	
Barrier Name	Palm Tree Rd Crossing	
Fishway Type Needed	Rock Ramp	
Approx. Cost of Fishway	\$75-80k

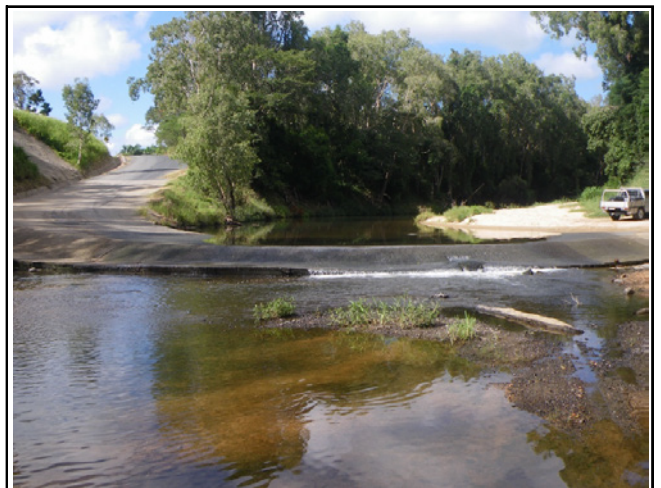
Overall Priority	4	
Stage 1 & 2 Priority	Stage 1	Stage 2
	23	9
Barrier ID	2630	
Stream Name	Constant Ck	
Location	21° 2.847'S	148° 59.299'E
Barrier Type	Weir/Road Crossing	
Barrier Name	Freds Weir	
Fishway Type Needed	Pre-cast/Rock Ramp	
Approx. Cost of Fishway	\$60-80k

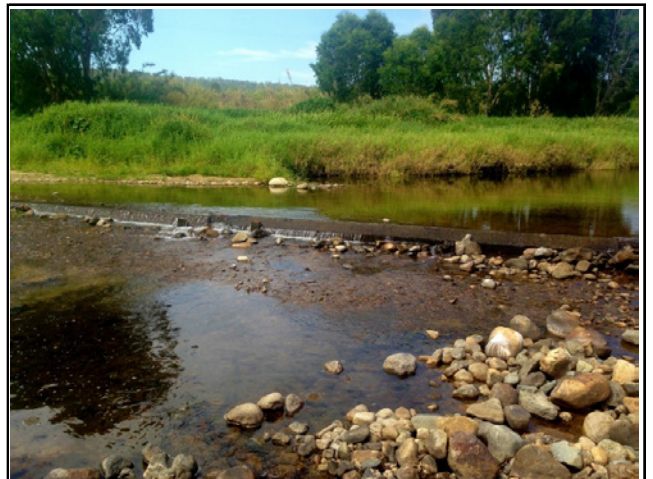
Overall Priority	7	
Stage 1 & 2 Priority	Stage 1	Stage 2
	31	3
Barrier ID	2614	
Stream Name	Jolimont Ck	
Location	20° 58.698'S	148° 52.734'E
Barrier Type	Weir	
Barrier Name	Mulherin Rd Crossing	
Fishway Type Needed	Pre-Cast/Rock Ramp	
Approx. Cost of Fishway	\$150-200k

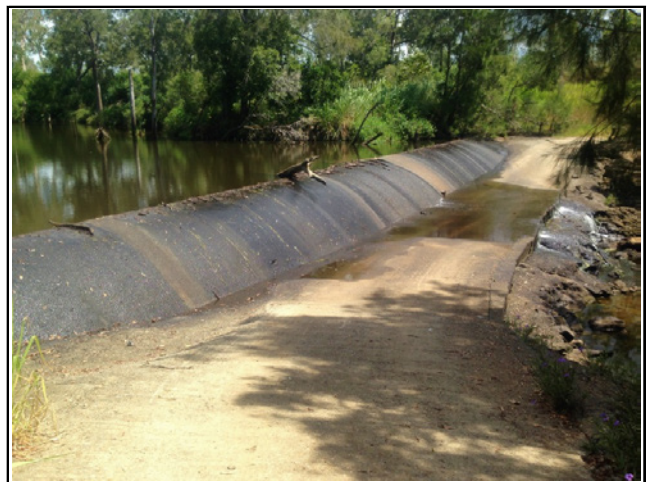
Overall Priority	7	
Stage 1 & 2 Priority	Stage 1	Stage 2
	5	12
Barrier ID	2588	
Stream Name	Blackrock Ck	
Location	20° 51.307'S	148° 45.426'E
Barrier Type	Causeway/Culvert	
Barrier Name	Old Bowen Rd Crossing	
Fishway Type Needed	Rock Ramp	
Approx. Cost of Fishway	\$60-70k

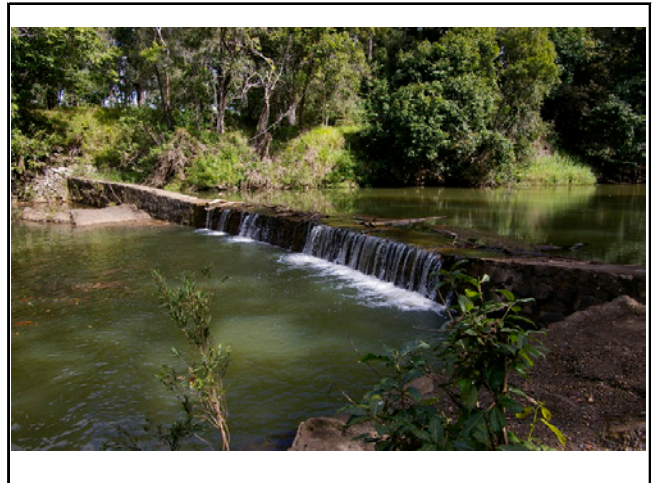
Overall Priority	11	
Stage 1 & 2 Priority	Stage 1	Stage 2
	4	3
Barrier ID	3965	
Stream Name	Carmila Creek	
Location	21° 54.723'S	149° 24.010'E
Barrier Type	Gauging Weir	
Barrier Name	DNRM Gauging Weir	
Fishway Type Needed	Rock Ramp	
Approx. Cost of Fishway	\$20-30k

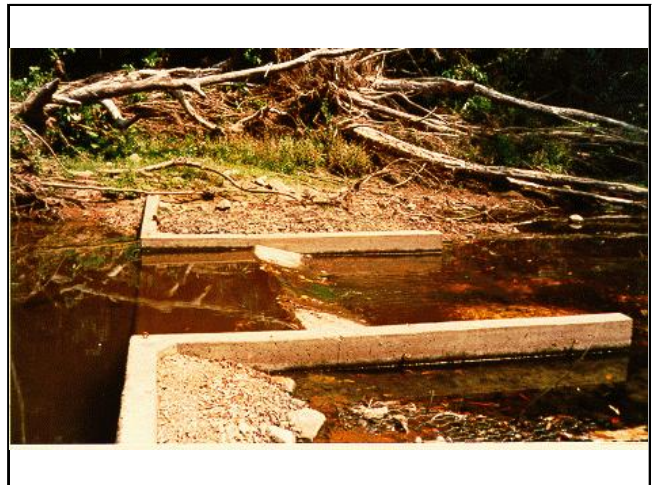
Overall Priority	11	
Stage 1 & 2 Priority	Stage 1	Stage 2
	23	17
Barrier ID	3574	
Stream Name	Marion Creek	
Location	21° 42.179'S	149° 23.753'E
Barrier Type	Culvert Causeway	
Barrier Name	Marion Settlement/Notch Pt Rd	
Fishway Type Needed	Rock Ramp + Baffles	
Approx. Cost of Fishway	\$20-30k

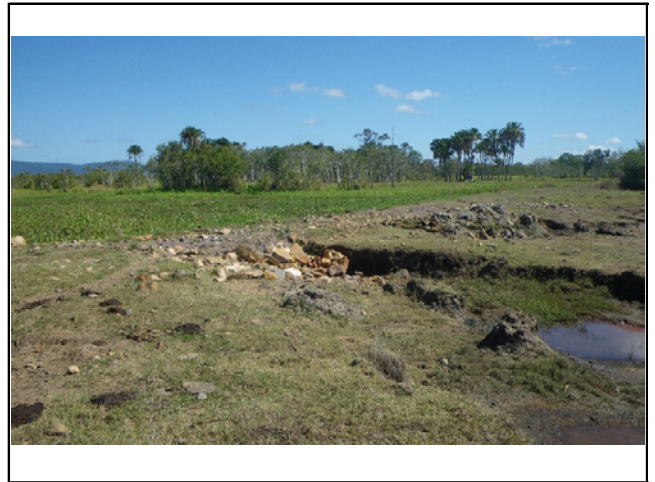
Overall Priority	13	
Stage 1 & 2 Priority	Stage 1	Stage 2
	4	12
Barrier ID	3174	
Stream Name	Cherry Tree Ck	
Location	21° 33.311'S	149° 15.379'E
Barrier Type	Culverts	
Barrier Name	East Inneston Rd	
Fishway Type Needed	Baffles	
Approx. Cost of Fishway	\$10-20k

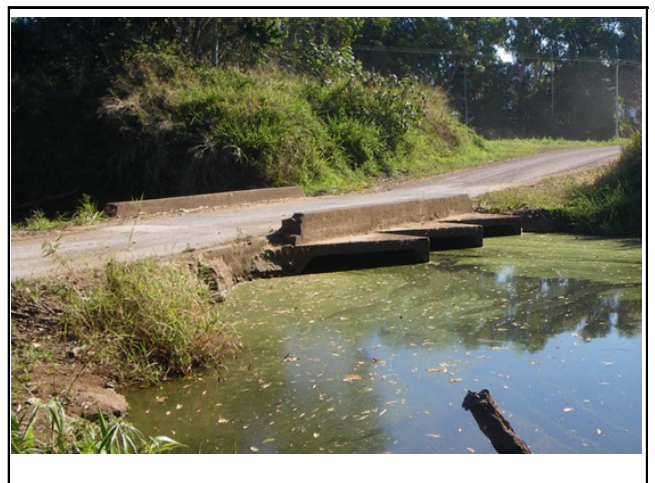
Overall Priority	13	
Stage 1 & 2 Priority	Stage 1	Stage 2
	53	17
Barrier ID	3981	
Stream Name	Boundary Creek/Wetlands	
Location	21° 31.499'S	149° 15.879'E
Barrier Type	Earth Bund/Causeway	
Barrier Name	Tidal Bund	
Fishway Type Needed	Rock Ramp/Precast Cone	
Approx. Cost of Fishway	\$75-85k

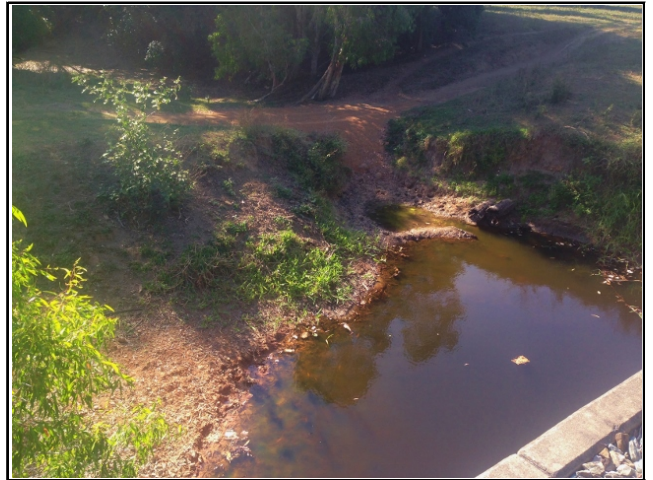
Overall Priority	13	
Stage 1 & 2 Priority	Stage 1	Stage 2
	31	22
Barrier ID	3933	
Stream Name	Mares Nest Creek	
Location	20° 34.932'S	148° 26.414'E
Barrier Type	Pipe Causeway	
Barrier Name	Station Rd	
Fishway Type Needed	Rock Ramp	
Approx. Cost of Fishway	\$40-50

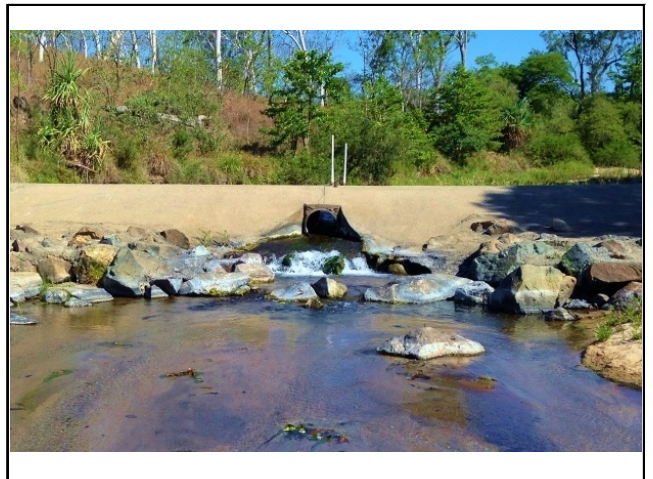
Overall Priority	18	
Stage 1 & 2 Priority	Stage 1	Stage 2
	53	34
Barrier ID	3881	
Stream Name	Lethe Brook	
Location	20° 26.286'S	148° 34.183'E
Barrier Type	Culvert + Rock Causeway	
Barrier Name	Upstream Railway Crossing	
Fishway Type Needed	Removal/Rock Ramp	
Approx. Cost of Fishway	\$40-60k

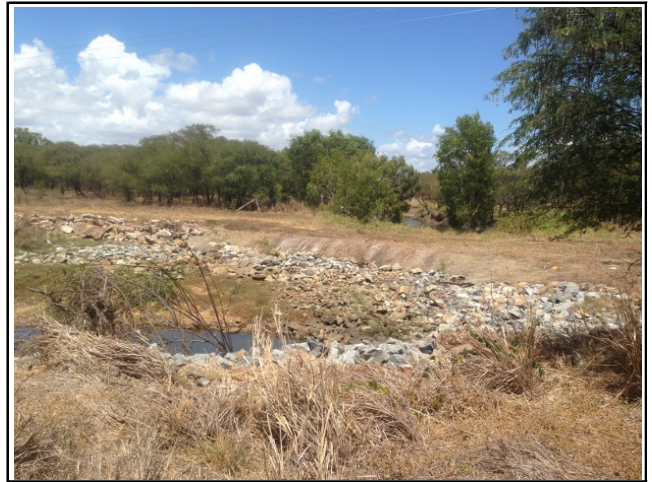
Overall Priority	18	
Stage 1 & 2 Priority	Stage 1	Stage 2
	31	17
Barrier ID	3942	
Stream Name	Boundary Ck (O'Connell R)	
Location	20° 41.756'S	148° 31.704'E
Barrier Type	Road Crossing/Culverts	
Barrier Name	Doughertys Rd Crossing	
Fishway Type Needed	2 x Rock Ramp + Baffles	
Approx. Cost of Fishway	\$30 - 40 k

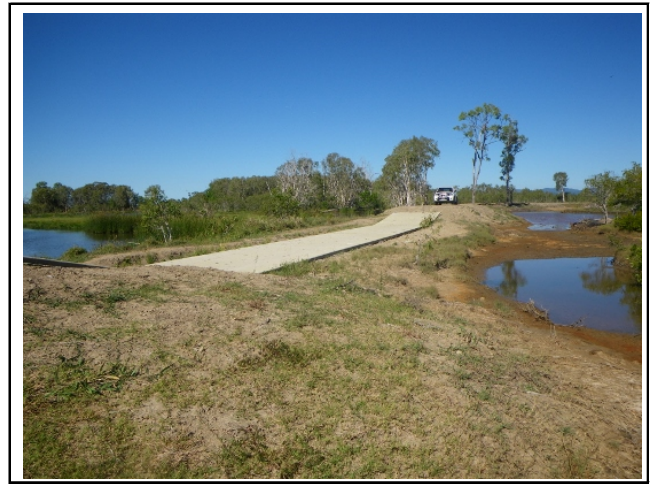
Overall Priority	18	
Stage 1 & 2 Priority	Stage 1	Stage 2
	31	22
Barrier ID	2616	
Stream Name	Jolimont Ck	
Location	20° 59.429'S	148° 53.303'E
Barrier Type	Culvert Road Crossing	
Barrier Name	Narpi Rd Crossing	
Fishway Type Needed	Baffled Culverts/ R.Ramp	
Approx. Cost of Fishway	\$60-80k/\$20-30k

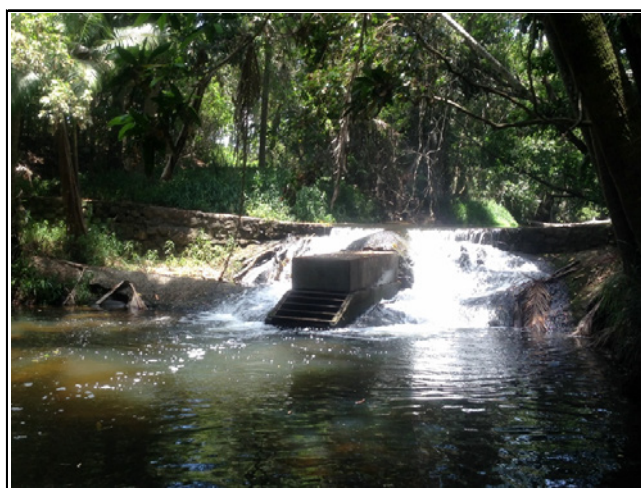
Overall Priority	26	
Stage 1 & 2 Priority	Stage 1	Stage 2
	31	29
Barrier ID	2610	
Stream Name	Macquarie Ck	
Location	21° 0.221'S	148° 51.181'E
Barrier Type	Weir	
Barrier Name	Private	
Fishway Type Needed	Pre-Cast/Rock Ramp	
Approx. Cost of Fishway	\$150-200k

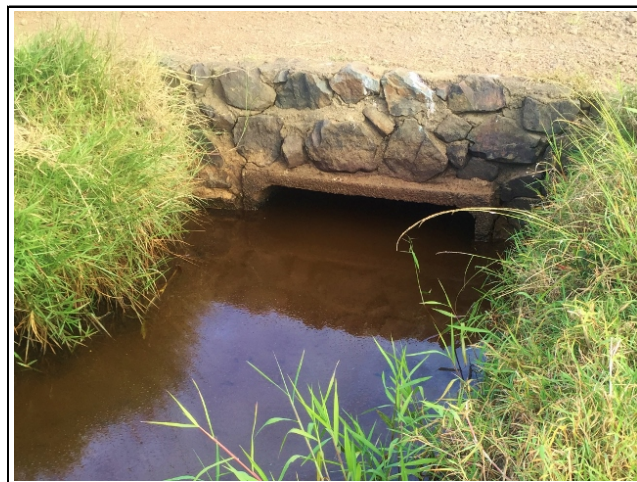
Overall Priority	26	
Stage 1 & 2 Priority	Stage 1	Stage 2
	67	34
Barrier ID	3928	
Stream Name	Thompson Creek	
Location	20° 31.006'S	148° 36.359'E
Barrier Type	Wetland Riser Pipe Bund	
Barrier Name	Thompson Ck Wetlands	
Fishway Type Needed	Rock Ramp	
Approx. Cost of Fishway	\$70-90k

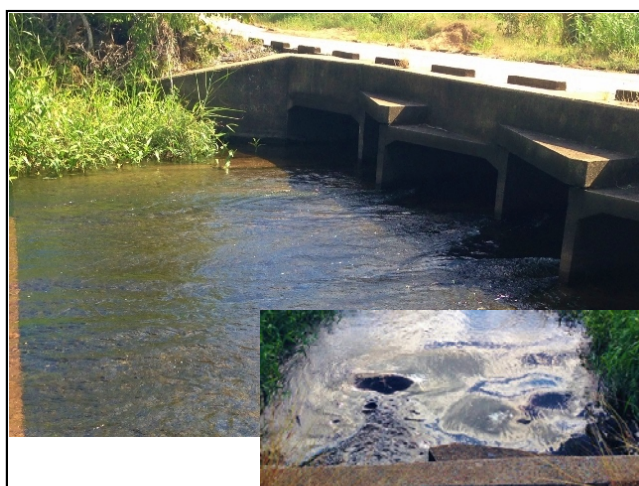
Overall Priority	33	
Stage 1 & 2 Priority	Stage 1	Stage 2
	53	43
Barrier ID	2744	
Stream Name	Carmila Creek	
Location	21° 55.368'S	149° 21.468'E
Barrier Type	Weir/Causeway	
Barrier Name	Streeters Rd Causeway	
Fishway Type Needed	Rock Ramp	
Approx. Cost of Fishway	\$40-50k
